## SERVICE BULLETIN

**APPLICABILITY:** 2016-18MY Crosstrek  
 2016-18MY Forester  
 2016-18MY Impreza  
 2016-18MY Legacy & Outback  
 2017-18MY WRX

**NUMBER:** 15-312-23R

**SUBJECT:** Data Control Module (DCM)  
 Dark Current Diagnosis

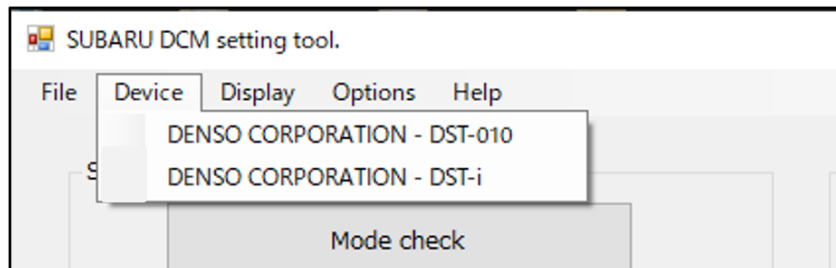
1. From the Toughbook, go to the the button on the desktop for: MyDocuments, then from the file window, go to > Subaru > DCM Setting Tool, and click on the shortcut marked **DcmSettingTool**.
2. Upon the initial opening of the factory mode tool or when the configuration file is not specified, an error message will appear on the screen. Click on **OK** and ignore this error. A window will pop up to then specify the key file. Confirm the appearance matches the example image below and click **Open**. If the pop up does not appear or match the example, proceed to Step 6 below.
3. ONLY use the menu and button on the left side of the window with the “subscription mode setting” at the top of the window.
4. Before using the tool, ensure that under the Device menu that, DENSO CORPORATION - DST-i or DST-010 is selected.

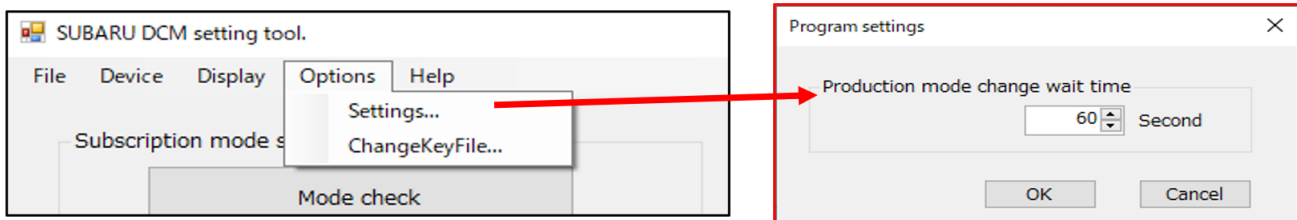
5. Before using the tool, ensure that under the Options menu sub-menu Settings, the Production mode change wait time setting is set to 60 second.

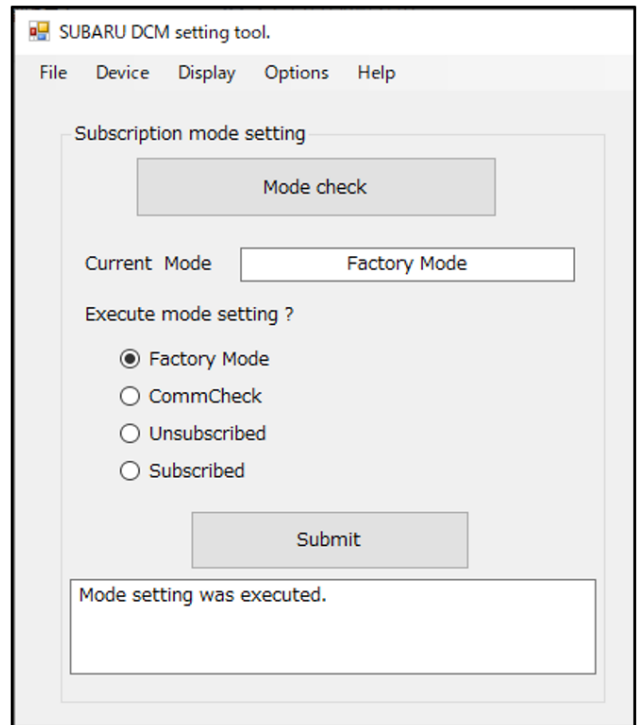
1. Click the Mode Check button.
  - A. If any mode is displayed other than Factory, continue with the mode change procedure.
  - B. If Factory mode is already indicated, there is no need to continue this procedure. The Technician must re-evaluate his parasitic draw test results to determine how to resolve that concern best.
2. Ensure that the Factory Mode button is clicked.
3. Click the Submit button. The message box under the Submit button should indicate that the “Mode setting was executed.”

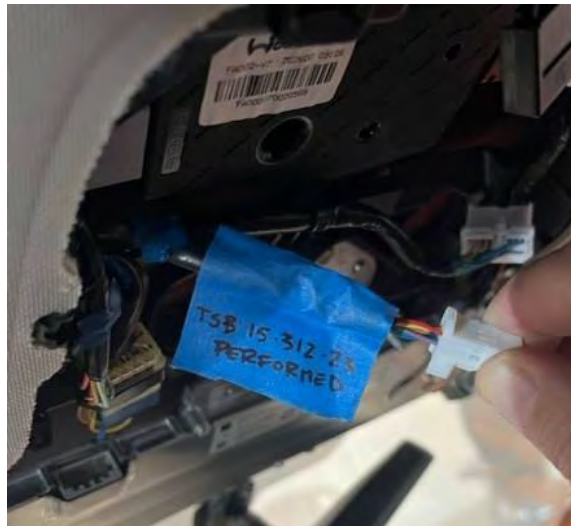
- C. A DCM successfully moved to Factory Mode will have the Green Telematics LED illuminated whenever the key is on. This Green indicator LED does not indicate a valid subscription, it indicates a non-comm checked DCM in Factory Mode. **DO NOT** perform a comm check to a DCM in Factory Mode.
5. Once the Current Mode is confirmed as Factory Mode, remove the overhead trim panel and disconnect the SOS / i-Button switch so it is not accidentally depressed.
  6. Wrap the switch assembly connector using a tape that can be written on, leaving a pigtail piece accessible to write the TSB number on. Use a permanent marker like a “Sharpie” to indicate this TSB number for future reference. This tape will prevent any unwanted electrical connections and identify the TSB that indicates why it should remain disconnected. See the example image below.
