Symptom - Rattling Noises from Around the Rear Axle: Checking Engine Mount (SY 183/21)

Model Line: **911 (992)**

Model Year: **As of 2020 up to 2024**

Concerns: **Rear engine mount**

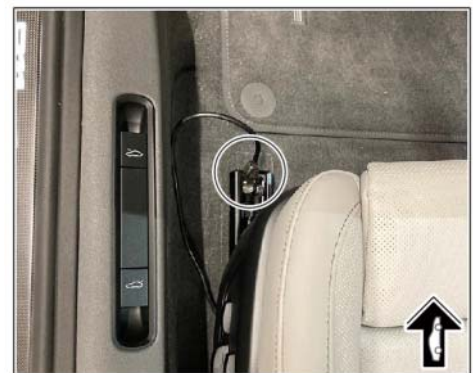
Item sensor channel B

- Sensor type: Acceleration sensor
- Item: Passenger compartment
- Fastening on the vehicle: Seat rail for driver seat at **left** ⇒ *Item sensor channel B*

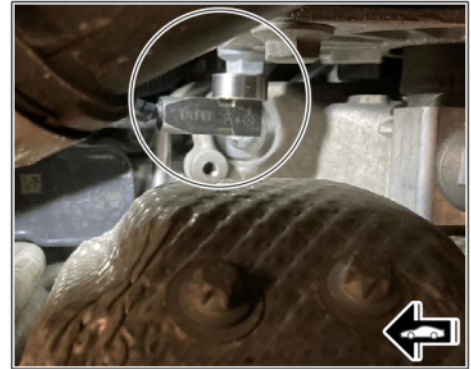
Item sensor channel C

- Sensor type: Acceleration sensor
- Item: Engine compartment
- Fastening on the vehicle: Screw on PADM bearing on the **left** on longitudinal member ⇒ *Item sensor channel C*

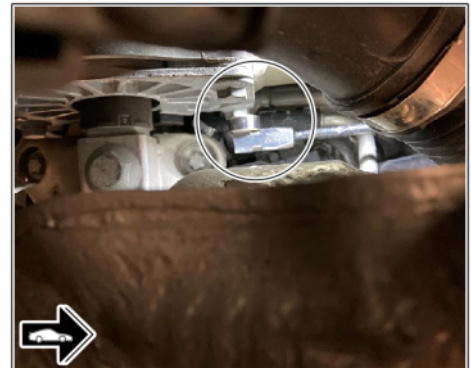
Item sensor channel D

- Sensor type: Acceleration sensor
- Item: Engine compartment
- Fastening on the vehicle: Screw on PADM bearing on the **right** on longitudinal member
⇒ *Item sensor channel D*

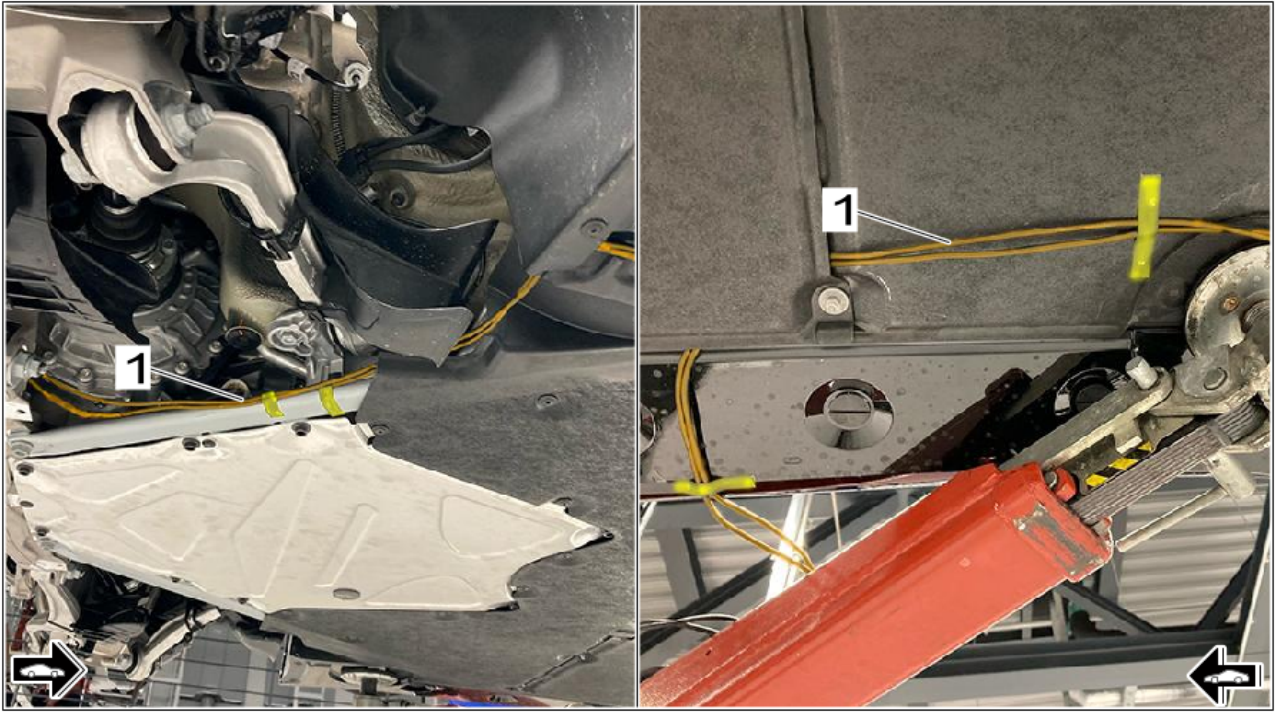
Example of routing / fastening underbody

- 4 Route the test leads ⇒ *Example of routing / fastening underbody -1-* in such a way that they are not damaged during the analytical run.
