## TECH TALK - VOLUME 279

### MARCH/APRIL 2024

## TECHNICAL INFORMATION

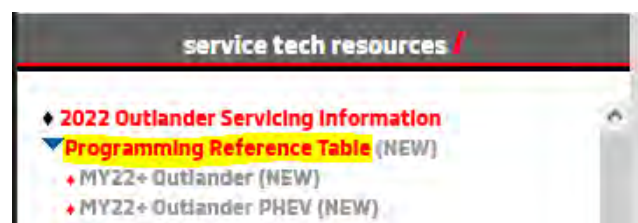
After replacing a Control Unit during auto configuration, the progress bar may load to 51% - 56% and then displays a server error. This can occur for several reasons. First the Control Unit needs to be programmed before Auto Configuration can be completed. Second, the Control Unit was programmed with the incorrect part number and needs to be re-programmed with the correct part number before Auto Configuration can be completed.

Outlander (DG) Control Unit programming part number list can be found on MDL > Service > Service Tech Resources > Programming Reference Table

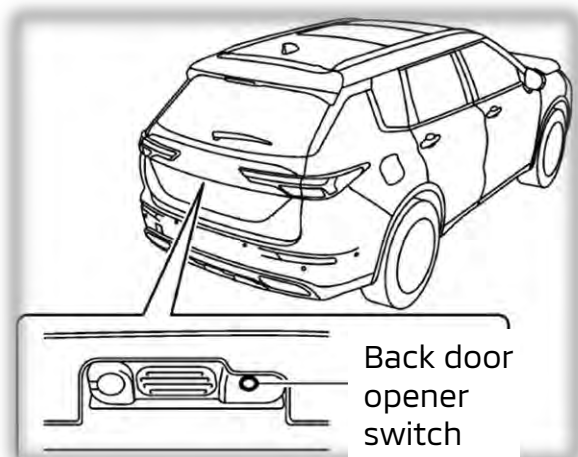
This article introduces the cause and confirmation method for the issue that the vehicle tailgate will open unintentionally.

Leave the KOS key in the storage location:

- Push the back door opener switch or
- 'Deliberately trigger the hands-free sensor' to make sure the car doesn't respond.

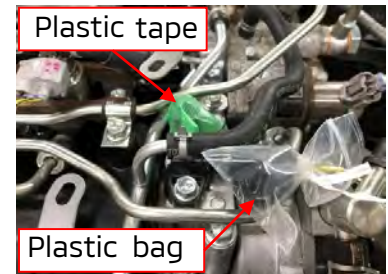
During maintenance operations, sensors or connectors may be exposed to liquids: water or LLC.

4N14 - Common rail pressure sensor issue due to high-pressure car washing. Worst case scenario: Engine stall, unable to restart.

When the connector is disconnected, please protect it with waterproof material: plastic tape or plastic bag.

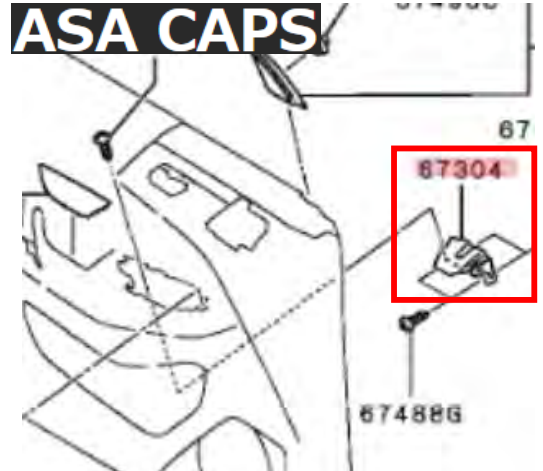
Due to the screw hole structure of the door pull handle bracket, strong opening/closing operations may cause the tapping screw to rotate and loosen, resulting a loose door handle with noise. To prevent this phenomenon from occurring, changes were made to the Bracket on the front left/right doors and specified the tightening torque as shown below.

2023-2024 OUTLANDER PLUG-IN HYBRID (GNOW)  
2022-2024 OUTLANDER (GMOW)
