# Technical product information

<b>Topic</b>	Rear screen sunblind operational issues
<b>Market area</b>	Australia E04 Bentley rest Asia and Australia (6E04),China 723 Volkswagen (Anhui) Automotive CO (6723),China 796 VW Import Comp. Ltd (Vico), Beijing (6796),Germany E02 Bentley rest Europe (6E02),Japan E03 Bentley Japan (6E03),Korea, (South) E08 Bentley South Korea (6E08),United Arab Emirates E06 Bentley Middle East and Africa (6E06),United Kingdom E01 Bentley UK (6E01),United States E05 Bentley USA and rest America (6E05)
<b>Brand</b>	Bentley
<b>Transaction No.</b>	2070643/4
<b>Level</b>	EH
<b>Status</b>	Approval
<b>Release date</b>

### New Flying Spur

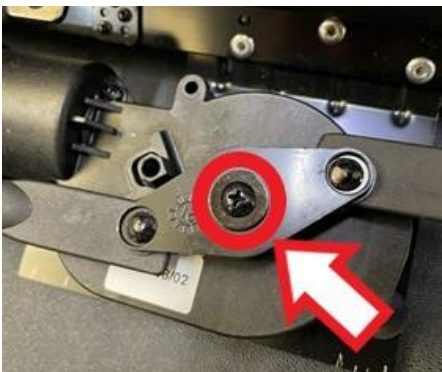
Diagnosis requirements - Gearbox jam or Rotator plate jam (Blind non operational)

- Referring to Figure 7 - Remove the rotator plate fixing (2.5Nm)
