Technical product information

Topic	New Continental GT and GTC - Window drop glass operation
Market area	Australia E04 Bentley rest Asia and Australia (6E04),China 723 Volkswagen (Anhui) Automotive CO (6723),China 796 VW Import Comp. Ltd (Vico), Beijing (6796),Germany E02 Bentley rest Europe (6E02),Japan E03 Bentley Japan (6E03),Korea, (South) E08 Bentley South Korea (6E08),United Arab Emirates E06 Bentley Middle East and Africa (6E06),United Kingdom E01 Bentley UK (6E01),United States E05 Bentley USA and rest America (6E05)
Brand	Bentley
Transaction No.	2070497/8
Level	EH
Status	Approval
Release date

New Continental GT and GTC

Retailer glass reset procedure for GT/GTC

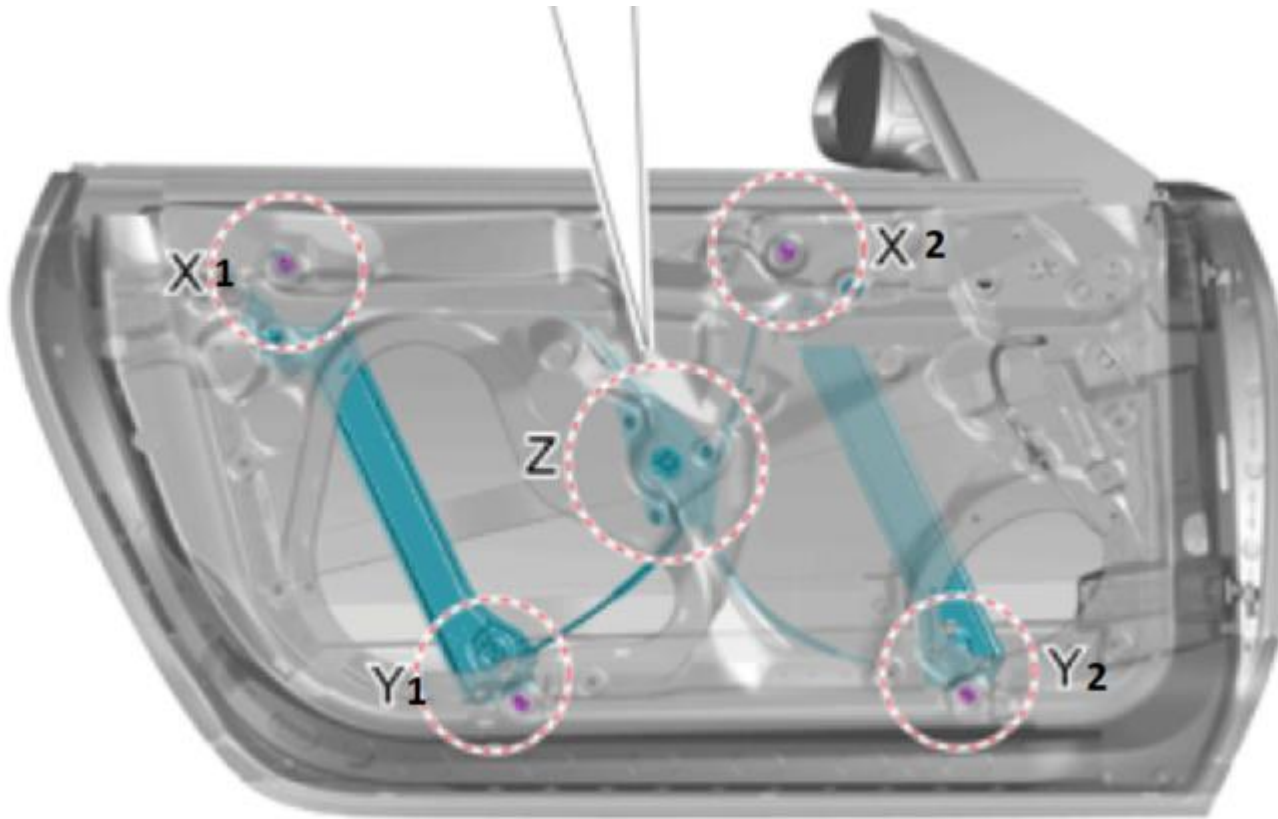
Regulator adjusters X1 X2

Measure from top of mounting washer to frame

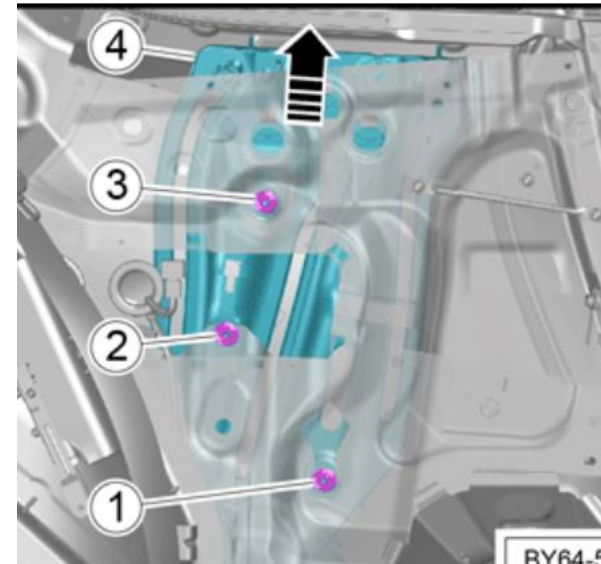
- Rear quarter regulator adjuster reset

Before resetting adjusters remove the 3 13mm lock nuts (1-3 in image) to allow adjusters to be fully screwed in without damaging the regulator, Also ensure black closing panel (see page 12) is not stopping the regulator from moving when performing these adjustments.

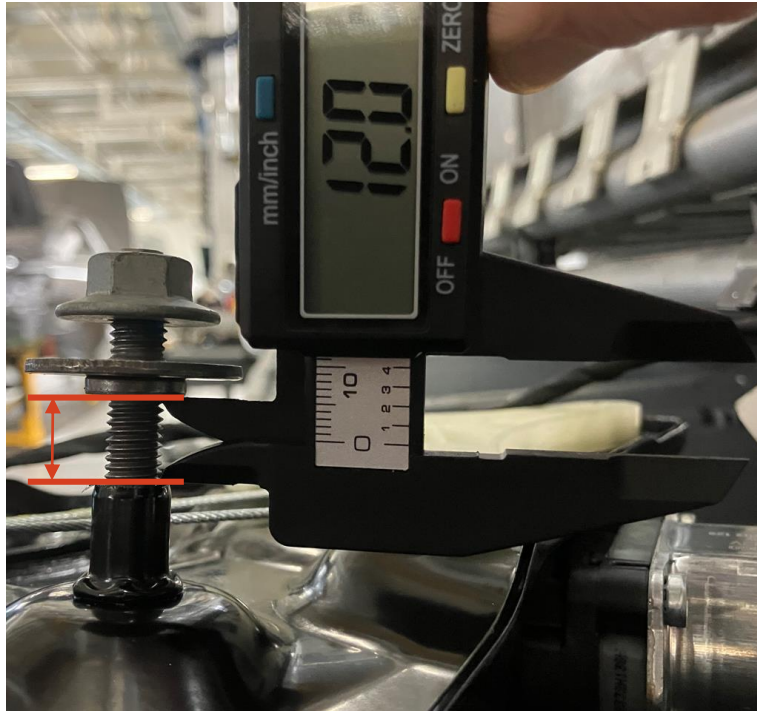
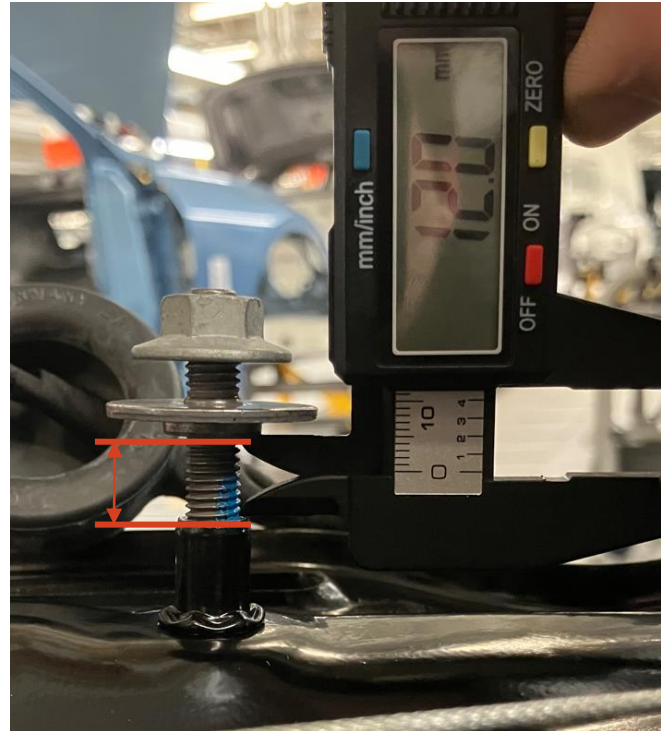
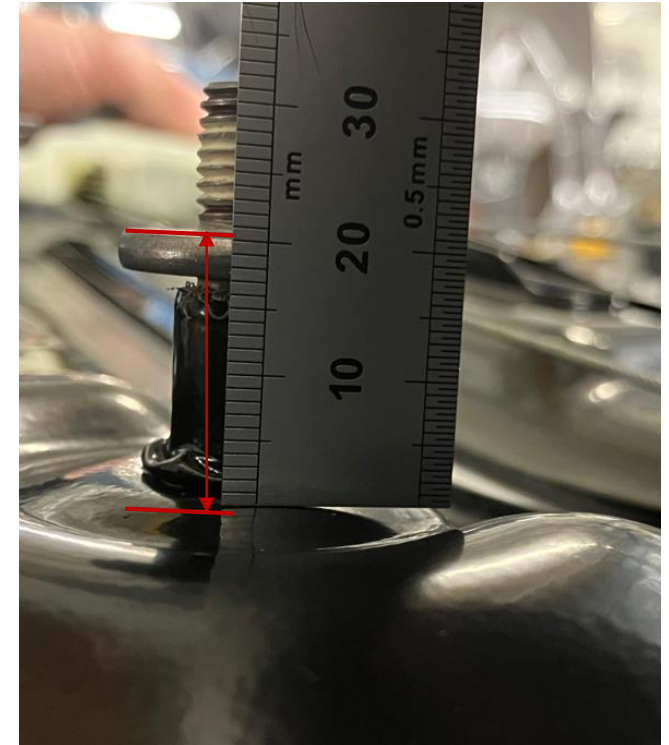
- Rear quarter regulator adjuster reset

fully screw in clockwise until hard stop, then unscrew 1 turn anticlockwise to achieve 20mm gap as seen below

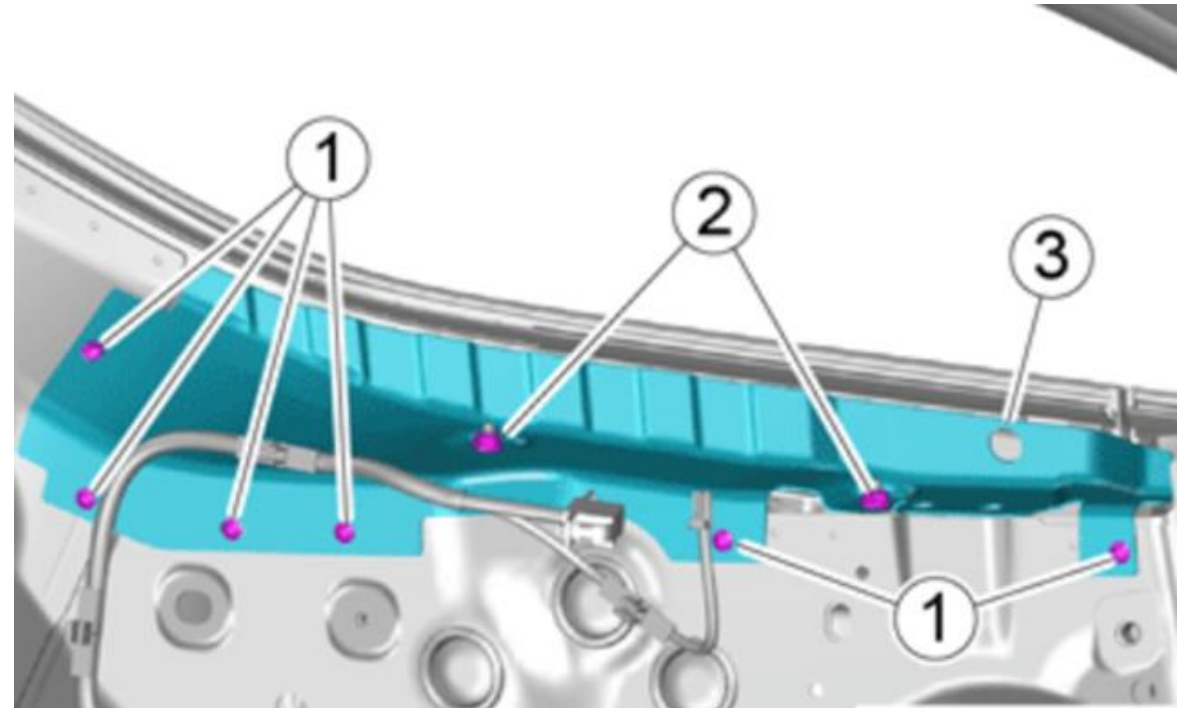
10mm nuts (item 2) must be loosened when adjusting the 3 regulator adjusters to allow the regulator to move. Retighten and check measurements after each adjustment is made

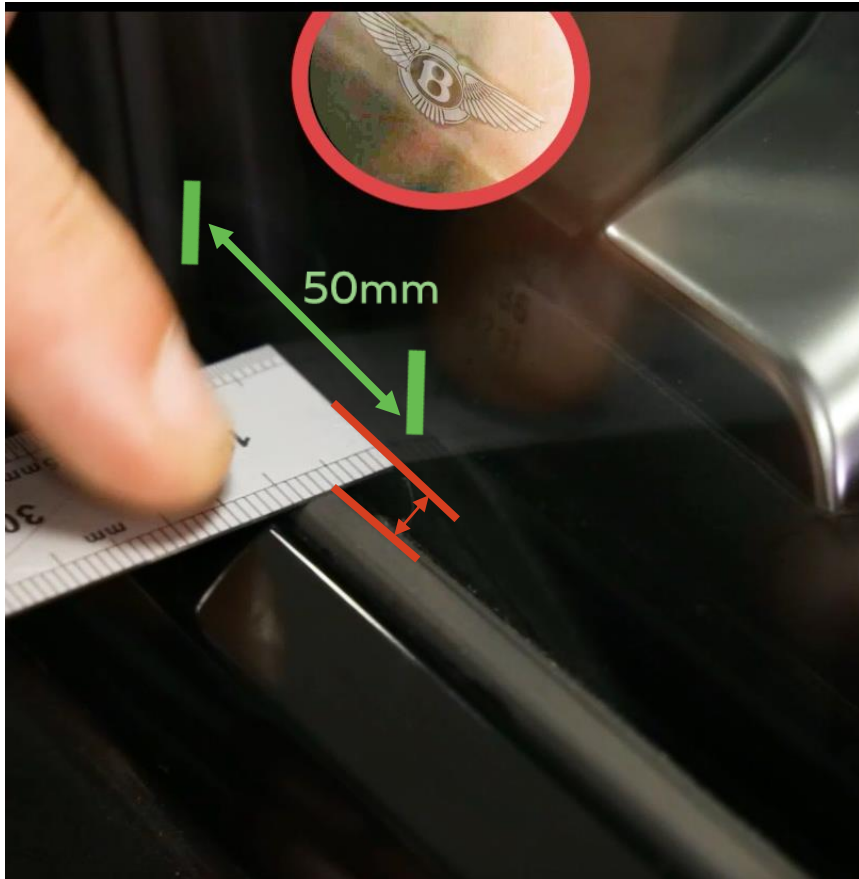
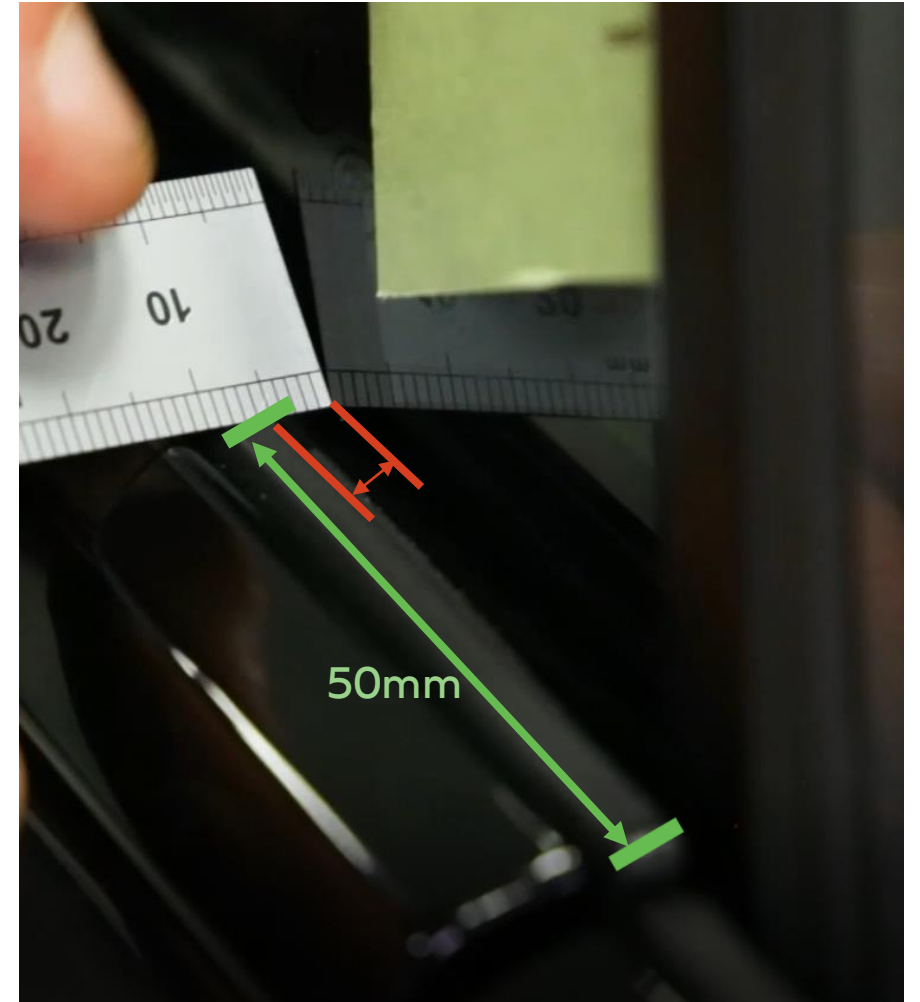
- **Waistrail measurement checking/resetting**

Set waist rail gapping to between 4-6mm as mentioned in Glass setting guide videos on E-Academy and also check for parallelism along front and rear windows to door/quarter. 50mm from edge of Waistrail seal, roughly underneath the Bentley wings.
