<b>Technical Service Bulletin</b>	<b>GROUP</b> <b>BODY ELECTRICAL</b>	<b>NUMBER</b> <b>21-BE-008G</b>
	<b>DATE</b> <b>May, 2021</b>	<b>MODEL(S)</b> <b>G70 (IK)</b>
<b>SUBJECT:</b> SOFTWARE UPDATE FOR MODEM INFORMATION DISPLAYING ALL ZEROS

**Description:** Certain vehicles may experience 504 Time Out errors when using the Genesis Connected Services Mobile App. When asked to provide Modem Information (IMEI/USIM), the Head Unit (HU) displays all zeros. This bulletin describes the procedure to update the Head Unit Software to correct this condition.

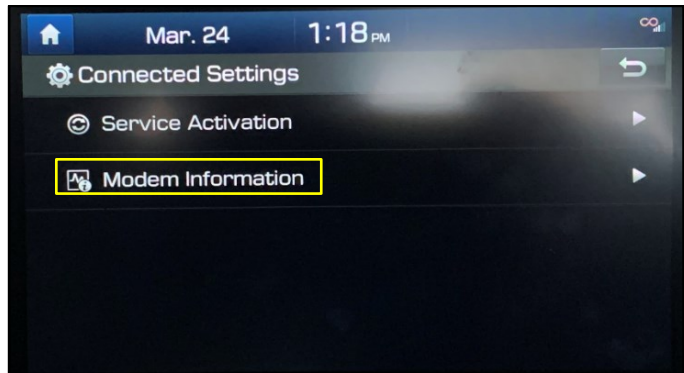
5. Select Modem Information.

6. USIM & IMEI information will display all zeros.

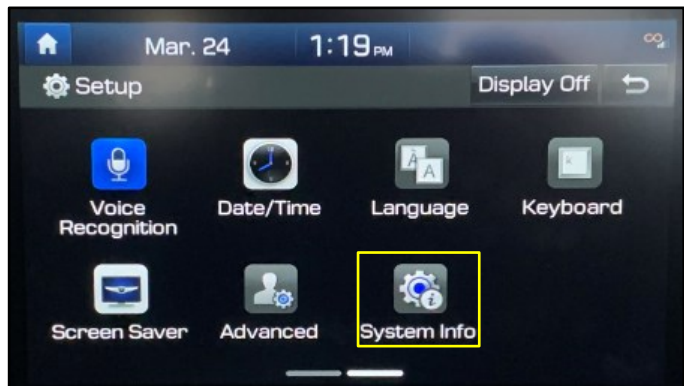
7. Return to the **Setup** screen and select the **System Info** icon.

For AVN 5.0, the **System Info** icon will change to the **General** icon after the update is complete.

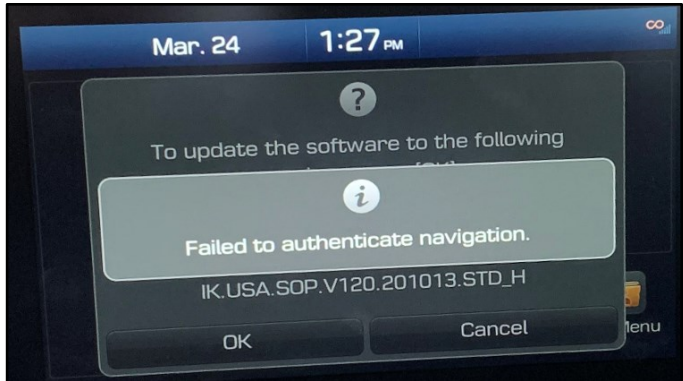
9. Insert the SD Card Back into the vehicle SD Port.

User may receive error message "Failed to authenticate navigation".

Please ignore and proceed to update the device by pressing OK or returning to **System Info**.
