**SERVICE BULLETIN**

**APPLICABILITY:** 2020-2022MY Outback & Legacy  
 2022-2023MY BRZ  
 2022-2023MY WRX

**NUMBER:** 15-270-20R

**SUBJECT:** FOTA (Firmware Over-The-Air) Reprogramming for DENSO Gen 4 Audio / Navigation Infotainment Systems

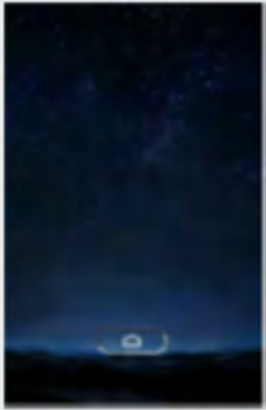
No.	Conditions/Symptoms to be improved
1	Unexpected CP1 system reboot resulting from an inter reset to sync internal communication with Bluetooth module.
2	CID restarts itself right after engine is started.
3	CID resets and reboots.
4	<p>4 Right after starting up, the CID is blank only displaying the background without icons.</p>

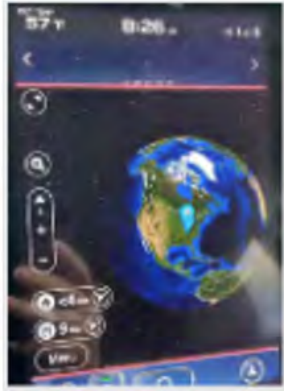
No.	Conditions/Symptoms to be improved
14	<p>Navigation map scale is changed to the lowest setting (globe is displayed).</p>

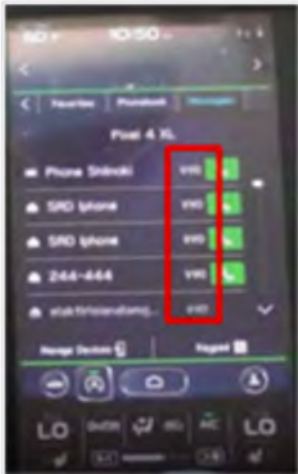
15	<p>When “Call” button is pressed in “Confirm Destination” screen of Navigation system (to call the destination site,) the call can be made but the screen does not transit to phone call screen.</p>
16	<p>When selecting “Phone-&gt;”Message,” message received time is displayed incorrectly as “1/1/0.” It can occur with an Android phone with a specific Android OS (Pixel 6, Pixel4a, Pixel4XL, Xperia etc. ) in which time zone data is attached to the message receiving time.</p>

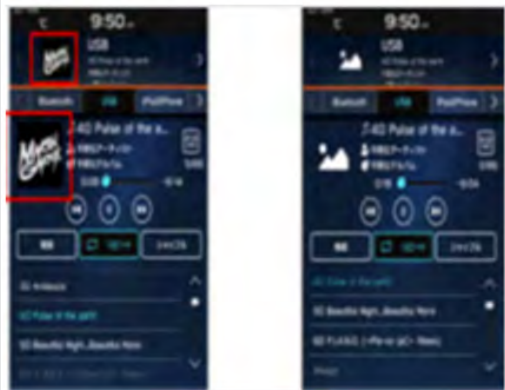
17	<p>Even when using the same mobile device that was paired previously, a message of “Are you sure you want to activate this profile?” is prompted and confirmation is needed to activate the device.</p>
18	<p>Cover art of previous music is displayed when playing music without cover art in USB audio. It can occur when music with and without cover art is mixed and stored together a single USB.</p>

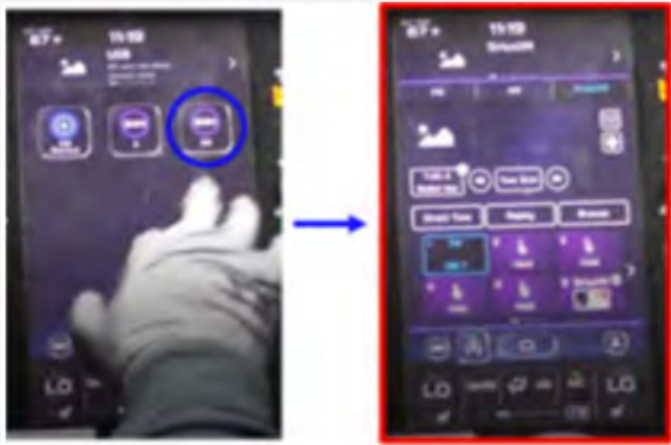
22	The mode does not switch to Media, after “Media” icon is selected.
23	<p>When selecting shortcut for SXM channel on “Home” screen, the screen is changed to SXM but no sound is coming or no channel name is displayed.</p>

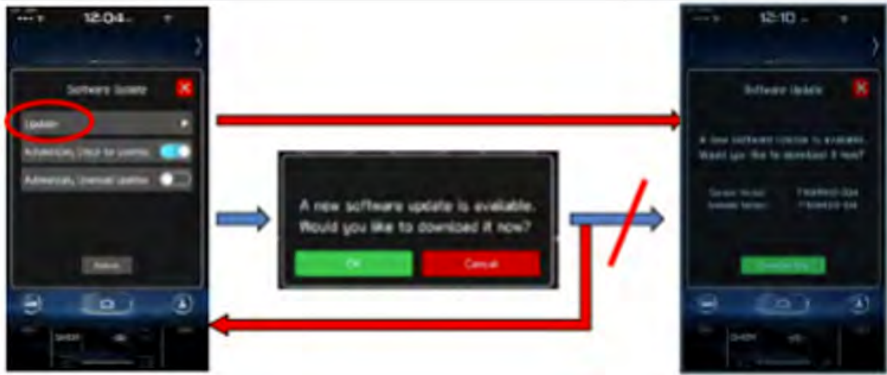
24	<p>When using FOTA service to update the software by selecting “Setting” &gt; “Software Update,” a message of “A new software update is available. Would you like to download it now?” is displayed but the downloading does not start after pressing “OK.” When this symptom occurs, it comes back to the “Software Update” screen. The downloading can be started by pressing the “Update” on the “Software Update” screen. (Temporary solution.)</p>

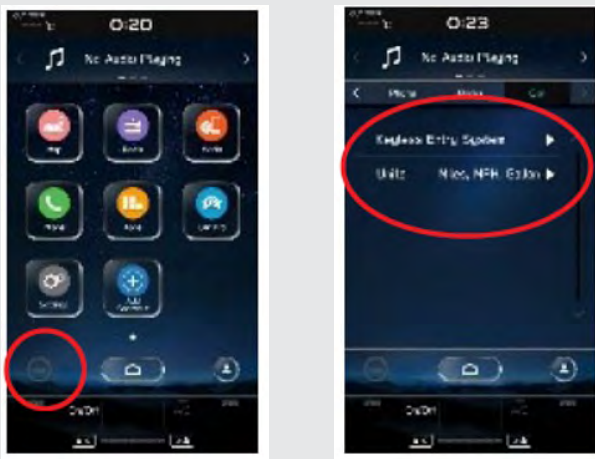
5	Ring tones and the voice from the other end on the hands-free phone call cannot be heard	USB ONLY
6	Android Auto does not function. “Android Auto is Disconnected” is displayed with Launch Error message.	USB ONLY
7	Time setting is not possible in Manual mode	USB ONLY
8	<p>Vehicle Setting Icon in &lt;Home&gt; menu is grayed out. Menu list in the “Car” tab in the Setting Menu is not displayed.</p>

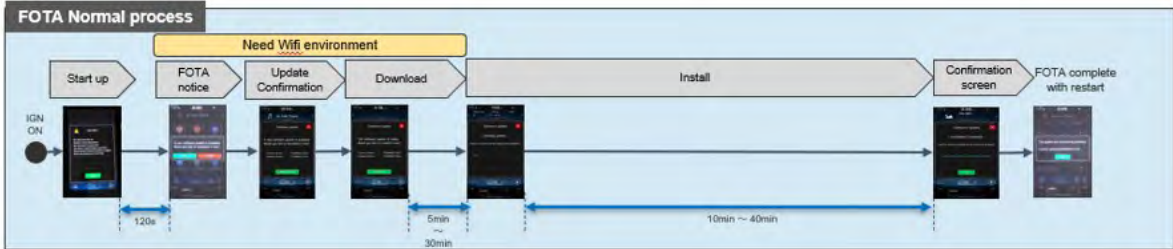
No.	Conditions/Symptoms to be improved
1	<p>System restarts itself during FOTA (Firmware Over The Air) update. FOTA operation is conducted in two processes: downloading (from the server to the Cockpit Control Unit via Wi-Fi) and installation (inside the Cockpit Control Unit). During the FOTA operation, after the new software has been downloaded to the Cockpit Control Unit (CCU) customer is to push “Install Now” on the Center Information Display (CID) to start installation of the software.</p>

<p>However, in rare case, the CCU restarts itself* during installation.</p>

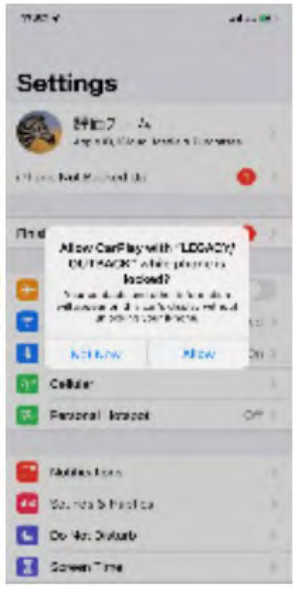
3	Cannot finish registration, DMS user registration
4	Cannot select Wi-Fi to ON, button is gray out
5	Intermittent loss of Bluetooth connection
6	Phone contacts transfer fails, when pairing iPhone with Bluetooth
7	Blank display when connecting CP1 to Wi-Fi network with long name (over 32 characters)
8	<p>While using Apple CarPlay, "SUBARU" is displayed on the iPhone Setting menu instead of vehicle name &lt;LEGACY/OUTBACK&gt;</p>

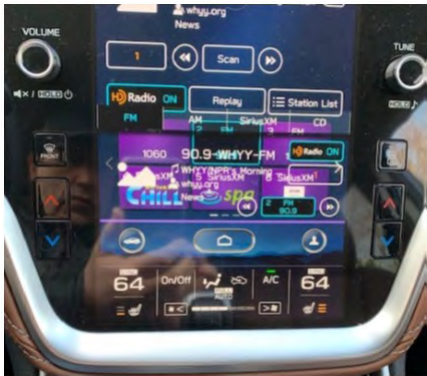
No.	Conditions/Symptoms to be improved
10	Screen is no changed to Composer or Album screen, iPhone /iPod connected as iPod mode
11	<p>CID shows multiple images simultaneously</p>

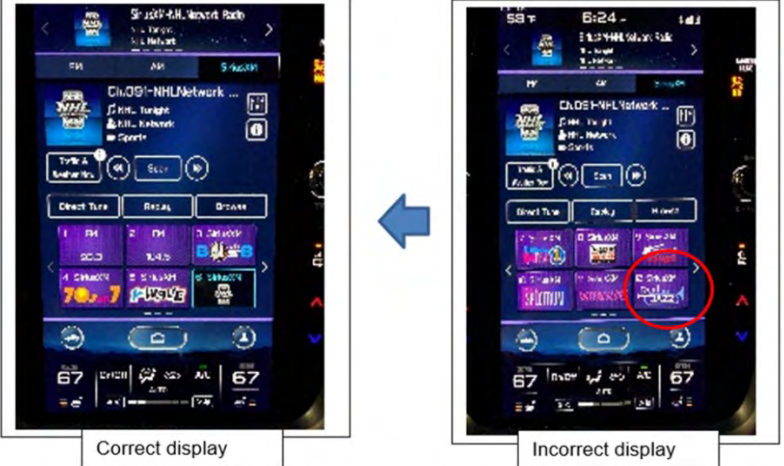
No.	Conditions/Symptoms to be improved
38	Temperature setting cannot be controlled by Voice Recognition in Canadian (C*) specification
39	Preset outline is not shown following station selection using steering switch

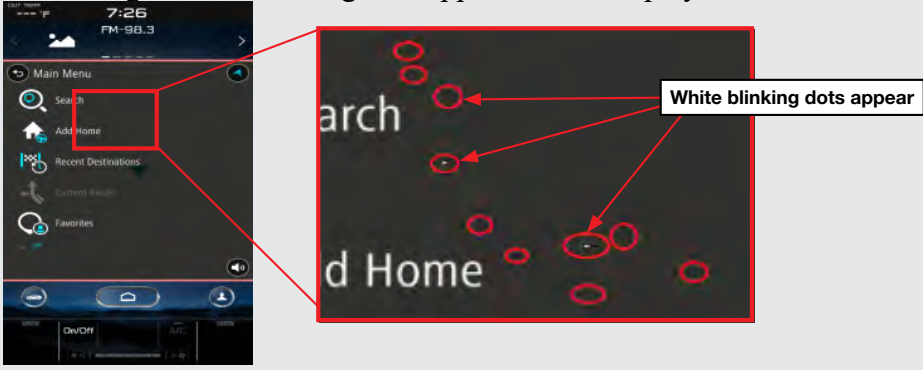
No.	Symptom to be improved	FOTA
1	Several minutes after Engine start, Center Information Display (CID) reboots itself	Yes
2	After extended usage, white blinking dots appear on the display.

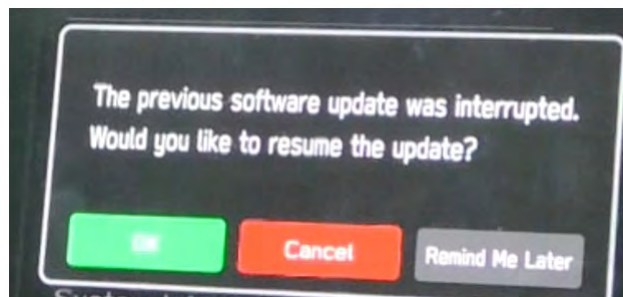
**7. If you receive the following message during the update:**

- a. The above message will display if the vehicle is turned off during the software update process. Select “OK” to resume the process.

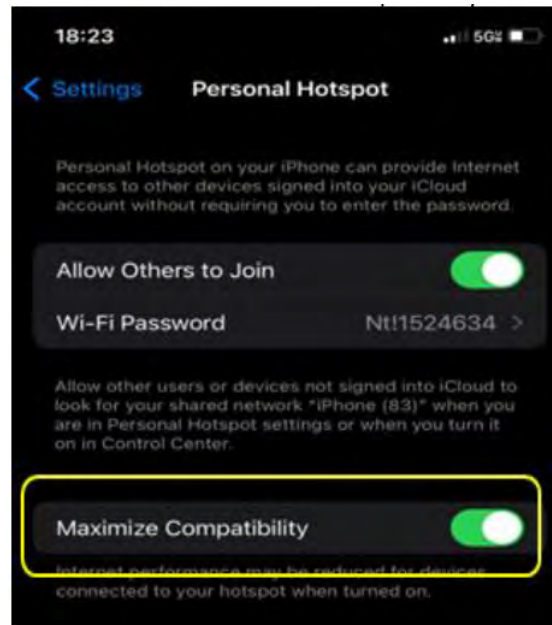
## 8. CP1 connectivity issues observed when tethered via iPhone hotspot (Phone as Modem/Wi-Fi Hotspot).

1. iPhone Settings: Advise the customer to adjust their iPhone hotspot settings as follows:

- Navigate to Settings > Personal Hotspot.
- Enable Maximize Compatibility.

2. Frequency Confirmation: Verify the connected network on the CP1. Ensure it's operating on the 2.4 GHz band. If not, manually select the 2.4 GHz network option on the CP1, if available.

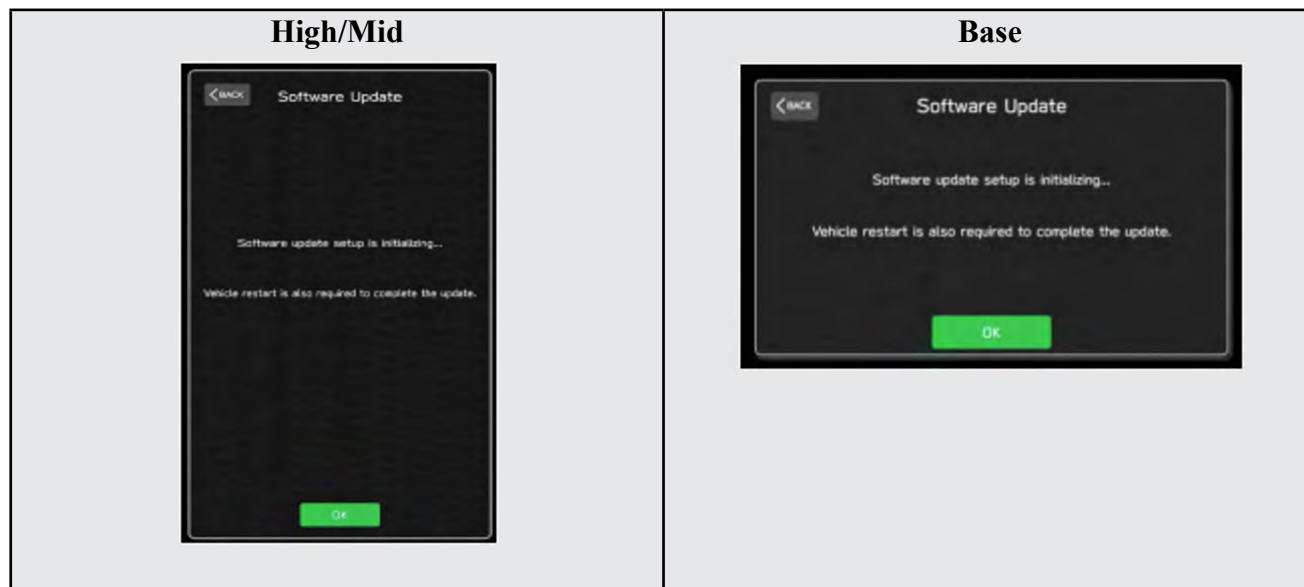
Follow this procedure in the RARE case of “Software update setup is initializing...” message is displayed: • If the screen shown below appears, WAIT for approximately 30 minutes or as long as necessary (waiting for longer than 60 minutes might indicate system malfunction).

1. Turn the ignition OFF, open the driver's door, close the driver's door and **WAIT** for 3 or more minutes before proceeding further.
2. Open the driver's door again and either turn the ignition ON (if a charger is connected) or start the engine.
3. Please proceed with USB Update following TSB 15-261-20.

**IMPORTANT NOTE:** If this procedure is required, contact Techline as additional action may be necessary
