Service Bulletin

Bulletin No.: 23-NA-191

Subject: Shake and/or Shudder During Steady Speed and/or Light Throttle Acceleration Between 25 and 50 MPH (40 and 80 KM/H)

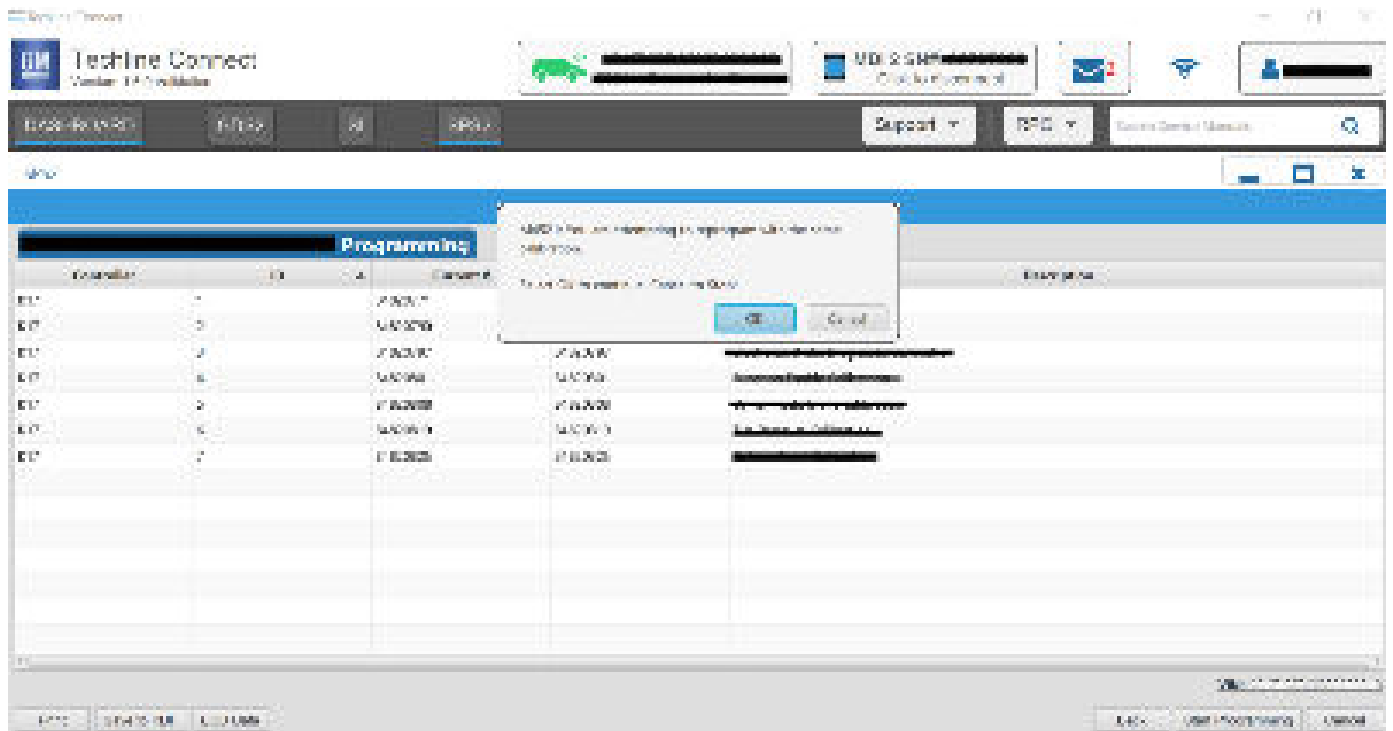
5877000

Important: Techline Connect screens shown above.

Important: If the same calibration/software warning is noted on the TLC Summary screen, select OK and follow screen instructions. After a successful programming event, the WCC is located in the Service Programming System dialogue box of the SPS Summary screen. No further action is required. Refer to the Warranty section of the bulletin.
