Service Bulletin

Bulletin No.: 08-07-30-021G

Subject: Loss of High Speed GMLAN Communications, Intermittent No Crank, IP Gage Fluctuation, Intermittent Door Lock Cycling, Intermittent Chime Operation, Various IP Warning Lamps Illuminated, Transmission May Not Shift, Communication DTCs U0073, U0100, U0101, U0102, U0109, U0121 or U0140 Set (Repair Terminals in Transmission Harness Connector, Repair Open or Shorted GM High Speed LAN Circuits, Open or Shorted Data Link Resistor, Corrosion or Poor Connections in Various Control Module Connectors)

Models: 2007–2010 Cadillac XLR
 2007–2012 Cadillac Escalade Models
 2009–2012 Cadillac Escalade Hybrid
 2007–2012 Chevrolet Avalanche, Corvette, Silverado, Suburban, Tahoe
 2008–2012 Chevrolet Silverado Hybrid, Tahoe Hybrid
 2007–2012 GMC Sierra, Yukon Models
 2008–2012 GMC Sierra Hybrid, Yukon Hybrid
 2008–2009 HUMMER H2
 Equipped With Gasoline Engine and 6 Speed Automatic Transmission 6L80 (RPO MYC) or 6L90 (RPO MYD)
 Equipped With Hybrid Propulsion (RPO HP2) and Two Mode 2ML70 Automatic Transmission

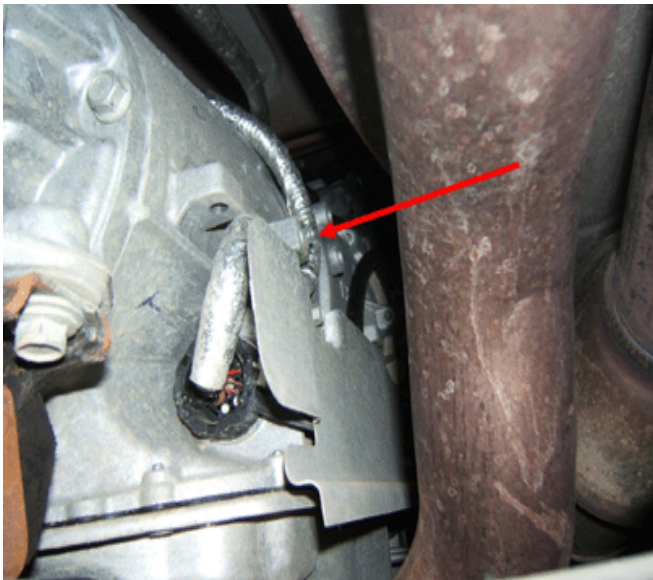
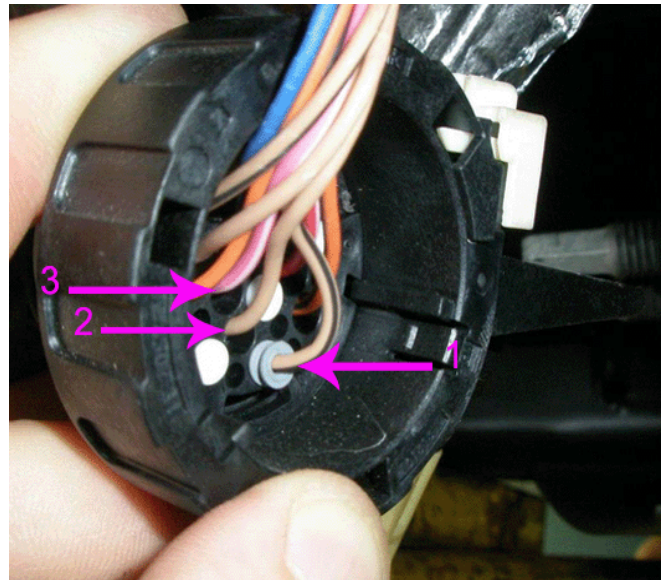
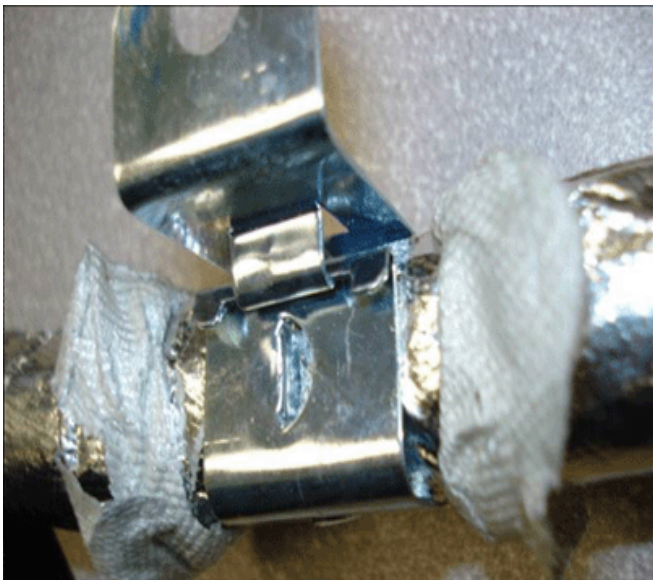
3. Locate the 16-way electrical connector on the right side of the automatic transmission as shown.
4. Inspect for chafed, damaged, pinched, open or shorted wiring within the conduit of the harness where it is secured at the transmission by a metal attachment clip as shown. Inspect any wiring harness where these metal attachment clips are used on the vehicle as needed.
 - ⇒ If the wiring is damaged, repair as needed. Refer to Power and Signal Distribution > Wiring Systems and Power Management > Diagnostic Information and Procedures in SI. Protect the conduit by covering any sharp edge with butyl tape and the conduit and wiring harness with woven polyester (PET) electrical tape. Secure the harness as needed.

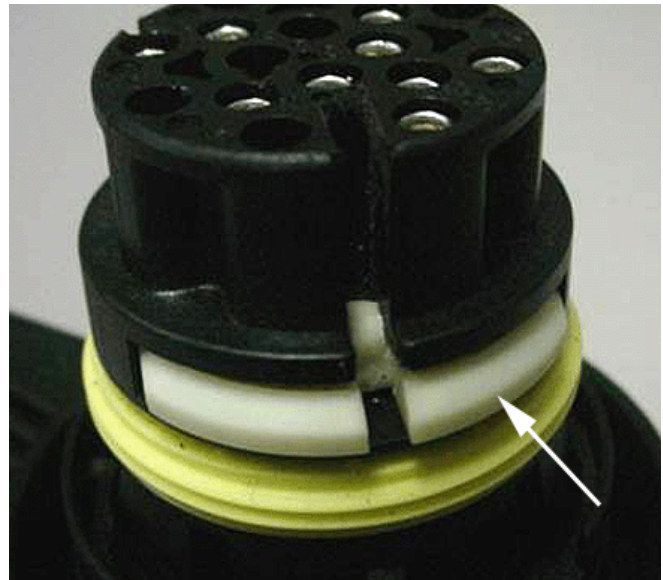
2089334

Locate the TPA lock in the reassembled transmission connector. Refer to the arrow in the illustration above, which points to a TPA lock. This one is in an unseated position. Using a small flat blade tool, push to seat the TPA until it bottoms out. Verify the TPA is fully seated.

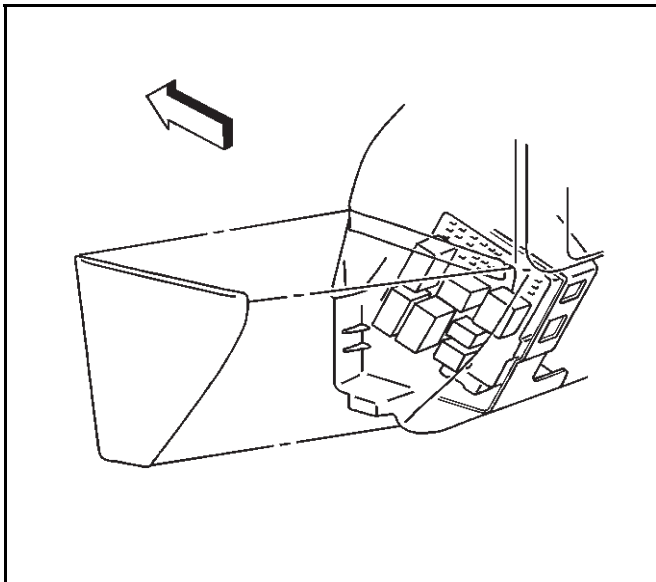
386487

4. Inspect connector X1 (1) on the back of the fuse block for a loose connection. Secure the connector as needed.
5. Install the left side fuse block.
6. Connect the negative battery cable. Refer to Battery Negative Cable Disconnection and Connection in SI.
7. Clear any DTCs that may be present with a scan tool and verify the proper operation of the vehicle.

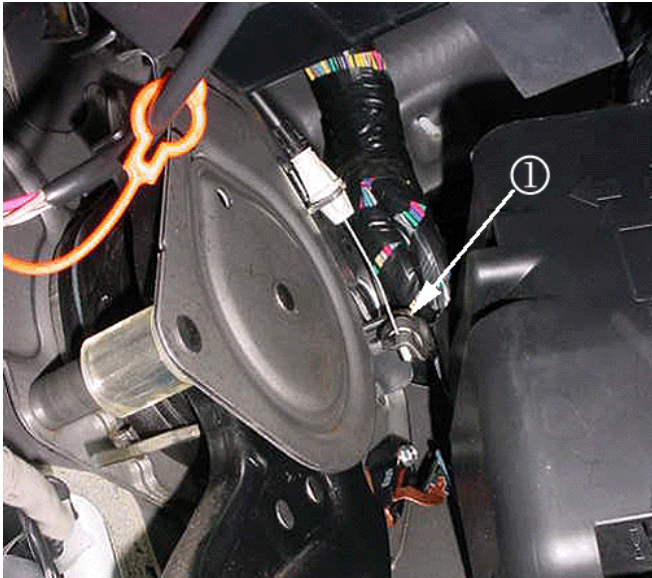
2002649

- The IP harness may be in hard contact with the top rear edge (1) of the park brake assembly.

1. Turn OFF the ignition and all accessories.
2. Inspect the IP harness for chafed, damaged, pinched, open or shorted wiring at the park brake pedal assembly. Refer to the potential damage points as shown in the photos - at the side and rear of the park brake assembly. Be advised that damage may be covered by electrical tape, or turned away and hid from view.

- ⇒ If the wiring is damaged, repair as needed. Refer to Power and Signal Distribution > Wiring Systems and Power Management > Diagnostic Information and Procedures in SI. Protect the harness by covering any sharp edge with butyl tape and the harness with woven polyester (PET) electrical tape.

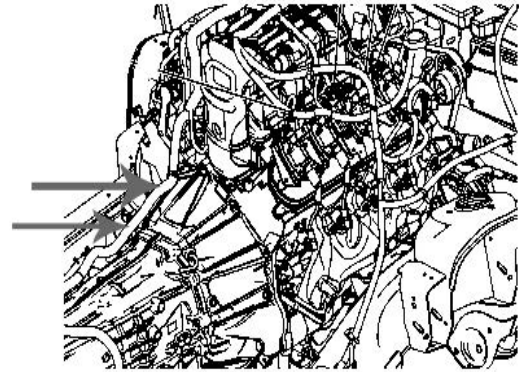
2434892

6. Lower the transmission sufficiently to provide access to the engine wiring harness where it routes from the engine intake manifold to the transmission bell housing as shown.
7. Release the wiring harness conduit from the retainers that secure it to the transmission and/or transfer case.

8. Examine the harness for wiring that may be exposed outside of the conduit. Inspect all areas for chafed, damaged, pinched, open or shorted wiring as shown. If damage to the wiring is not observed, then extract the wiring from the conduit and inspect all remaining areas as needed.

- ⇒ If the wiring is damaged, repair as needed. Refer to Power and Signal Distribution > Wiring Systems and Power Management > Diagnostic Information and Procedures > Wiring Repairs in SI. Protect the conduit by covering any sharp edge with butyl tape and the harness with woven polyester (PET) electrical tape. Secure the harness as needed.

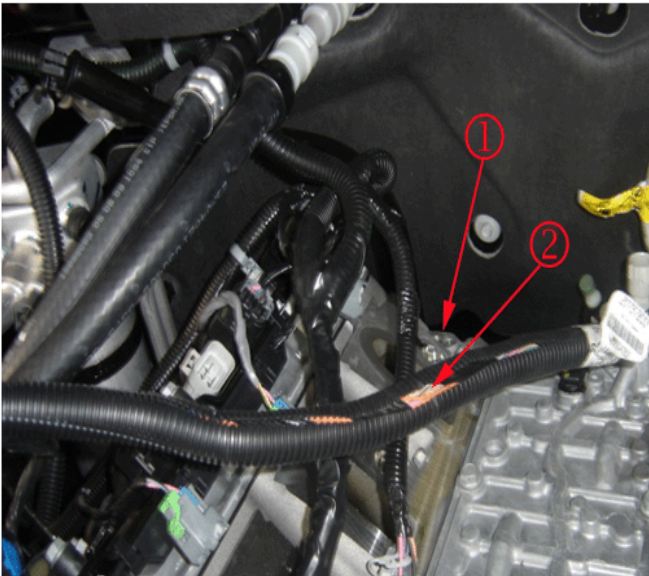
2328025

Inspect for chafed (1), damaged, pinched, open or shorted wiring. If damage is not observed, then extract the wiring from the conduit and inspect all of the remaining areas as needed.

⇒ If the wiring is damaged, repair as needed. Refer to Power and Signal Distribution > Wiring Systems and Power Management > Diagnostic Information and Procedures.

7. Protect the conduit by covering any sharp edges on the engine or transmission with butyl tape and the harness with woven polyester (PET) electrical tape.

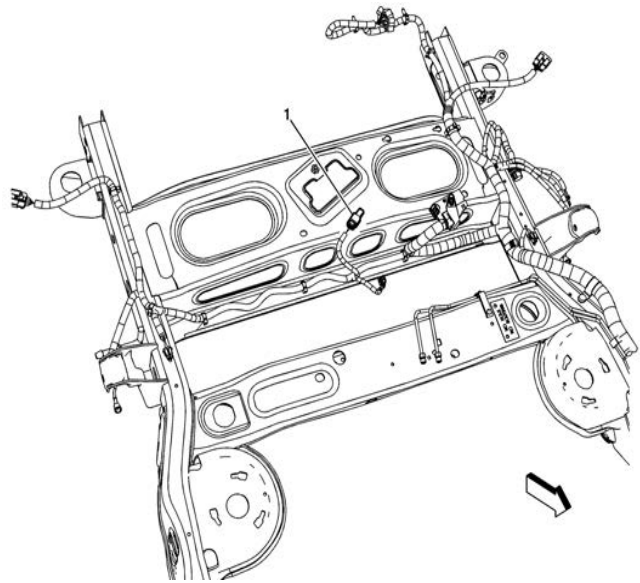
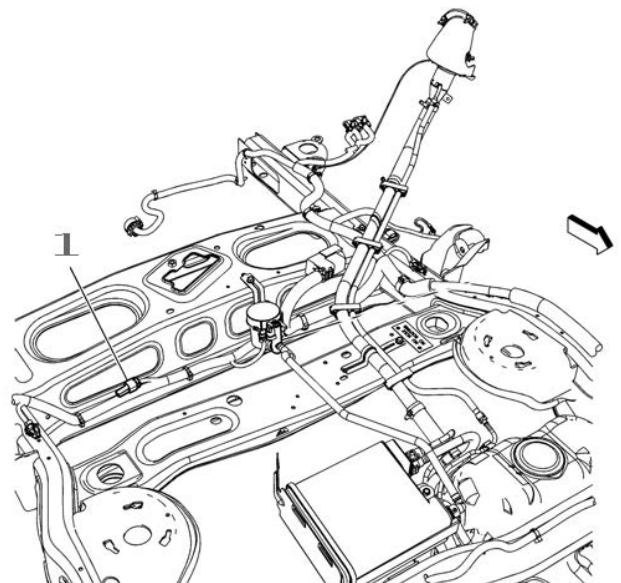
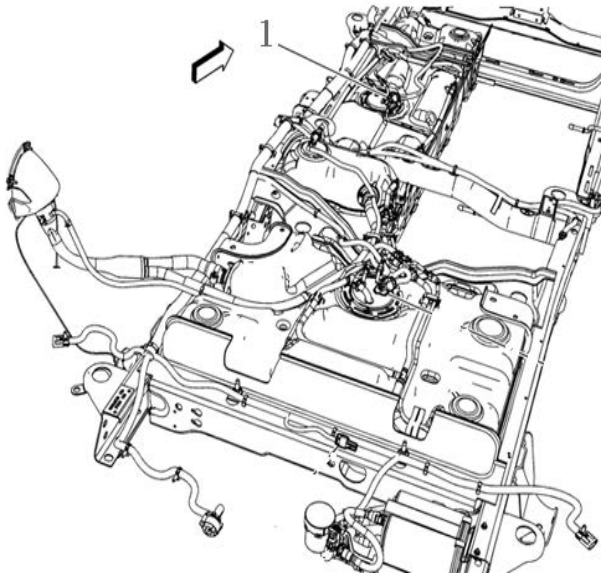
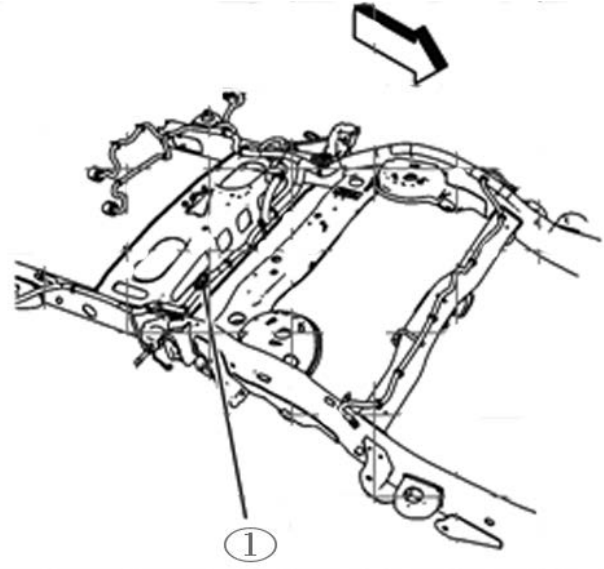
3. On the vehicle being serviced, observe the location of the terminator resistor. Inspect the wiring harness leading to the terminator resistor, for chafed, damaged, pinched, open or shorted wiring.

- ⇒ If the wiring is damaged, repair as needed. Refer to Power and Signal Distribution > Wiring Systems and Power Management > Diagnostic Information and Procedures. Protect the conduit by covering any sharp edge with butyl tape and the harness with woven polyester (PET) electrical tape. Secure the harness as needed.

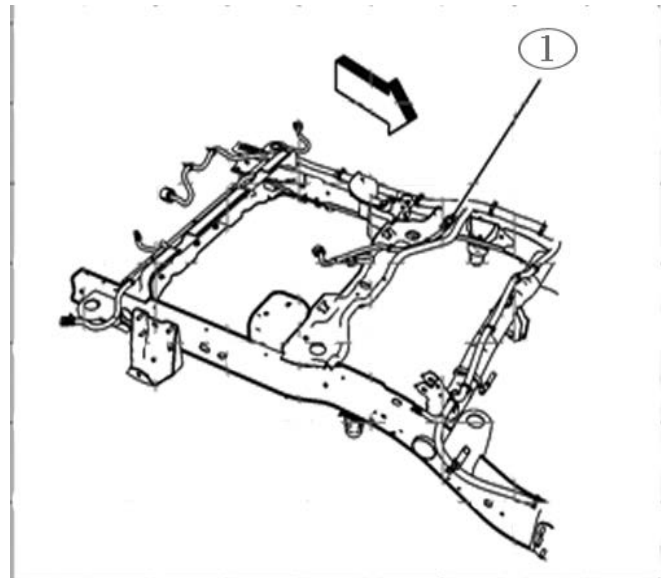
Typical Location of Data Link Resistor 1 (1) Long Wheel Base HD Vehicles

3. On the vehicle being serviced, observe the location of the data link resistor 1 (1). Inspect the wiring harness leading to the data link resistor 1, for chafed, damaged, pinched, open or shorted wiring.
 - ⇒ If the wiring is damaged, repair as needed. Refer to Power and Signal Distribution > Wiring Systems and Power Management > Diagnostic Information and Procedures. Protect the conduit by covering any sharp edge with butyl tape and the harness with woven polyester (PET) electrical tape. Secure the harness as needed.
 - ⇒ If damage is not found, proceed to Step 4.
4. Disconnect the electrical connector from the data link resistor 1.

5. Test the Data Link Resistor 1 for 110–130Ω.
 - ⇒ If the resistance is not within the specified range, replace the data link resistor 1 and proceed to Step 6.
 - ⇒ If the resistance is within the specified range, connect the electrical connector to the data link resistor 1. Refer to Power and Signal Distribution > Data Communications > Scan Tool Does Not Communicate with High Speed GMLAN Device **OR** Diagnostic Trouble Code (DTC) List - Vehicle in SI.
6. Connect the electrical connector to the data link resistor 1. Secure the data link resistor 1 as needed.
7. Lower the vehicle.
8. Clear any DTCs that may be present with a scan tool and verify the proper operation of the vehicle.

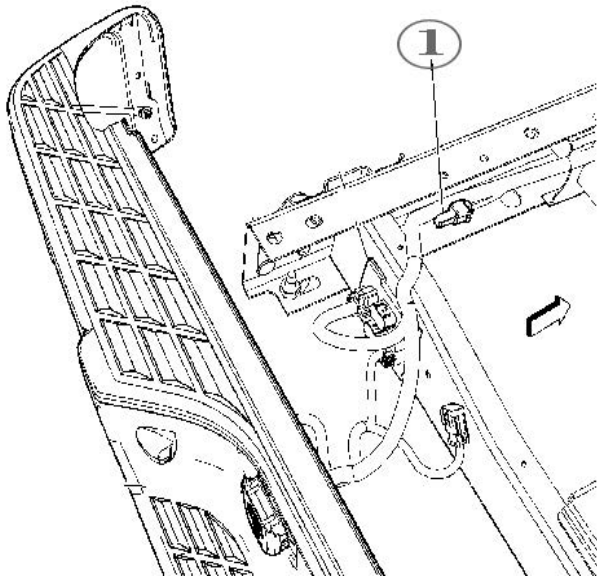
2651339

3. Typical location of a data link resistor 1 (1) mounted on the rear of the chassis.

4. Inspect the wiring harness leading to the rear data link resistor 1, between the truck box and frame for chafed, damaged, pinched, open or shorted wiring as shown.

- ⇒ If the wiring is damaged, repair as needed. Refer to Power and Signal Distribution > Wiring Systems and Power Management > Diagnostic Information and Procedures. Protect the conduit by covering any sharp edge with butyl tape and the harness with woven polyester (PET) electrical tape. Secure the harness as needed. Proceed to Step 9.

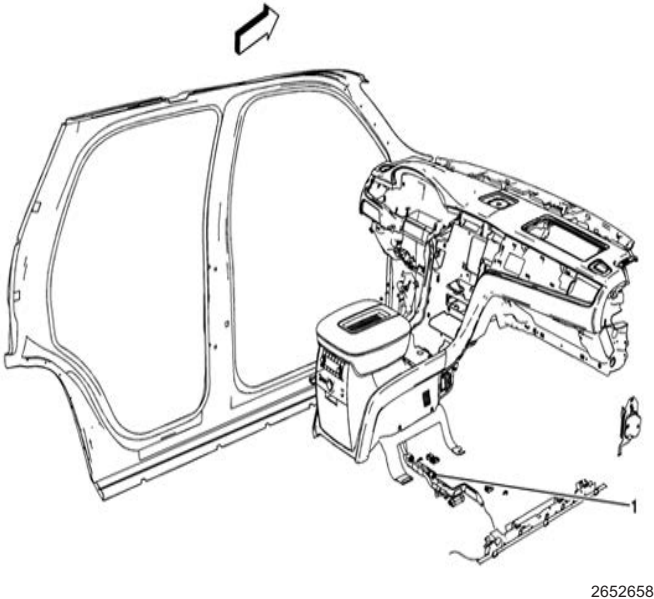
2. Inspect the harness leading to the data link resistor 2 (1) for chafed, damaged, pinched, open or shorted wiring. Refer to Power and Signal Distribution > Data Communications > Schematic and Routing Diagrams > Data Communication Schematics.

- ⇒ If the wiring is damaged, repair as needed. Refer to Power and Signal Distribution > Wiring Systems and Power Management > Diagnostic Information and Procedures. Protect the conduit by covering any sharp edge with butyl tape and the harness with woven polyester (PET) electrical tape. Secure the harness as needed.

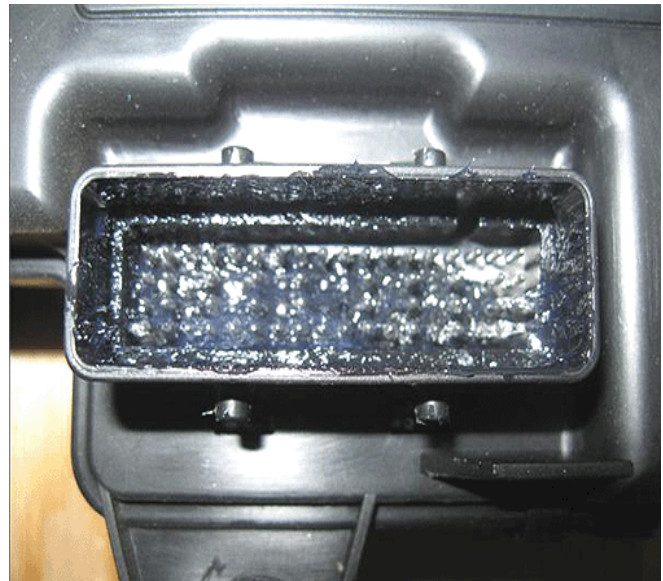
2214281

2. **DO NOT** apply an excessive amount of dielectric lubricant as shown, to the connectors as hydrolock may result when attempting to mate the connectors. This could cause terminals to back out, resulting in an intermittent connection.
