Product Update: Roof Molding Is Loose

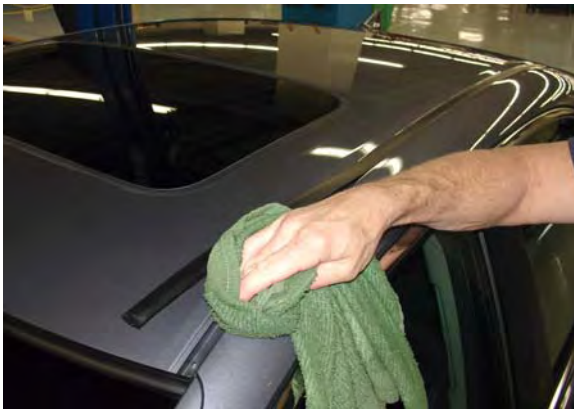
FRONT PIN

In high winds, the roof molding may lift in the middle, allowing either its front or rear retention clip to come loose.

- Apply a 50 mm bead of Konishi Bond to the front and rear pins as shown until the pins on the body are completely covered.
