# SERVICE CAMPAIGN BULLETIN

NTB12-081

## VOLUNTARY SERVICE CAMPAIGN 2013 ALTIMA TCM REPROGRAM

**CAMPAIGN ID #:** PC186**APPLIED VEHICLES:** 2013 Altima (L33) with QR25 engine only**Check Service COMM to confirm campaign eligibility.**

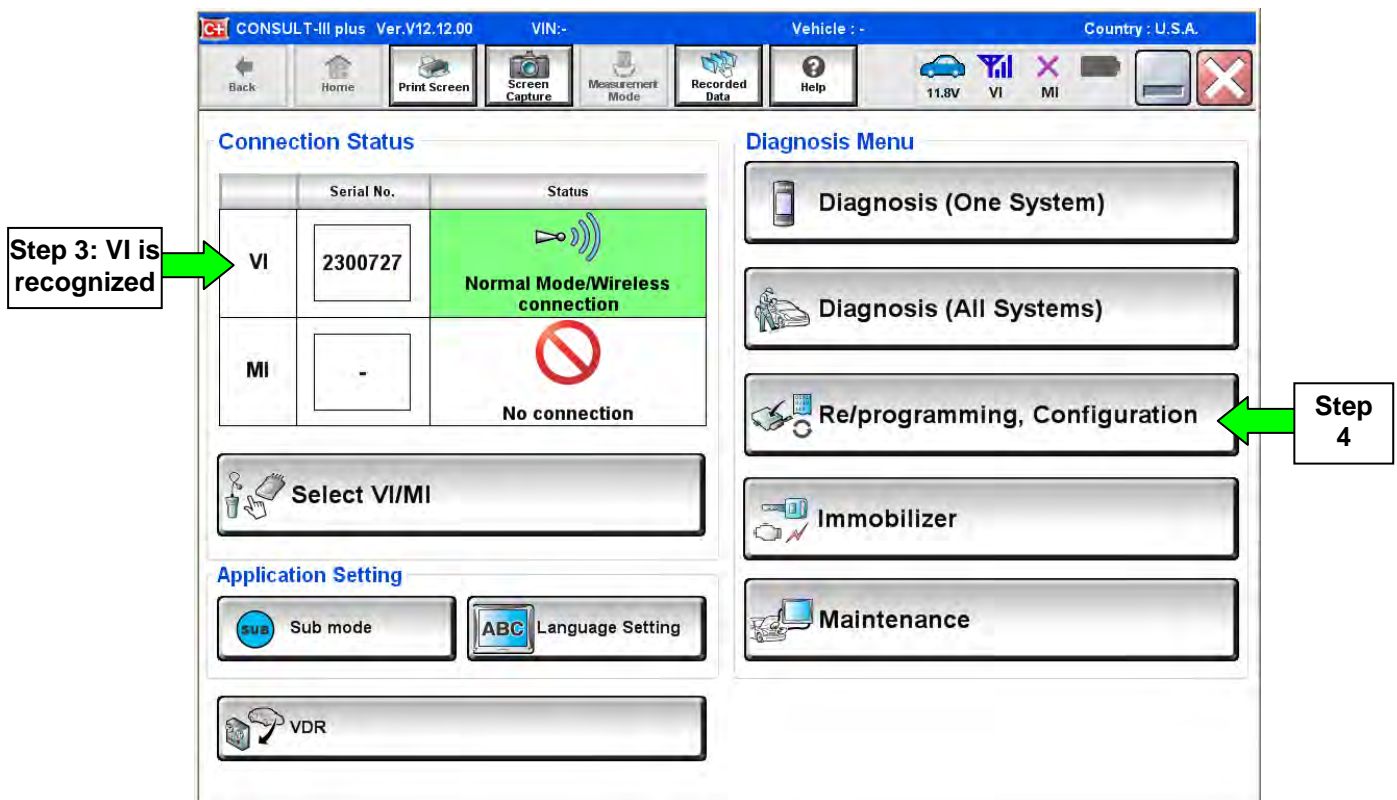
Figure 1

1. **Connect the CONSULT PC** to the vehicle to begin the reprogramming procedure.
2. Open ASIST on the CONSULT PC and start C-III plus.
3. Wait for the plus VI to be recognized / connected.
  - Serial number will display when the plus VI is recognized / connected.
4. Select **Re/programming, Configuration**.

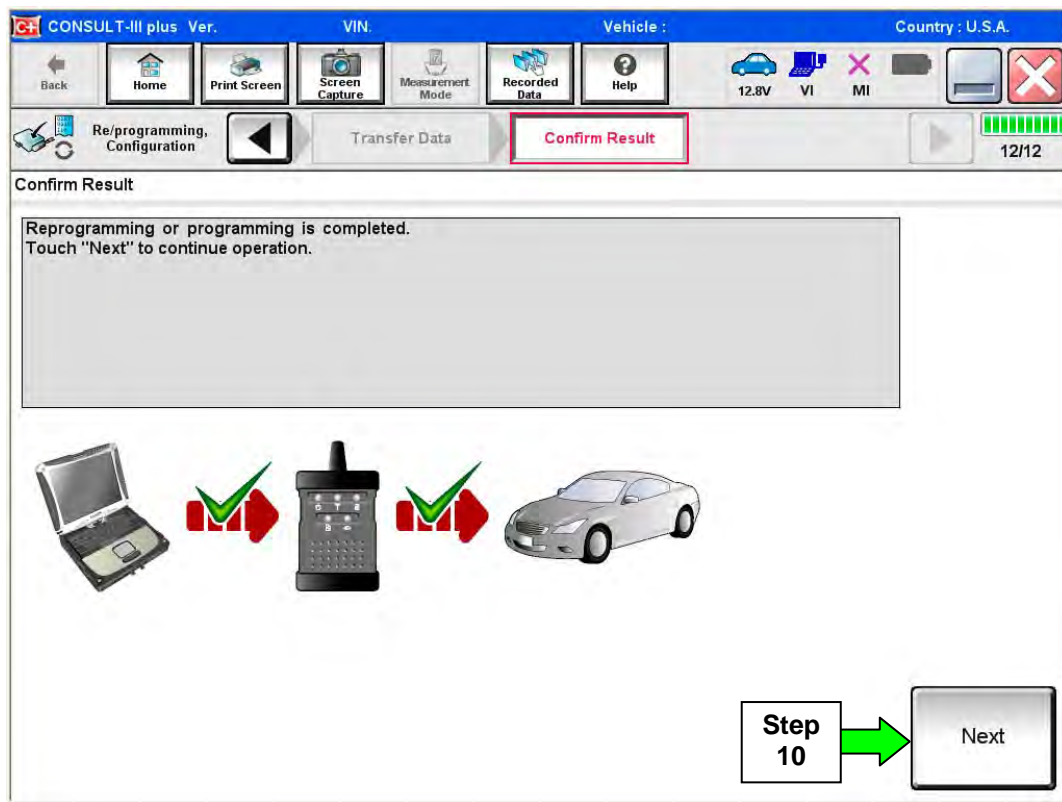
8. When the screen in Figure 4 displays, reprogramming is complete.
