**SERVICE BULLETIN**

**APPLICABILITY:** 2013MY Legacy and Outback Models Equipped With 2.5L FB Engine      **NUMBER:** 11-122-12  
**DATE:** 11/02/12

**SUBJECT:** Difficulty Starting, Rough Idle, Cam Position or Misfire DTCs  
 DTCs P0340, 341, 345 or 346, P0301, 302, 303 or 304

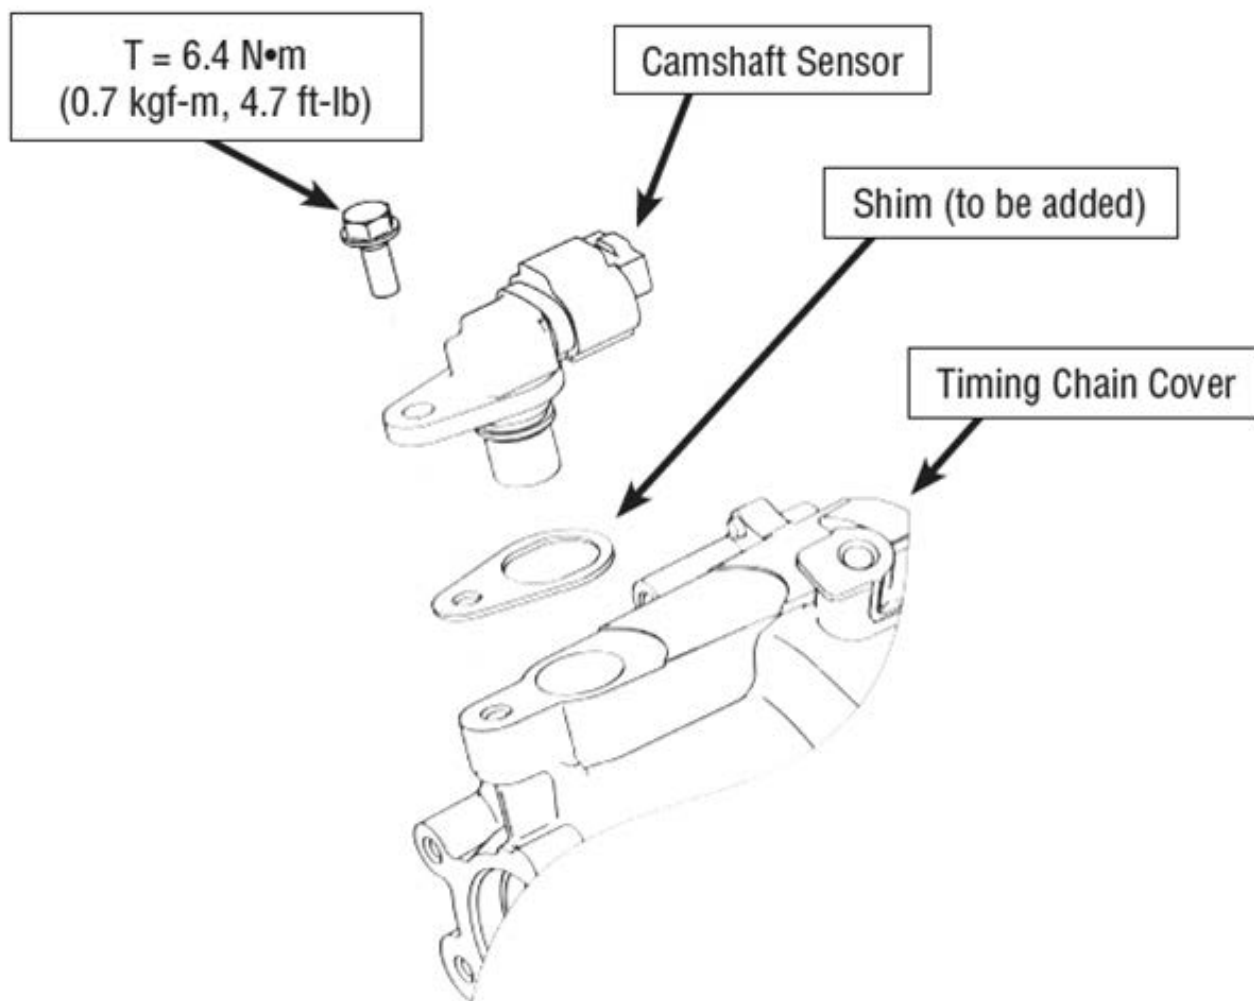
**Component Overview**

**The specified clearance is 1.3 +/- .05mm (1.25 to 1.35mm or .049" to .053").**

- Record radio station presets (and navigation system favorites if applicable).
- Disconnect the negative battery cable.
- Remove the camshaft position sensor from the timing chain cover using the procedure in the applicable Service Manual.

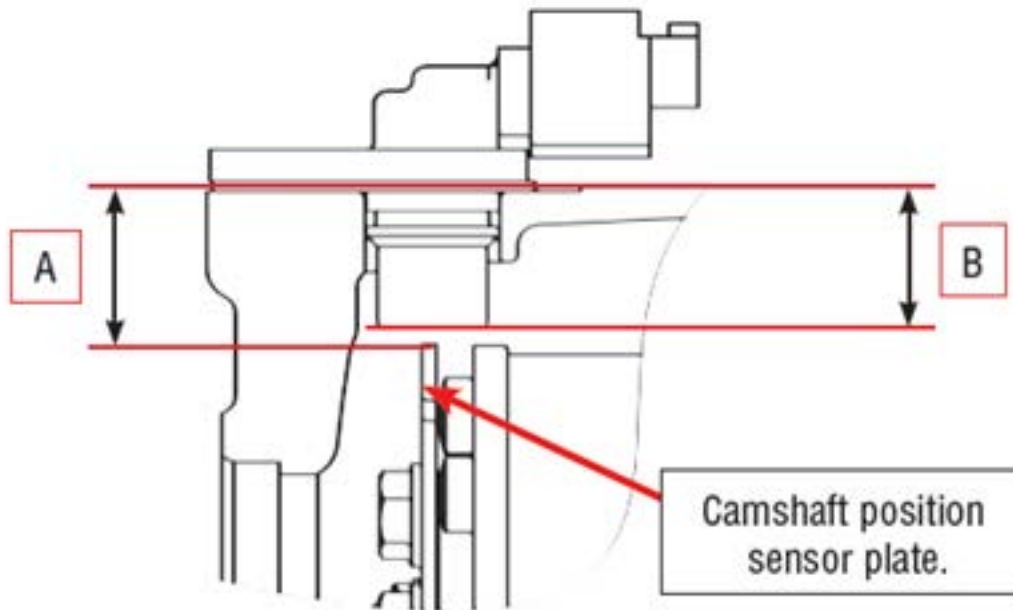
**MEASUREMENTS:**

**A**= Top surface of the timing chain cover to camshaft sensor plate

**B**= Camshaft Position Sensor mating surface to the bottom of the sensor

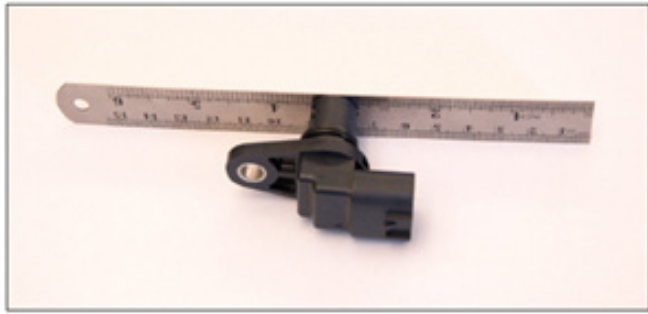
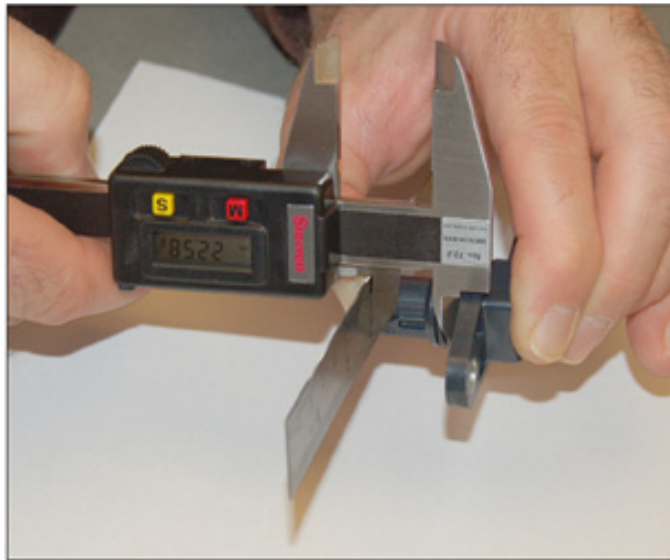
Measure the camshaft position sensor mating surface (the area that sits flush on the timing chain cover) to the bottom of the sensor and record measurement.

**IMPORTANT:** Be sure to account for the thickness of the flat washer when performing your calculations to determine the required shim thickness.
