## Product Improvement Campaign

No: C1006210

Re: V68.1 EEC Reprogramming

Product Improvement Campaign C1006210 – V68.1 EEC Reprogramming

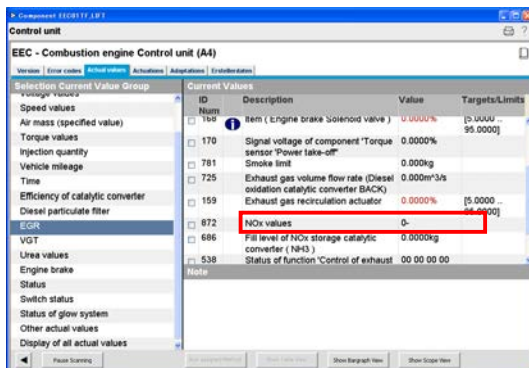
## (1) NOx sensor

- Drive the vehicle at 80 km/h [49.7mph] about for 30 minutes to collect the service data (actual measurements) using FUSO Diagnostics. Then check to confirm that the NOx sensor is active (NOx value of FUSO Diagnostics other than “-1-” is indicated).

- Turn on DPF manual regeneration and then right after finished DPF manual regeneration check the service data (actual measurements) using FUSO Diagnostics. Then check to confirm that the NOx sensor is active (NOx value of FUSO Diagnostics other than “-1-” is indicated)
- Within 10 minutes, Run the engine at idle to determine the NOx value of FUSO diagnostics. If a value more than 200ppm (200 in reading of FUSO Diagnostics) is indicated continuously, faulty NOx sensor is suspected. Replace the NOx sensor.

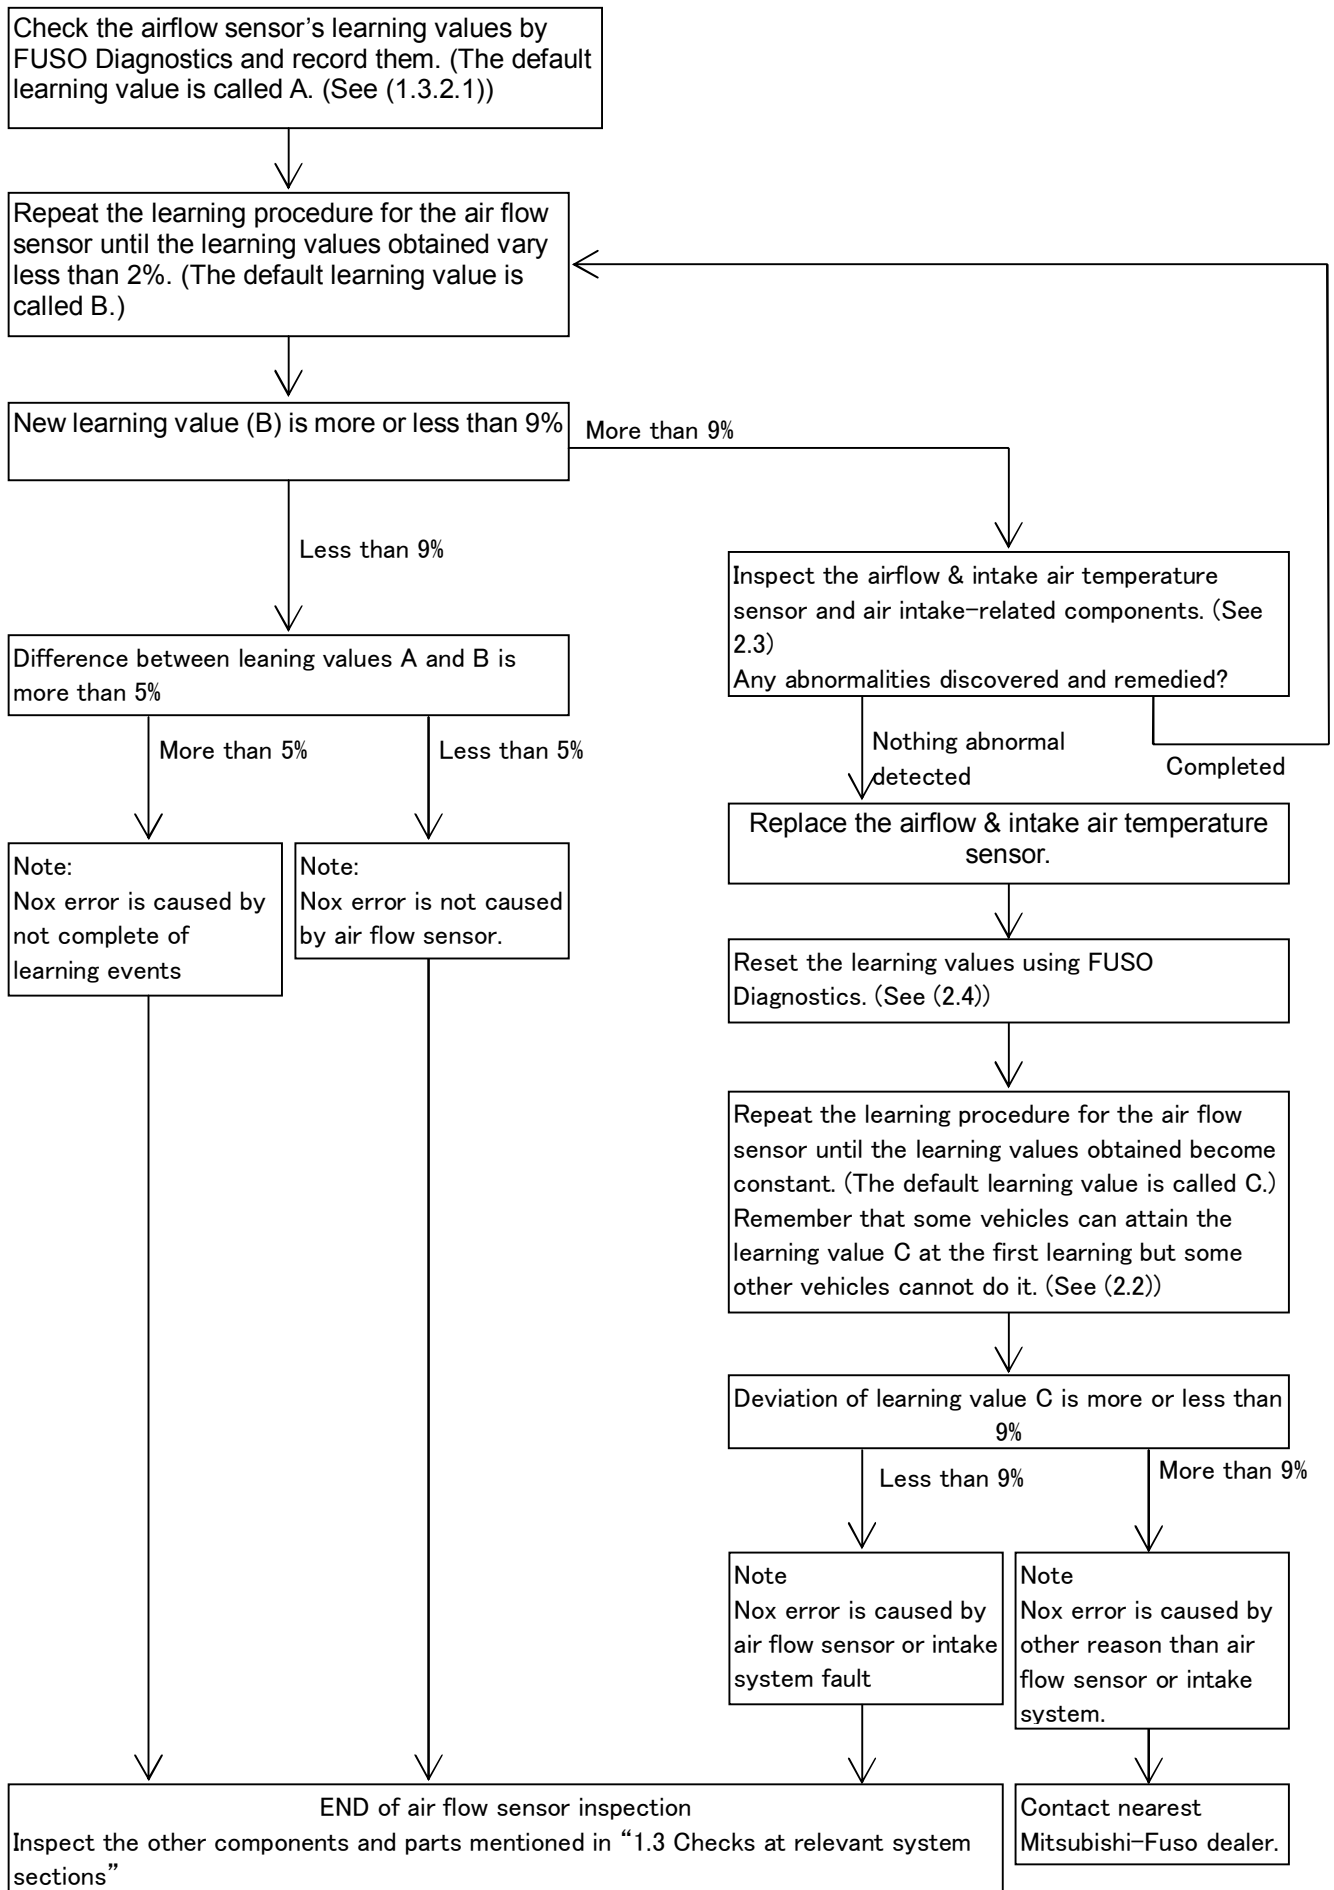
(2) Air flow & intake air temperature sensor.

- Inspect the air flow & intake air temperature sensor according to the following flowchart:

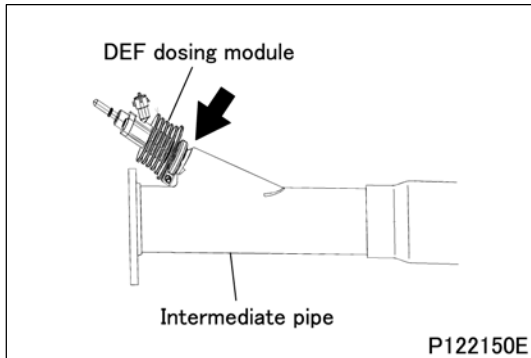
(5) DEF dosing module, DEF supply module (motor and heater)

- Check that there are no gas leaks and adhesion of deposits on the attachment part of the DEF dosing module. If there is some abnormality, then it is possibility that the attachment failure of the DEF dosing module is the cause of NOx errors.
- Remove the DEF dosing module. Check the DEF dosing module and its mount are in a proper condition.
- Replace gasket (ME556058), if dosing module is removed.
