ITB14-004

January 24, 2014

## VOLUNTARY SERVICE CAMPAIGN 2014 Q50 INFINITI InTouch SOFTWARE UPDATE

**CAMPAIGN I.D. #:** P4205  
**APPLIED VEHICLES:** 2014 Q50 (V37)  
2014 Q50 Hybrid (V37)

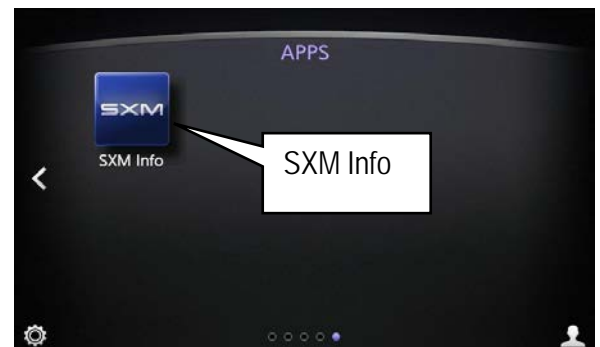
Figure 42

- b. On the lower display screen find and select the **SXM Info** app.
  - With navigation, scroll two screens to the right.
  - Without navigation, SXM is on the main screen.
