ITB14-004a

February 14, 2014

VOLUNTARY SERVICE CAMPAIGN 2014 Q50 INFINITI InTouch SOFTWARE UPDATE

APPLIED VEHICLES: 2014 Q50 (V37)
2014 Q50 Hybrid (V37)

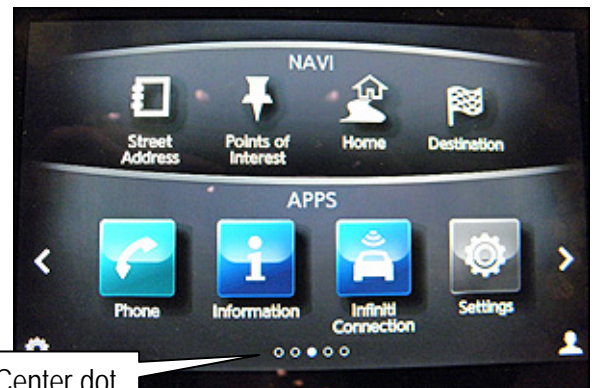
Figure 41

- a. Wait for screens to fully initialize.
 - The bottom of the lower screen must show the center dot highlighted.

NOTE: With navigation is shown, without navigation is similar.

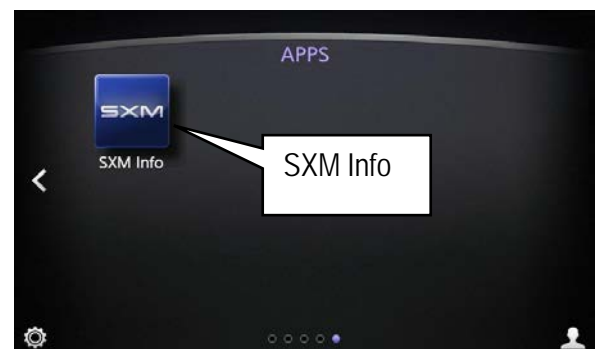
Figure 42

- b. On the lower display screen find and select the **SXM Info** app.
 - With navigation, scroll two screens to the right.
 - Without navigation, SXM is on the main screen.

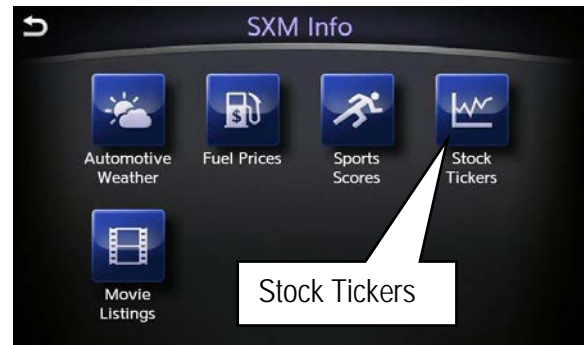
Figure 43

c. Push **Stock Tickers**.

- If the Stock Tickers feature functions correctly refresh is not needed. Procedure is complete.

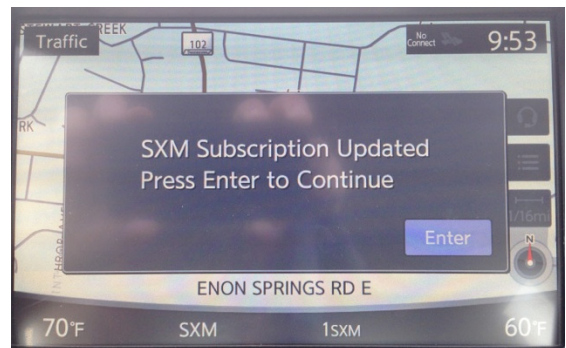
- Once the refresh is complete the screen in Figure 45 will display.
- Push Enter.
