**WARRANTY
CAMPAIGN**
**ROADSTER
WARRANTY
Bulletin**

Campaign no.: 2011-0016
2012-0006

Subject: **TO BE PERFORMED AT PDI ON
UNREGISTERED (UNSOLD) VEHICLES**
**1- Updated Throttle Body Actuator
Protection**
2- ECM and TCM Software Updates
**3- Middle Side Panel Grommet
Replacement (2011 Models Only)**

No. **2012-8**
REVISION 1
January 23, 2014

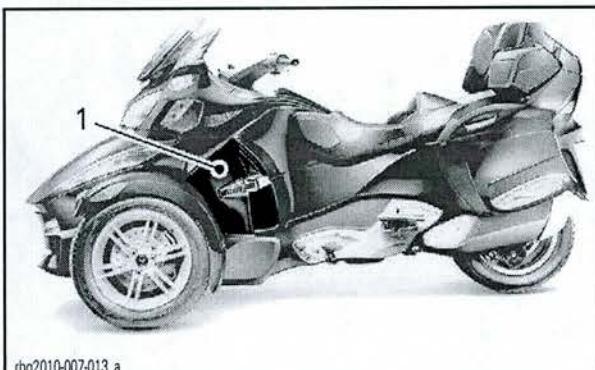
rbg2010-007-013_a

On some 2011 vehicles, on which 2011-8 OR 2011-13 WARRANTY CAMPAIGNS has not been performed, one of the middle side panels rubber grommets might fall off after multiple removal and installation of the panel.

1. Middle side panel

3. If required, remove the grommet using a flat screwdriver.
4. Scrape off any remaining grommet and glue residue from area where grommet was glued.
5. Install the new grommet.
6. Repeat steps on the other side of the vehicle.
