GROUP ELE	MODEL Multiple Models (See table below)
	NUMBER 077	DATE December 2014
TECHNICAL SERVICE BULLETIN		
SUBJECT: REAR VIEW CAMERA DIAGNOSIS/REPLACEMENT

This bulletin provides information to diagnose and/or replace the rear view camera of some Kia vehicles (see table below for specific models and production dates) which may exhibit inadequate image quality from the rear view camera. Possible concerns include:

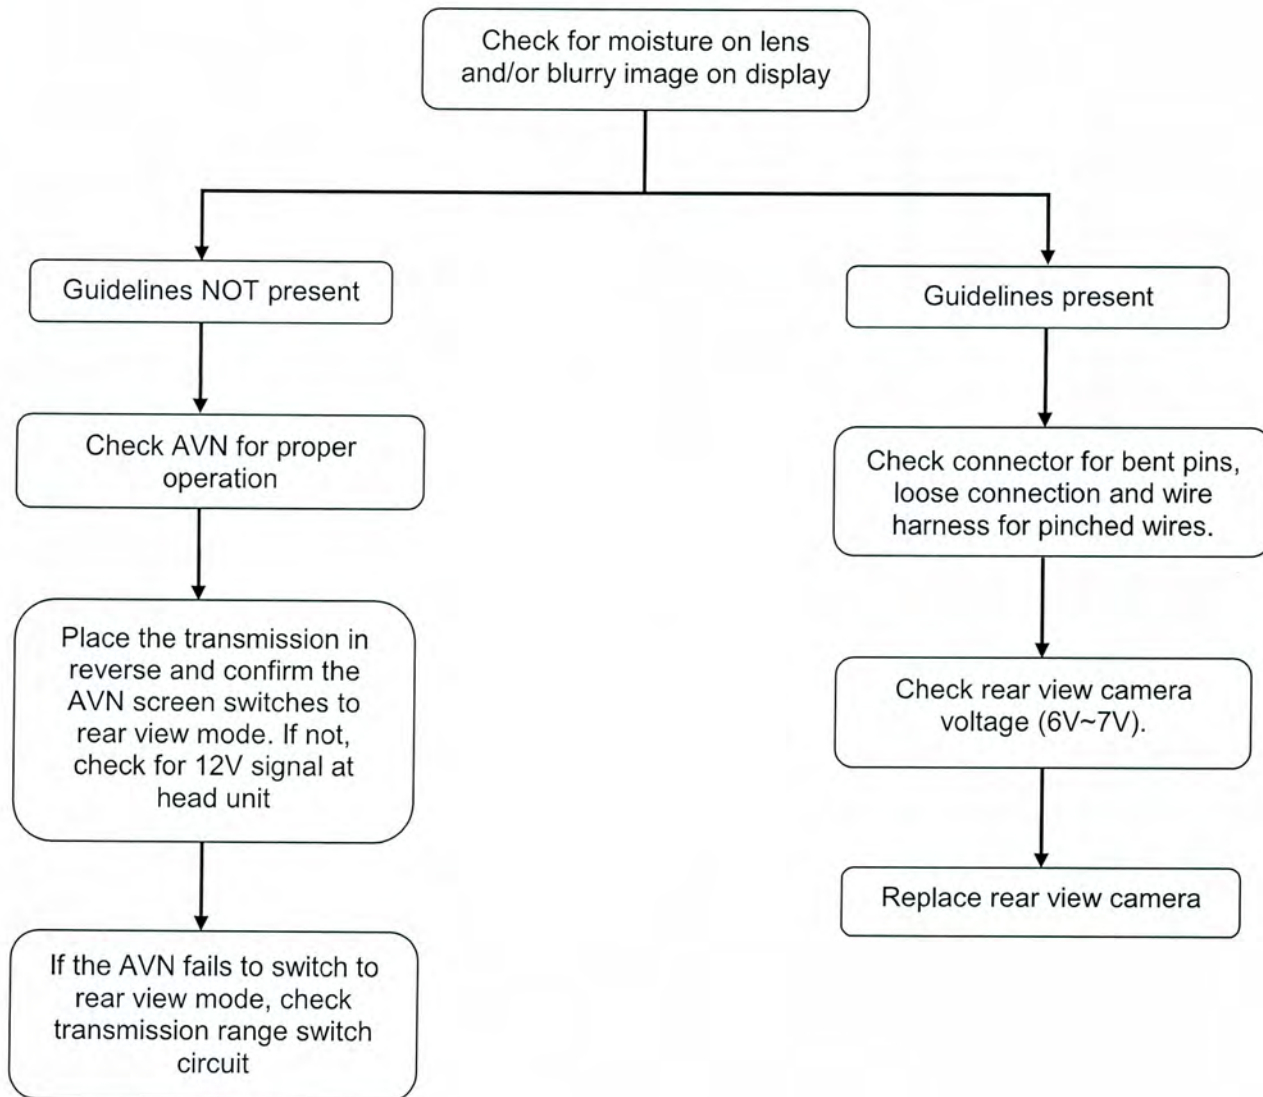
Diagnostic Flowchart:

- Blurry image quality
- Foreign material intrusion (i.e. water, dust, etc.)
- Intermittent operation from the rear view camera
- Missing on-screen parking guidelines/black or blank AVN screen when in reverse

Diagnose the concerns above using the information in this bulletin and, if necessary, replace the rear view camera with an improved part by following the applicable service procedure on KGIS.
