Technical Service Bulletin

NUMBER
14-BD-002

MODEL(S)
GENESIS SEDAN (BH)

SUBJECT: INTERMITTENT DOOR LOCK OPERATION

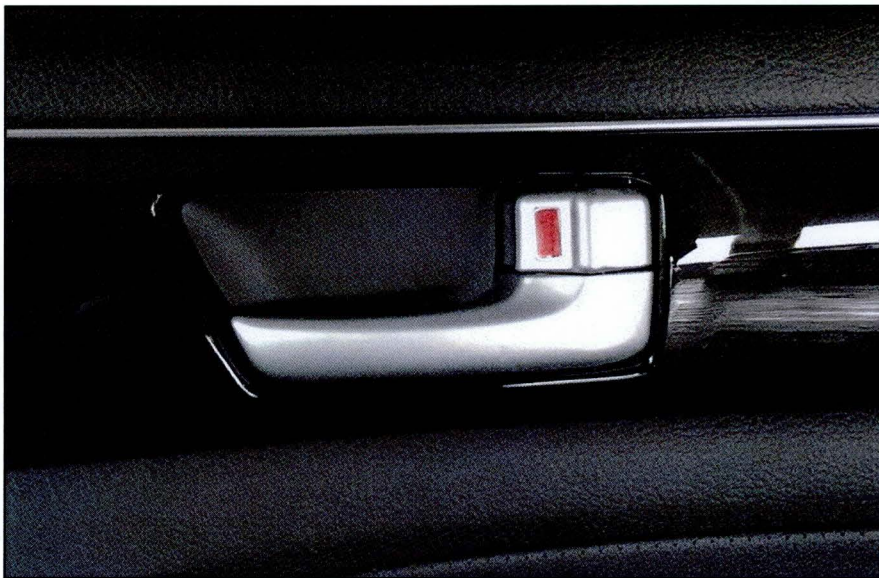
Certain Genesis Sedan (BH) vehicles may exhibit intermittent unlocking operation of the power door locks. If this condition is found, follow the inspection and repair procedure described below.
