GROUP BODY	MODEL 2011-2012MY Optima (TF)
	NUMBER 097	DATE June 2013
<b>TECHNICAL SERVICE BULLETIN</b>		
SUBJECT: COMBINED TSB/SERVICE ACTION: FUEL FILLER DOOR INSPECTION AND UPGRADE PROCEDURE (SA145)

**SUBJECT: OPTIMA RIGHT HAND FENDER SPLIT REPAIR PROCEDURE**

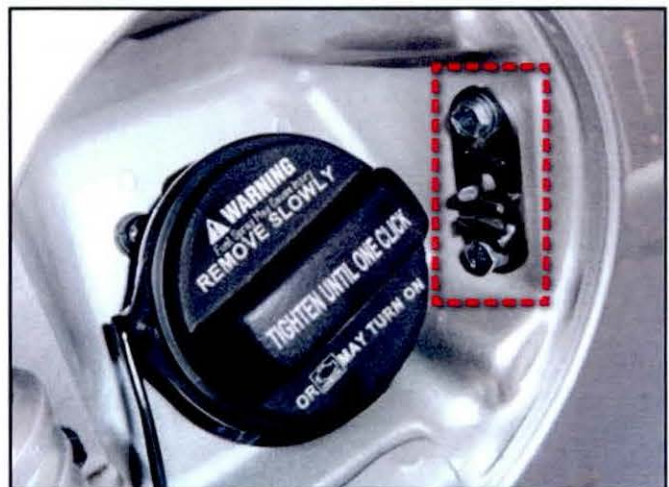
1. Open the fuel filler door and locate the latch assembly.

- Note the location of the upper and lower alignment guides (A) protruding from the body of the fuel filler door latch.
