SERVICE BULLETIN RELEASE - 04/03/2014

Subject: UNUSUAL NOISE FROM EXHAUST PIPE SEAL RING	Bulletin No: 01-007/14
	Last Issued: 04/03/2014

2009-2013 Mazda6 2.5L with automatic transmission

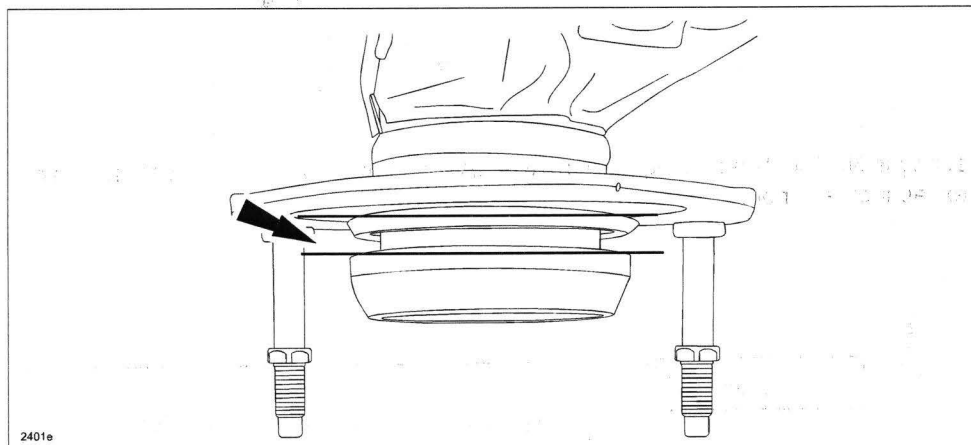
16. Install the special service tool (SST) to the seal ring so that the SST is even with the flange.
A: Installer (49 G040 002)
B: Handle (49 G040 001)

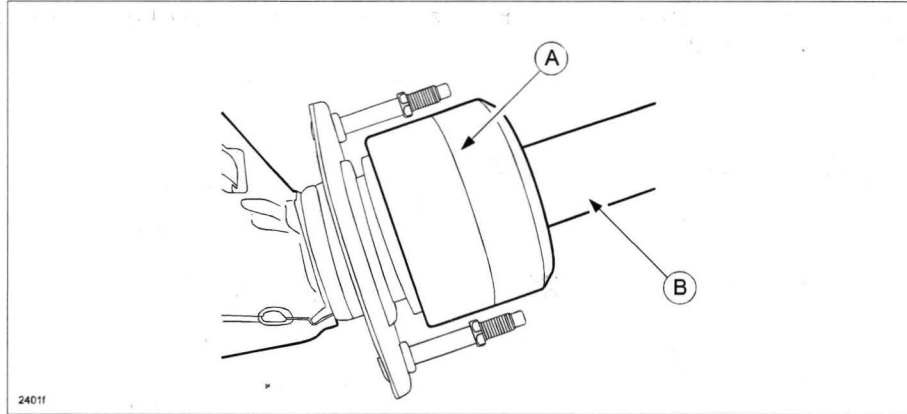
17. Seat seal ring by lightly tapping end of special service tool with a rubber hammer.
18. Push in seal ring (A) until edge of it contacts flange (B).

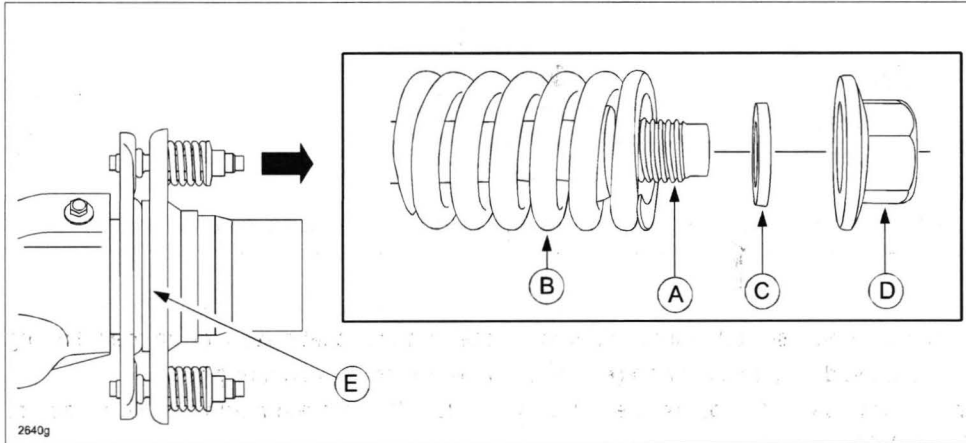
21. Install springs, washers (when necessary according to Step 11), and hex nuts in order.

- A - Exhaust Stud
- B - Spring
- C - Washer - (washer fits inside spring against stud shoulder)
- D - Hex Nut
- E - Seal Ring

NOTE: It is NOT necessary to install washers when the catalytic converter is replaced with a new one.
