01-007/14 – 2009-2013 MAZDA6 2.5L (A/T) – UNUSUAL NOISE FROM EXHAUST PIPE SEAL RING

Subject: UNUSUAL NOISE FROM EXHAUST PIPE SEAL RING	Bulletin No: 01-007/14
	Last Issued: 03/17/2014

2009-2013 Mazda6 2.5L with automatic transmission

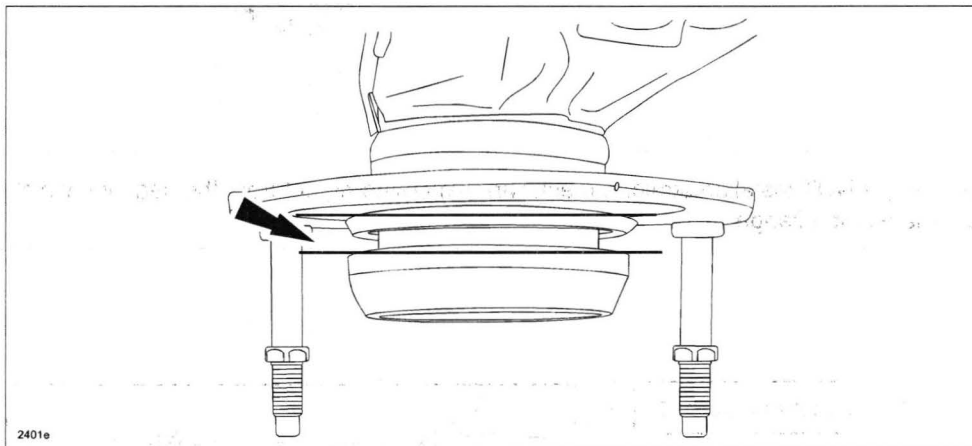
15. Replace old seal ring (A) with new seal ring (B). Push new seal ring (with green identification marking (C)) onto manifold flange by hand.

- Make sure seal ring fits straight and does not fall off when you remove your hand from the ring.
- Make sure seal ring fits straight, if not, there is a possibility the lubrication on the inner surface will be damaged when the seal ring is press-fitted with the special service tool.

CAUTION: DO NOT APPLY any type of grease to the seal ring as it will harmfully effect the lubricant performance originally applied on the seal ring and the noise will recur.

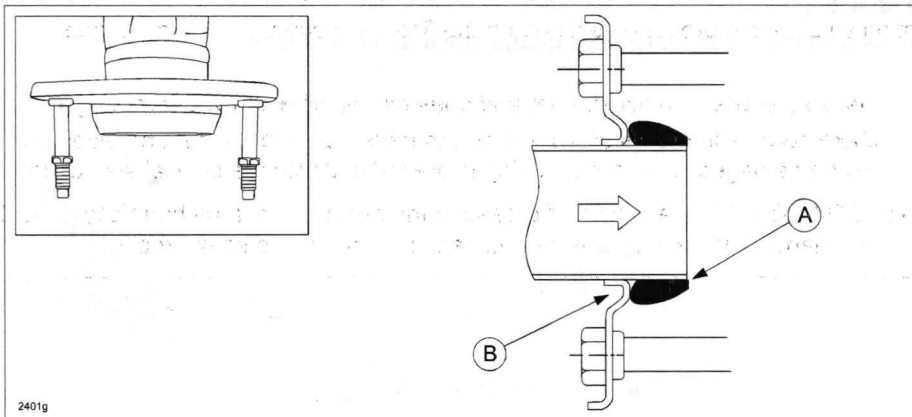
19. If the seal ring is NOT installed straight, mesh wire (A) will come out from the seal ring which will then contact the exhaust pipe flange.

17. Seat seal ring by lightly tapping end of special service tool with a rubber hammer.
18. Push in seal ring (A) until edge of it contacts flange (B).

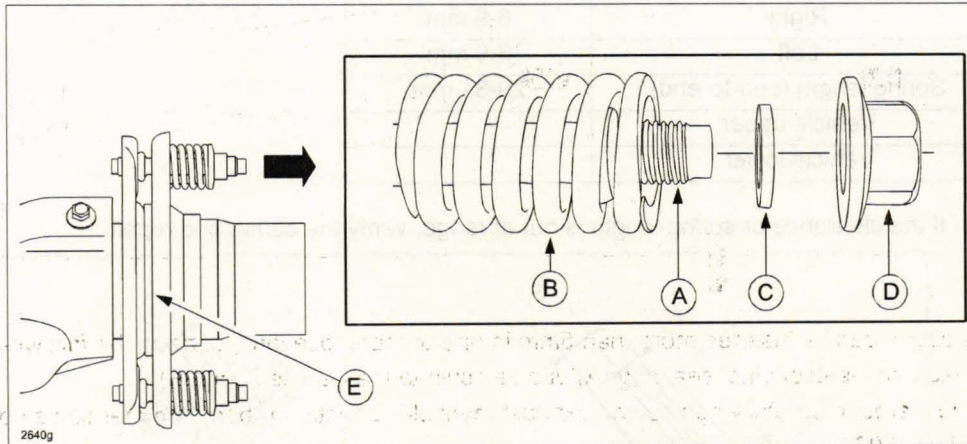
- A - Exhaust Stud
- B - Spring
- C - Washer - (washer fits inside spring against stud shoulder)
- D - Hex Nut
- E - Seal Ring

21. Install springs, washers (when necessary according to Step 11), and hex nuts in order.

NOTE: It is NOT necessary to install washers when the catalytic converter is replaced with a new one.
