TECHNICAL BULLETIN
JTB00275NAS2
24 OCT 2013

SECTION: 501-10

Folding Tray Latch Broken

XJ Range (X351)

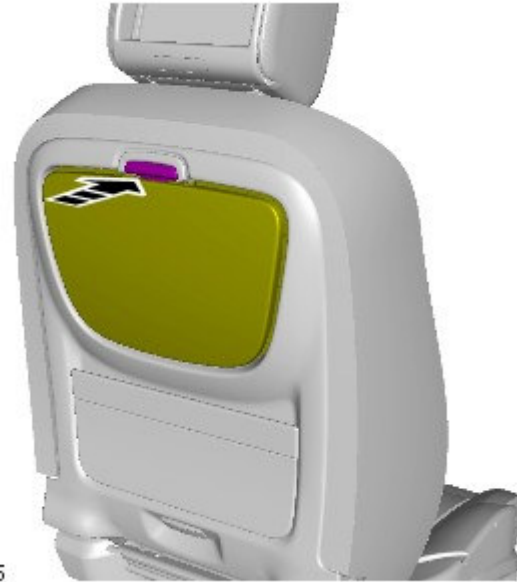
E127925

Situation: The folding tray latch may not latch closed and/or the latch may be broken.

Cause: This may be caused by washers fitted behind latch, resulting in increased force at latch fixing point.

1. Open the left-side folding tray.

**NOTE: Discard any washers found behind the fixing.**
