## SERVICE BULLETIN

**APPLICABILITY:** 2013MY Legacy and Outback 2.5L Models  
 2012-13MY Impreza 2.0L Models  
 2013MY XV Crosstrek  
 2011-2014MY Forester  
 2013MY BRZ

**NUMBER:** 11-130-13R

**SUBJECT:** Difficulty Starting, Rough Idle, Cam Position or Misfire DTCs  
 P0340, P0341, P0345, P0346, P0365, P0366, P0390, P0391,  
 P0301, P0302, P0303 or P0304

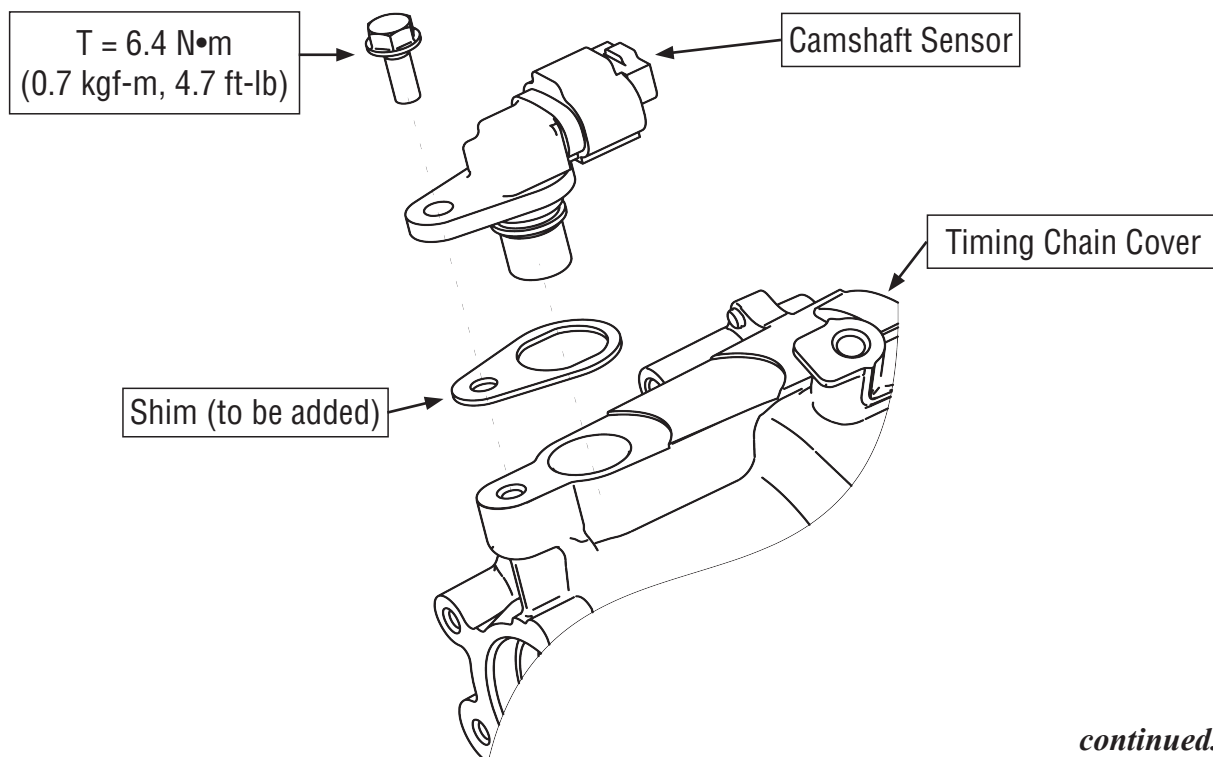
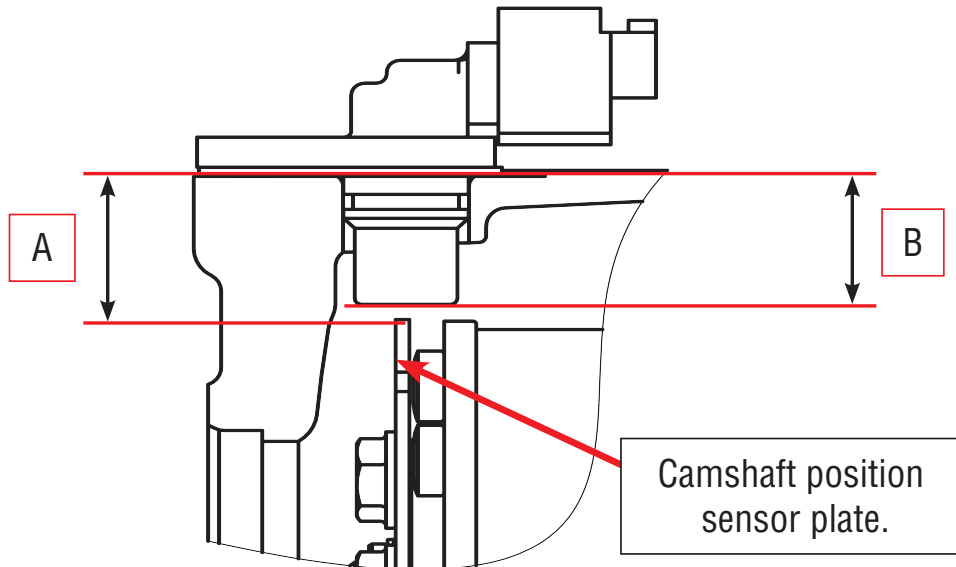
A = Top of timing chain cover to camshaft position sensor plate

B = Camshaft position sensor mating surface to the bottom of the sensor

The specified clearance is 1.3 +/- .05mm (1.25 to 1.35mm or .049" to .053").

1. Record the customer's radio station presets (and navigation system favorites if applicable).
2. Disconnect the negative battery cable.
3. Remove the camshaft position sensor from the timing chain cover using the procedure in the applicable Service Manual.

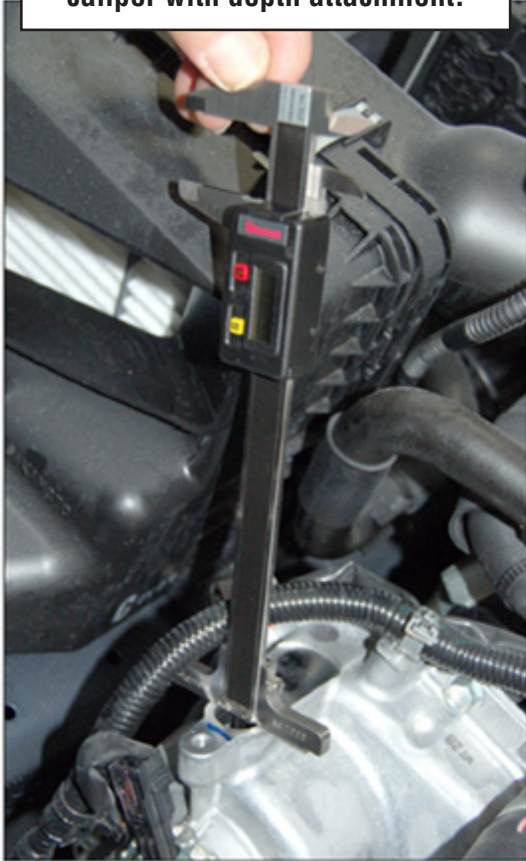
Measurement taken using digital caliper with depth attachment.

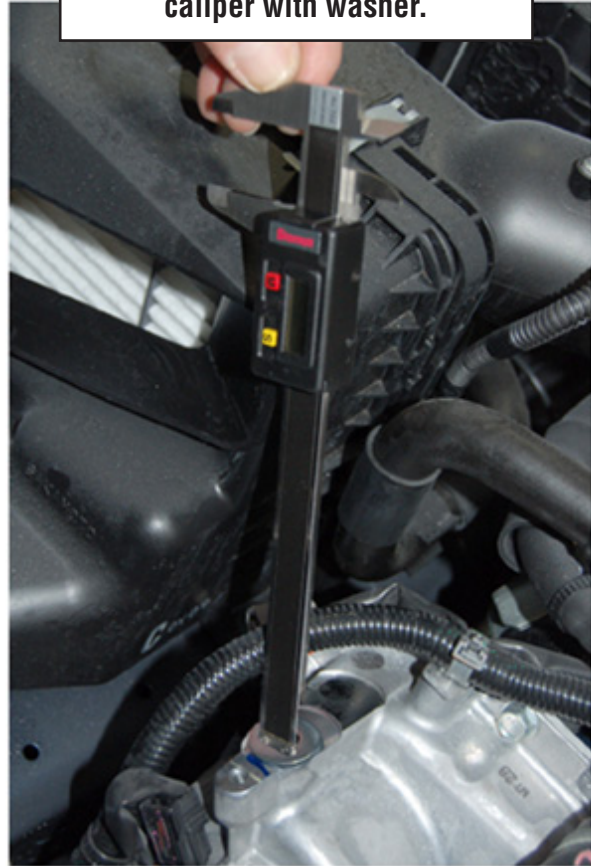
Measurement taken using digital caliper with washer.

**IMPORTANT:** When using the flat washer, make sure the washer is fully seated on the machined surfaces of the timing cover or your measurements will not be accurate.

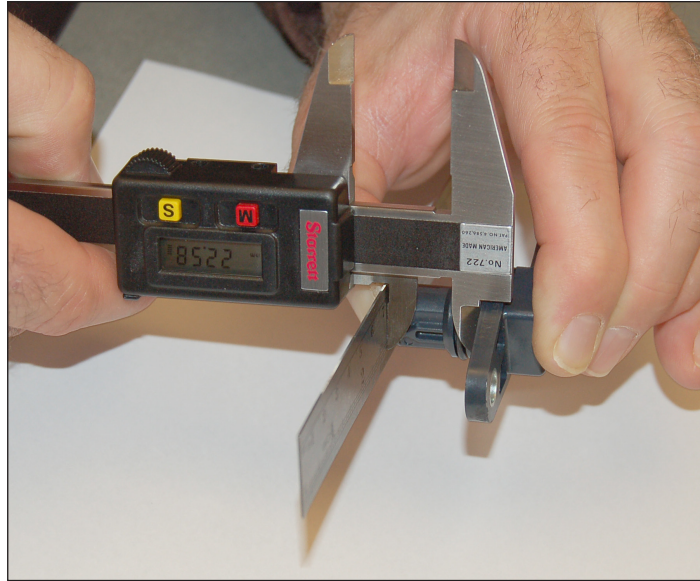
When taking measurement “B”, use a flat steel ruler or equivalent along with the digital caliper.

7. Measure the distance between the camshaft position sensor mounting surface and the bottom of the sensor as shown above.

**IMPORTANT:** Be sure to account for the thickness of the flat washer (if you are using one) when performing your calculations to determine the required shim thickness.
