# Technical Service Bulletin

## 94 Headlight Flickering or Warning On in Cluster (All Xenon Headlights)

94 13 10 2029194/4 March 4, 2013. Supersedes Technical Service Bulletin Group 94 number 13-03 dated February 1, 2013 for reasons listed below.

Model(s)	Year	VIN Range	Vehicle-Specific Equipment
Q7	2010	All	Premium Plus and Prestige
	2011	All	
	2012	All	
	2013	All	
	2014	All

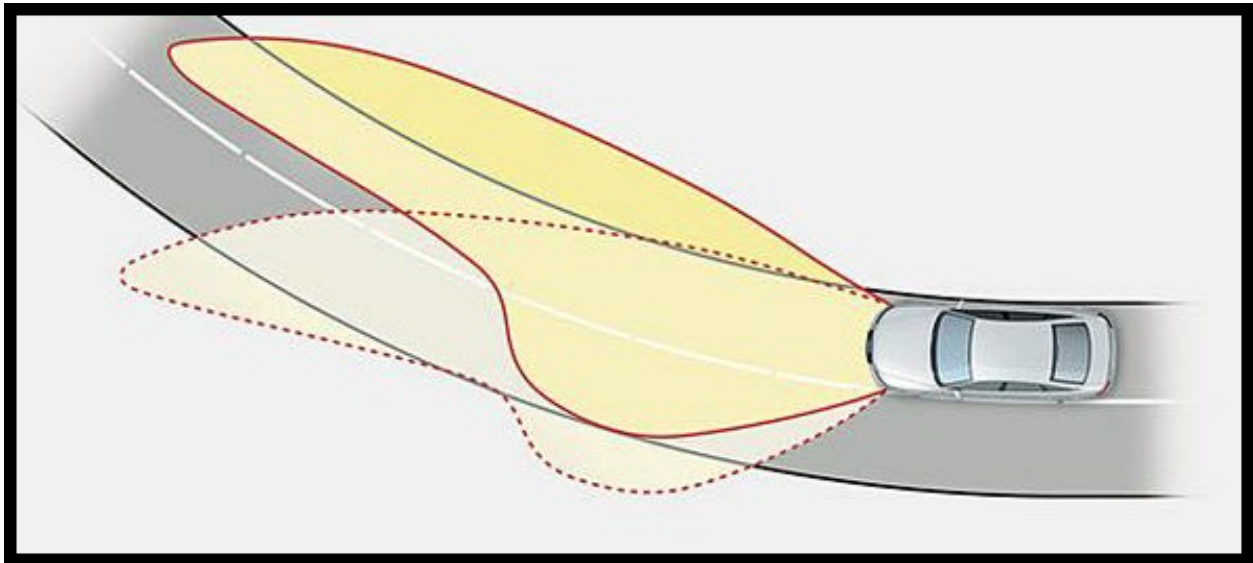
*Figure 5. Audi Adaptive Lighting illustration showing the maximum 15° curve of the light beam at speeds greater than 6mph.*

4. Ensure all the connectors are fully seated and locked. If a loose connector is found, skip step 5 and move to step 6.
5. If no loose connector is found, and the issue still persists, the issue is outside the scope of this TSB and the remaining steps can be skipped. A swap of headlamp components between left and right is the next logical step to narrow down the failed part of the headlamp.
6. Reassemble the headlamp and install it back in to the vehicle.
7. Clear the DTC(s) and retest with low beams activated, high beams activated, and all turn signals activated.
8. If no DTCs return, test the headlamp functionality in the garage or parking lot. In addition, perform a short road test and repeat the actuation of all headlamps functions while at a speed. To test the adaptive light function (if equipped), the vehicle will need to be driven around a corner at a speed greater than 6mph.
