Service Bulletin

Bulletin No.: 10-06-01-008G

Date: January, 2013

Subject: Engine Oil Consumption on Aluminum Block/Iron Block Engines with Active Fuel Management (AFM) (Install AFM Oil Deflector and Clean Carbon from Cylinder and/or Install Updated Valve Cover)

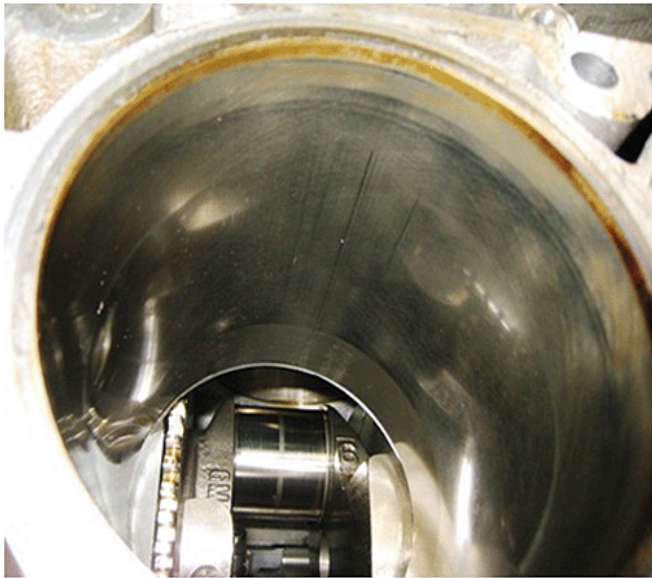
2596639

Note: It is not necessary to install the shield when doing the piston cleaning on a cast iron block engine since the cast iron block engine uses a different oil pump than an aluminum block engine, which results in a higher engine speed before the AFM pressure relief valve opens (cast iron block engines are less prone to the AFM oil spray condition described earlier). If you find it necessary to replace the pistons and/or remove the oil pan for any other reason, only then should you add the shield.
