# Service Bulletin

Bulletin No.: 10-06-01-008I

Date: February, 2013

**Subject:** Engine Oil Consumption on Aluminum Block/Iron Block Engines with Active Fuel Management (AFM) (Install AFM Oil Deflector and Clean Carbon from Cylinder and/or Install Updated Valve Cover)

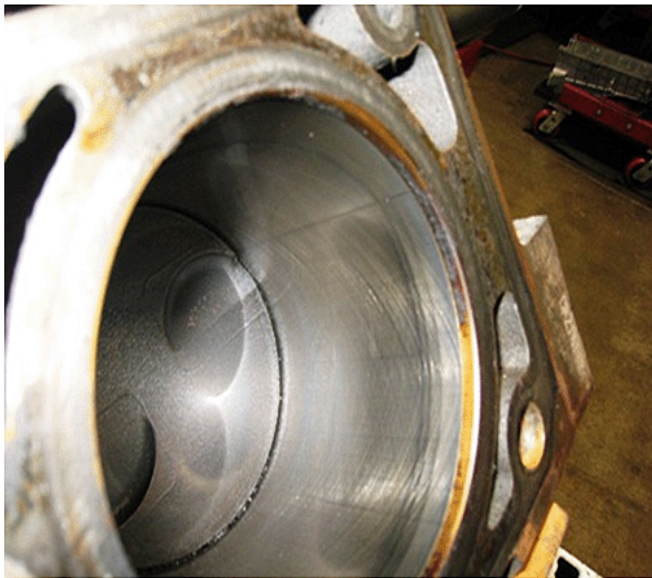
2596640

**Important:** Some minor scratches may be noticed on the cylinder walls during piston and ring replacement. If the scratch cannot be felt when running your finger nail over it, the scratch is considered normal wear and the block or engine should not be replaced.

**Note:** It is not necessary to hone or deglaze the cylinder walls. Honing may induce unnecessary cylinder wall and / or piston ring damage if it is done incorrectly and/or not cleaned thoroughly. Cylinder walls should be cleaned thoroughly with brake cleaner before installation of the new pistons and rings. Numerous engines replaced for oil consumption have been inspected. The cross hatch has been consistently good and is in specification. As a result, it should not be necessary to measure the cylinders if they pass the visual inspection.
