# **M-TIPS**

**UNIQUE REPAIR INFORMATION FOR  
MAZDA TECHNICIANS**

***JANUARY / FEBRUARY 2014***

## MULTI-MODEL REAR COMBINATION LAMP/FINISHER POOR APPEARANCE

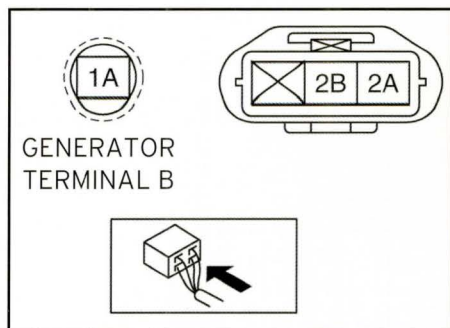
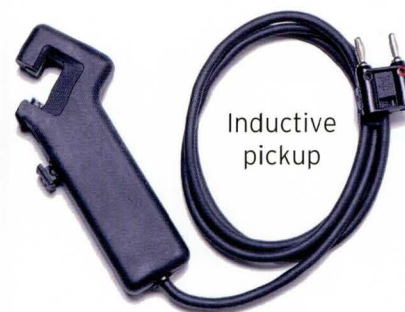
Battery Condition	Engine RPM	Generator Terminal		
		Terminal B		Terminal 2B Voltage
Fully Charged	idle	13-15 V	---	Voltage will increase with vehicle load
	2500	13-15 V	100 A (Nominal)

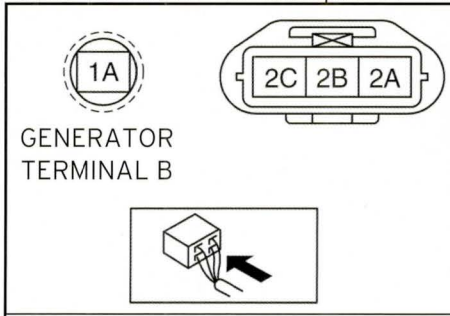
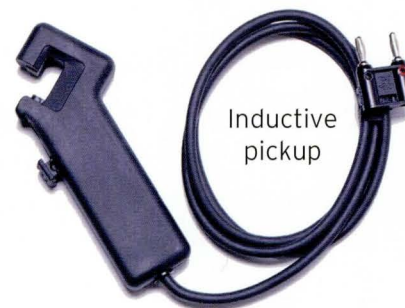
### Generator Voltage/Current Inspection (with i-ELOOP)

Battery Condition	Engine RPM	Generator Terminal		
		Terminal B		Terminal 2A, 2B
Fully Charged	idle	i-ELOOP Capacitor Voltage	---	Voltage will increase with vehicle load
	1000	15 V	130 A (Nominal)	
	2000	15 V	150 A (Nominal)	---
