SERVICE BULLETIN

APPLICABILITY: 2013MY Legacy and Outback Models with 2.5L FB Engines
 2011-14MY Forester Models with 2.5L FB Engines
 2012-13MY Impreza and 2013MY XV Crosstrek Models with 2.0L FB Engine

NUMBER: 02-157-14R
DATE: 08/28/14
REVISED: 09/08/14

SUBJECT: Surface Treatment Change To Oil Control Piston Rings

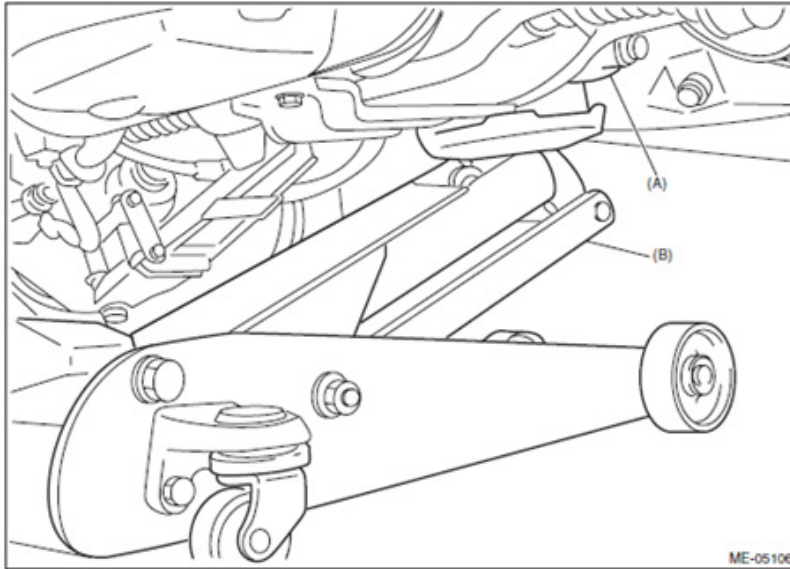
- When draining the engine oil, do not remove the engine oil filter. Leave the existing oil filter in place through engine disassembly, reassembly, installation and initial startup after engine reassembly.
- When removing the engine, there is no need to remove the transmission case cover (CVT only) or to disconnect / disturb any of the transmission harness connectors. While raising the transmission with the service jack placed under the front differential as shown in the illustration below, **only raise it enough to access and remove the engine mounting hardware**. Raising it too high can push the transmission up into the bulkhead / transmission tunnel and possibly cause damage.

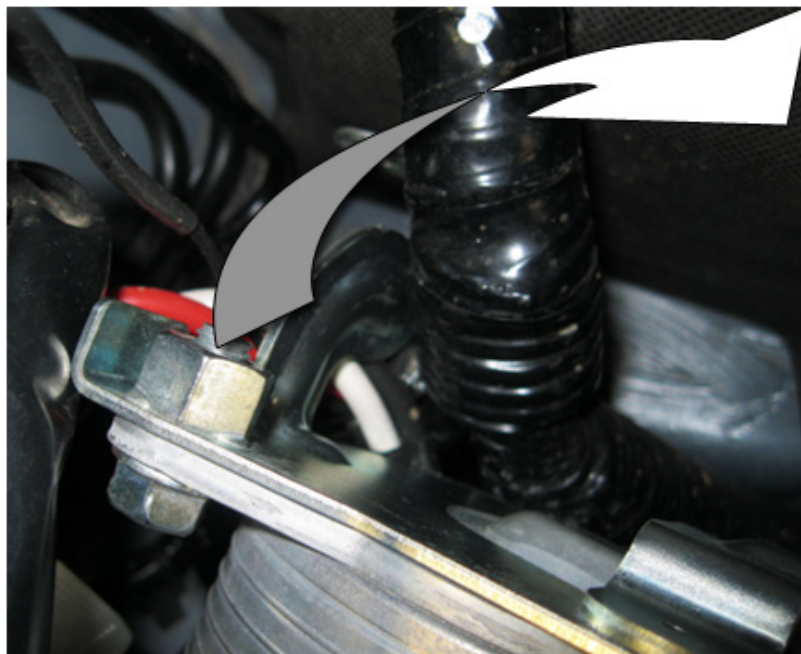
- When removing the CVT fluid cooler (if equipped), leave it attached to its mounting bracket and remove as an assembly (3 bolts) from the transmission. Disconnect just the engine coolant hoses from it and do not disturb the 2 short CVT fluid lines. Hook one of the cooler's mounting bracket "ears" behind the bulkhead harness as shown in the photo below to keep the cooler assembly out of your way. Use a shop cloth between the "ear" and the bulkhead harness to prevent any chafing.

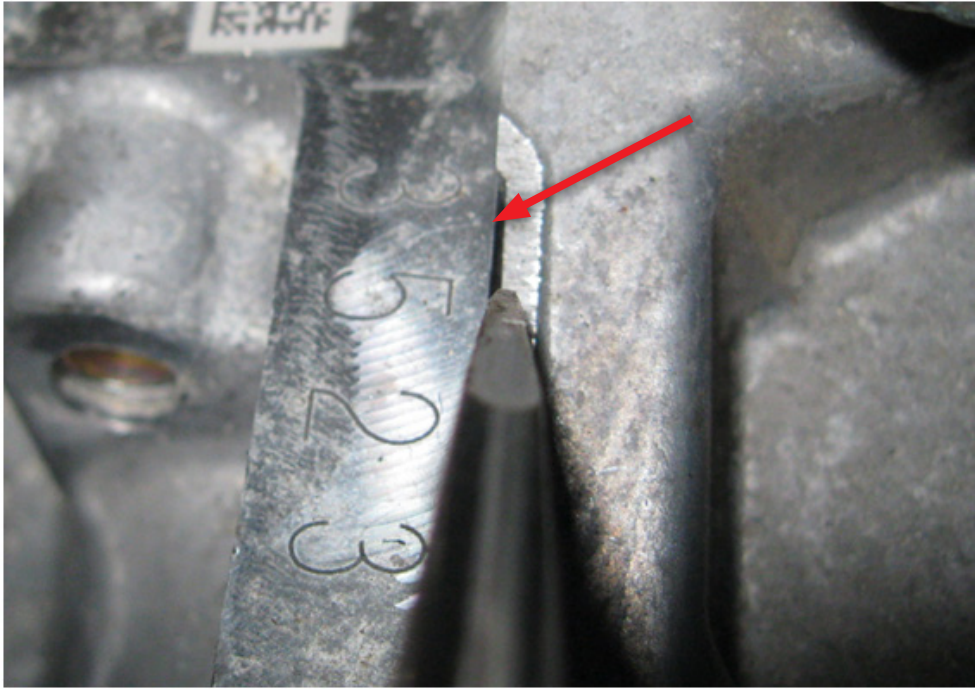
- To make separating the transmission (CVT) from the engine easier, there is a pry relief shown below in the machined mounting surface of the transmission case near the engine number. Use caution when applying any prying pressure and avoid twisting the tool to prevent case damage.

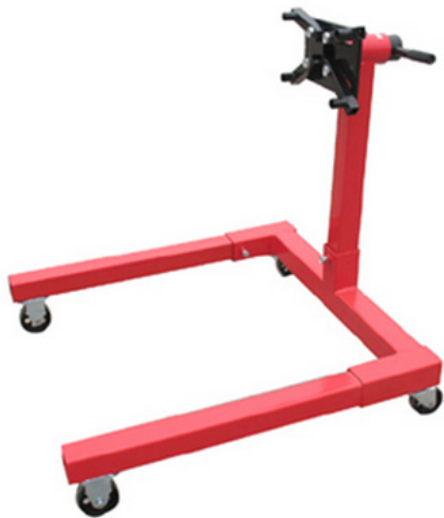
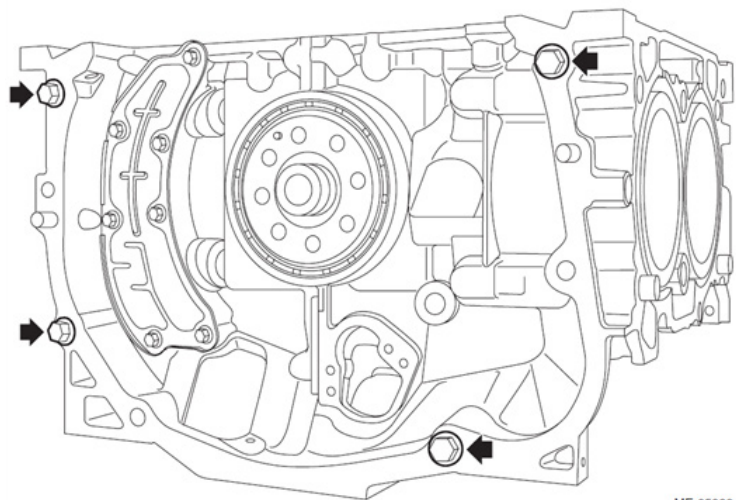
ME-05926

- Once the engine is removed, if you are using a generic engine stand (preferable since engine rotation is necessary), use the four mounting holes on the engine block shown below to mount it. **NOTE:** Do not use the mounting studs in the upper oil pan.

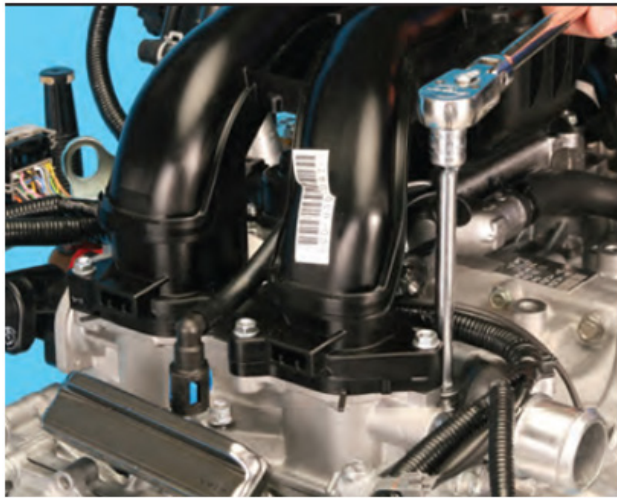
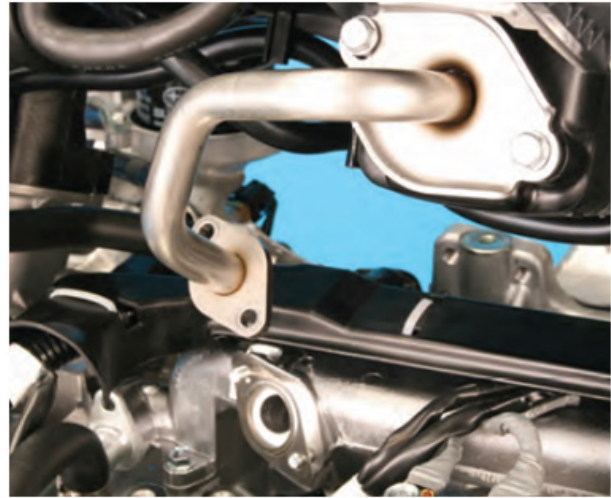
- When removing the intake manifold, as shown in the photos below, leave the TGV assemblies attached to the upper intake, remove the 2 nuts holding the EGR tube to the water pipe then remove the complete assembly from the cylinder heads as a unit.

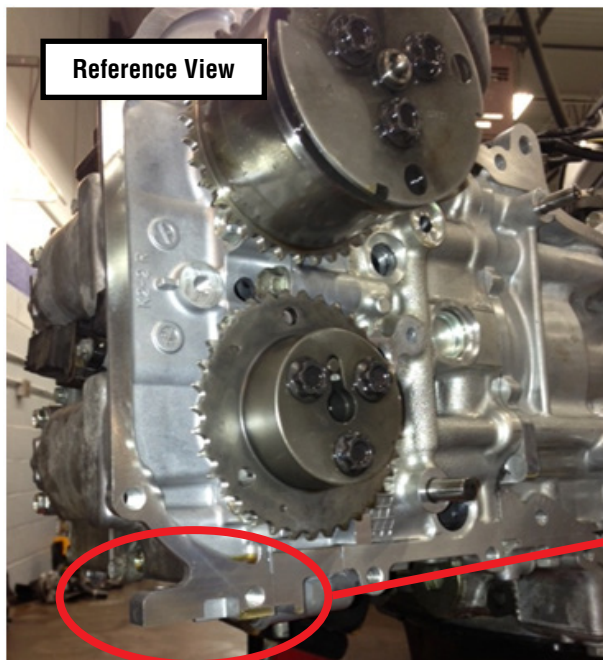
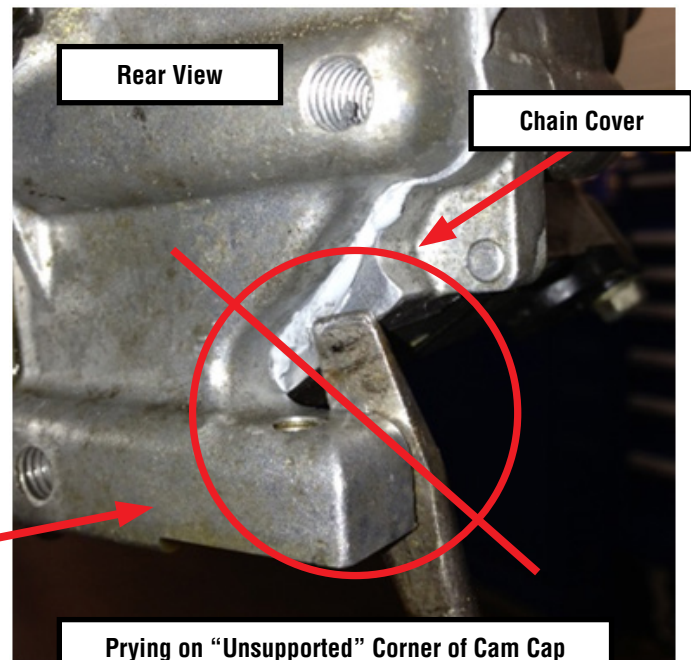
- There is no need to remove the oil dipstick tube or the original oil filter from the front chain cover. While the cover is removed, store it face (front side) down to minimize the chances of damaging the machined sealing surface on the block / head side. Also, don't use it as a tray to store other removed parts.
- **IMPORTANT:** After all 32 bolts securing the chain cover are removed, be **EXTREMELY** careful where you pry and what you pry on to break the silicone sealant's bond. The photos below show an example of where **NOT** to pry. In this case, the cam cap became cracked requiring a complete cam carrier replacement. *Patience is the key!*

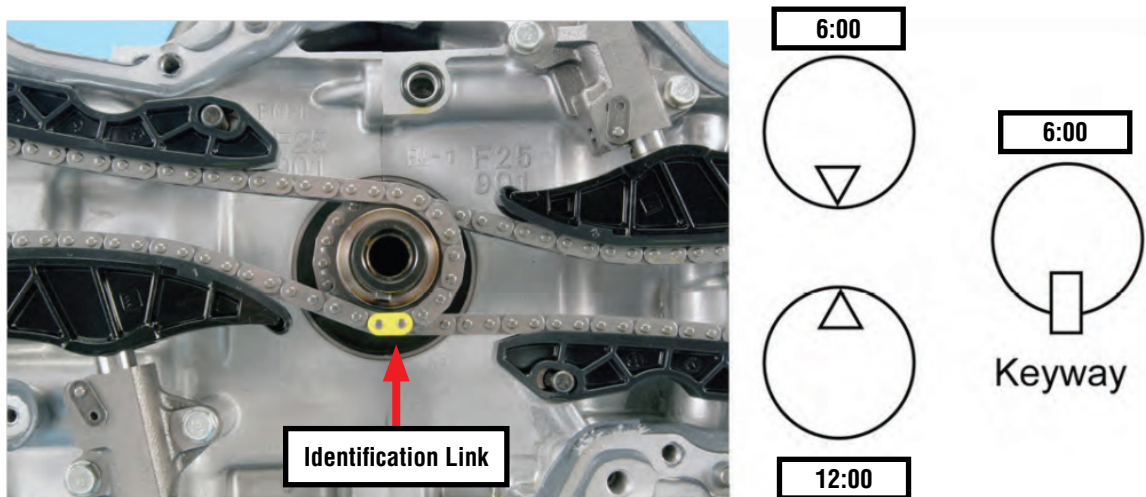
- Begin timing chain removal by positioning the crankshaft keyway at the 6:00 position. The RIGHT bank intake camshaft timing mark (Δ) must be at 6:00 with right bank exhaust timing mark at 12:00 (camshafts will be unloaded).

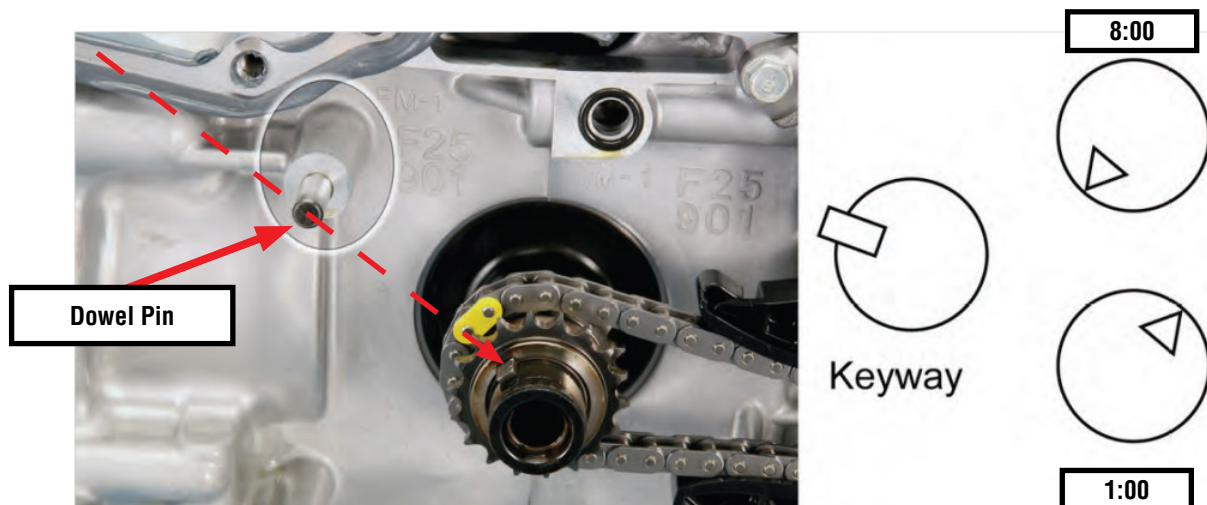
- Compress the chain tensioner by hand, insert a pin through the lever into the access hole to lock the plunger in place then remove the 2 bolts, tensioner, guides and right side timing chain.
- After turning the crankshaft CLOCKWISE, repeat the procedure for the LEFT side with the timing marks (Δ) positioned as shown below. Align the crank sprocket keyway with RH chain dowel pin (shown in red below).

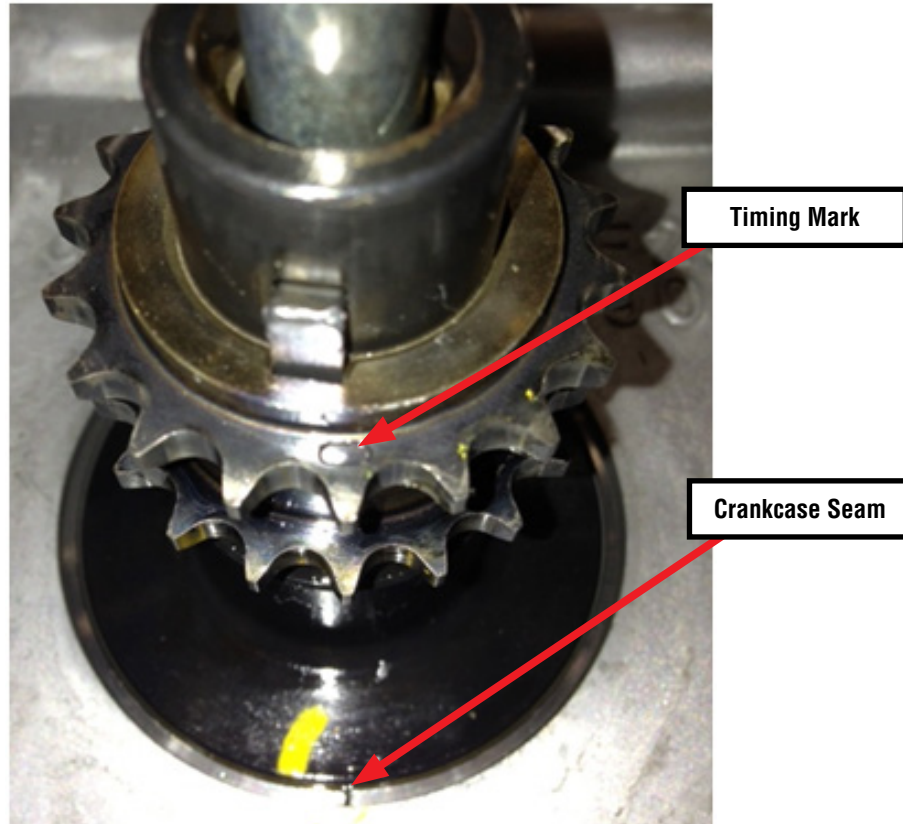
- Compress the chain tensioner by hand, insert a pin through the lever into the access hole to lock the plunger in place then remove the 2 bolts, tensioner, guides and the left side timing chain.
- After the left chain is removed, turn the crankshaft in a COUNTER CLOCKWISE direction until the timing mark on the crankshaft sprocket (NOT the keyway) is back to the 6:00 position as shown below. This positions all the pistons away from TDC and prevents accidental contact between the pistons and valves.

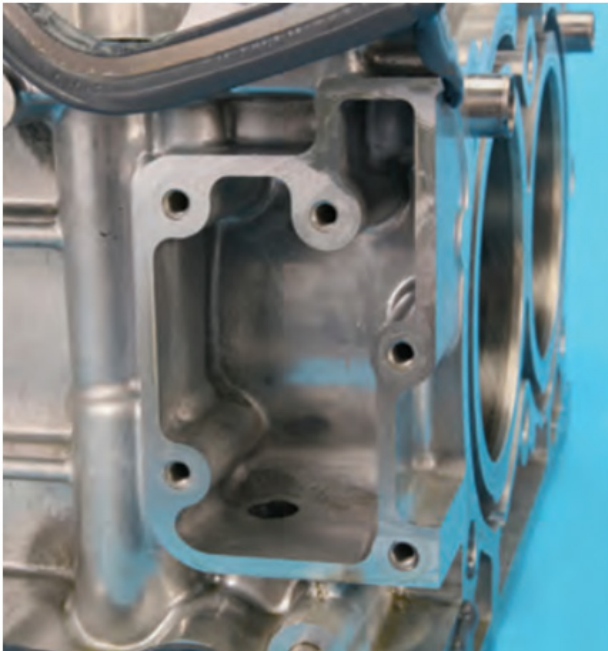
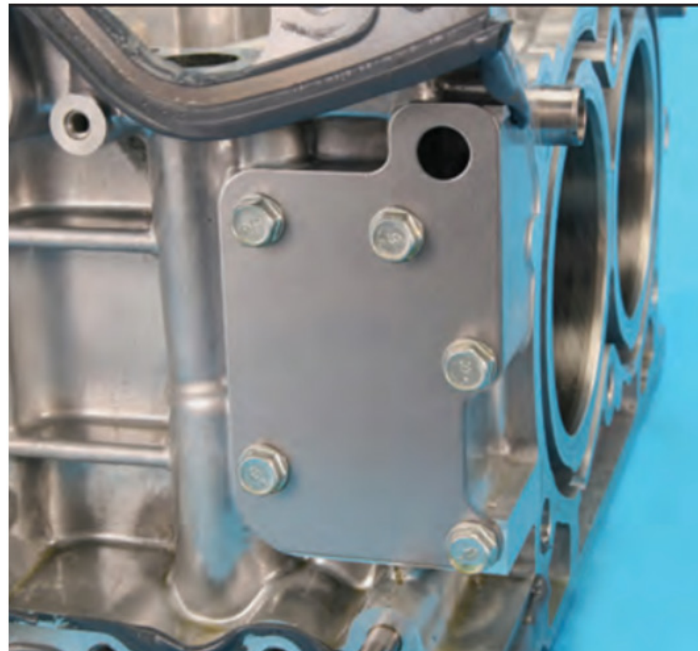
- Install the new **one-time use** PCV adapter. **NOTE:** Never try to reuse the original.
- Swap over the PCV assembly and the PCV baffle plate onto the front of the block. **NOTE:** No sealer is used between the baffle plate and the block.

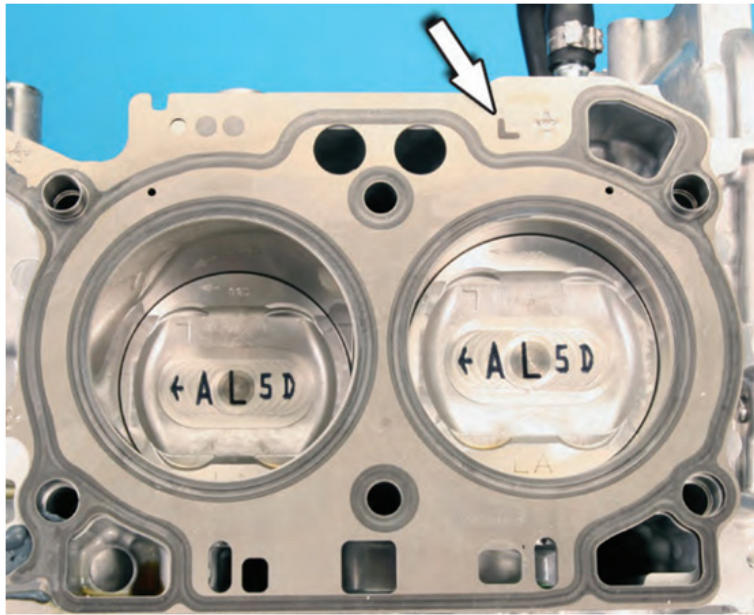
- If equipped, swap over the lower water jacket coolant baffles into the new block.
- Head gaskets are marked “L” and “R”. Always make sure they are properly installed while paying close attention to the sealer application areas as outlined in the Service Manual.

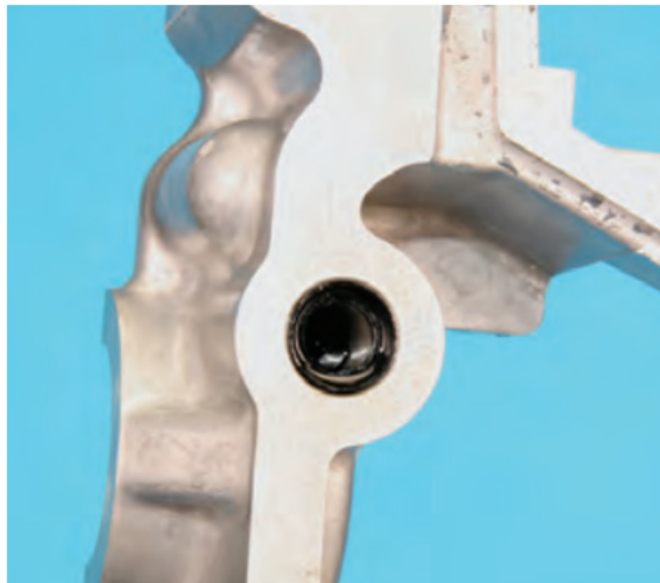
- Always make sure to clean the head bolt threads and apply engine oil to the threads and head bolt washers before starting the torque sequence. **Always follow the torque sequence closely.**
- **IMPORTANT:** If by chance the AVCS filter screens in the cam carriers have come loose or fallen out during disassembly, **they are directional and MUST be reinstalled in their original position.** There is an oil passage in the cam case which **MUST** align with a hole on the outside diameter of the filter screen tube otherwise, oil flow to the AVCS will be restricted or blocked resulting in engine damage.

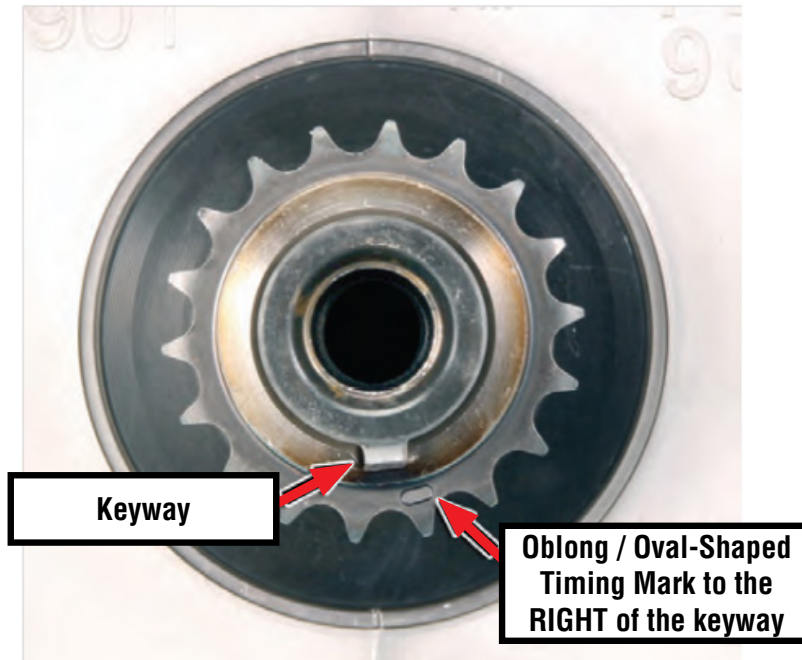
- To begin timing chain re-installation, turn the crankshaft **COUNTER-CLOCKWISE** until the crankshaft sprocket keyway is back to the 6:00 position. This positions the pistons away from TDC and prevents accidental contact with the valves. **NOTE:** The keyway is **NOT** a timing mark. The oblong / oval-shaped timing mark must face front and be to the **RIGHT** of the keyway as shown below. Do not confuse this mark with a mark which may be found on the back side of the sprocket.

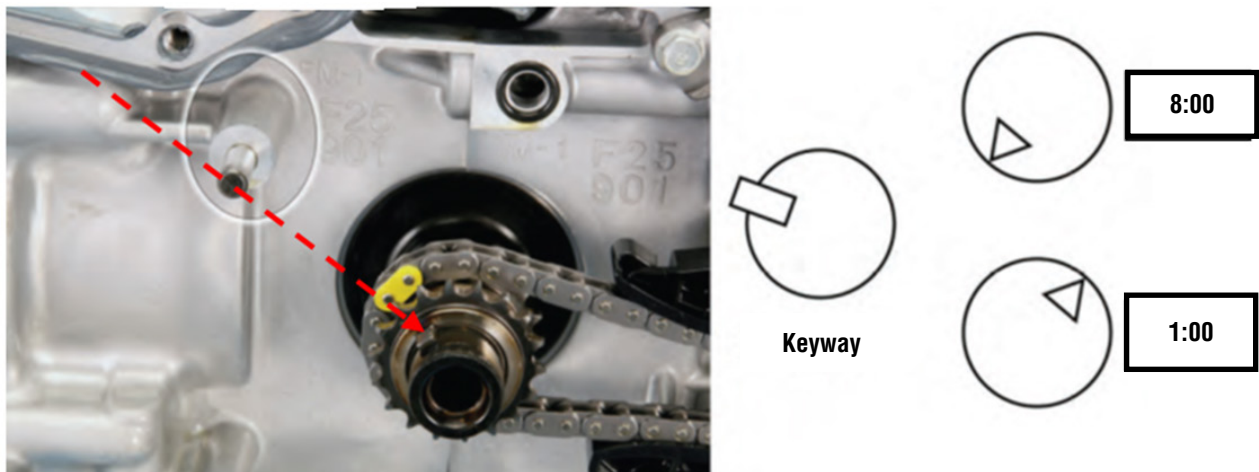
- Arrange the timing marks as shown below, turning the crankshaft **CLOCKWISE** into position. Align the indicator link with the timing mark on the crankshaft sprocket, keyway with the dowel pin.

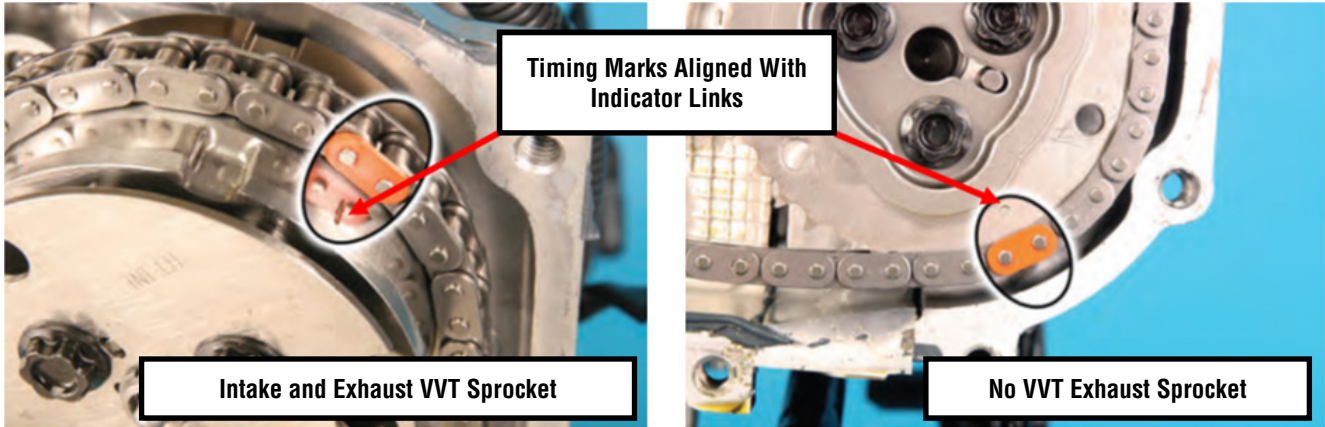
- Align the indicator links to the timing marks found on the outside of the sprocket assemblies as shown in the photos below (Exhaust sprocket face images vary with / without exhaust VVT).

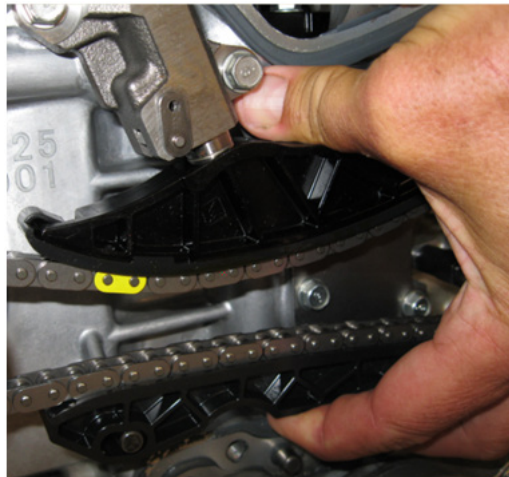
- Install the chain guides and tensioner. Once proper positioning has been confirmed, pull the pin to release the tensioner. With your hand, grab and squeeze the upper and lower chain / guides together as shown in the reference photo below to allow the plunger in the tensioner to fully extend and click into its furthest notch.

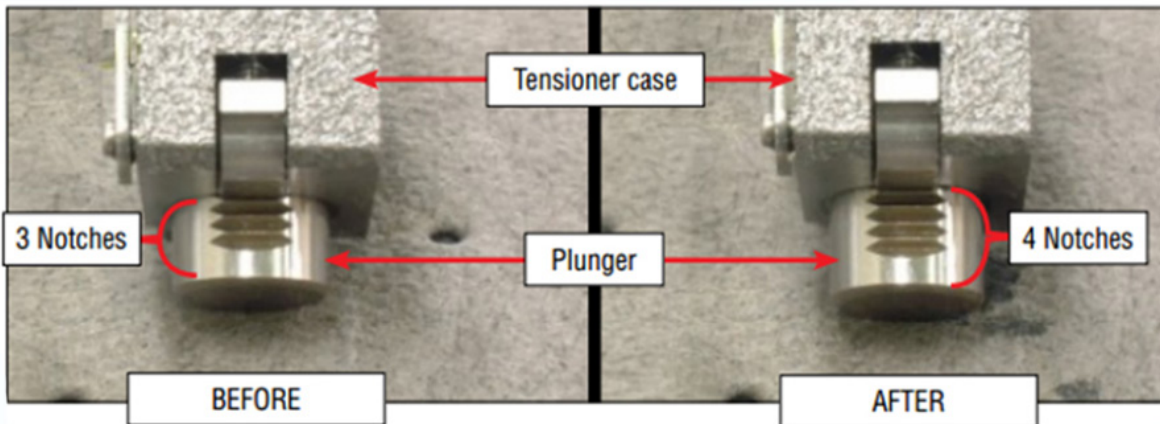
- If you have 3 notches showing, you want to get one more “click” so that 4 notches are visible as shown in the photos below. If you have 4 showing, you want to end up with 5. Whether you start with 3 or 4 will depend on the amount of wear present on the chains and guides. The number of clicks listed here is simply a guide. The point is to ensure proper initial chain tension is applied to avoid creating a brief rattle sound at engine start.

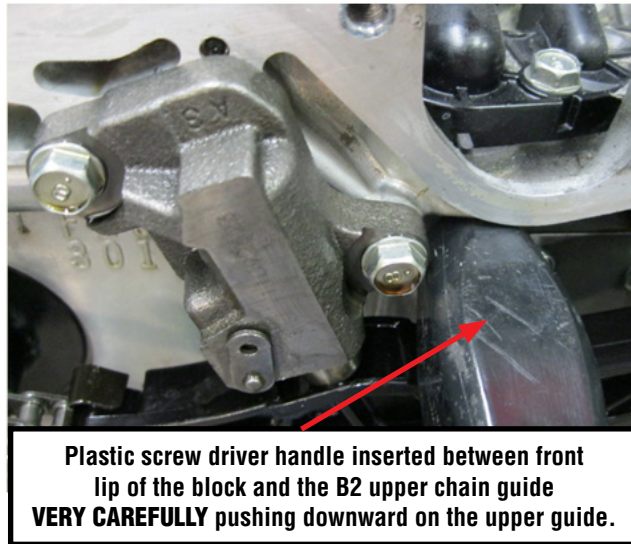
- If necessary, insert a plastic screwdriver handle between the lip of the block and the left side (B2) guide. Then, **VERY CAREFULLY** push down on the guide just enough to get the extra tensioner notch / “click”. When using this method, always make sure you are using plastic on plastic and NOT metal on plastic to avoid damaging the chain guides.

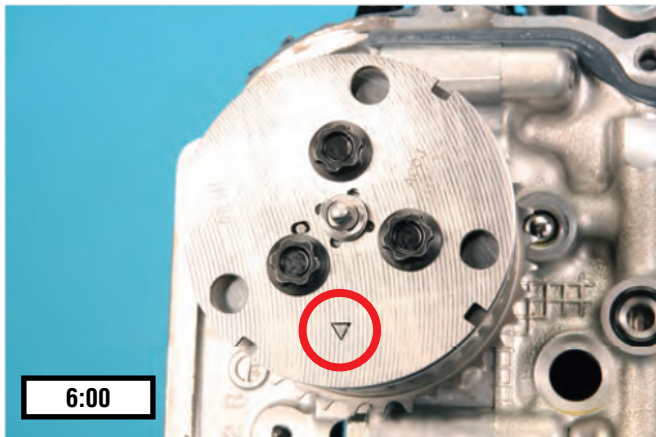
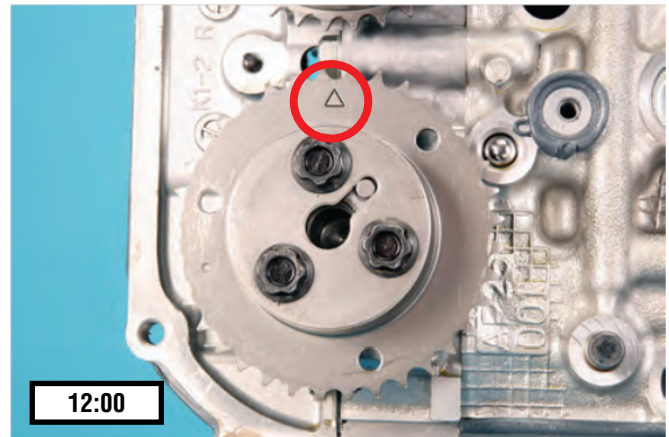
- Rotate the crankshaft **COUNTER-CLOCKWISE** until the crankshaft sprocket timing mark is at the 6:00 position. Position the cam sprocket timing marks as shown below; intake 6:00, exhaust 12:00.

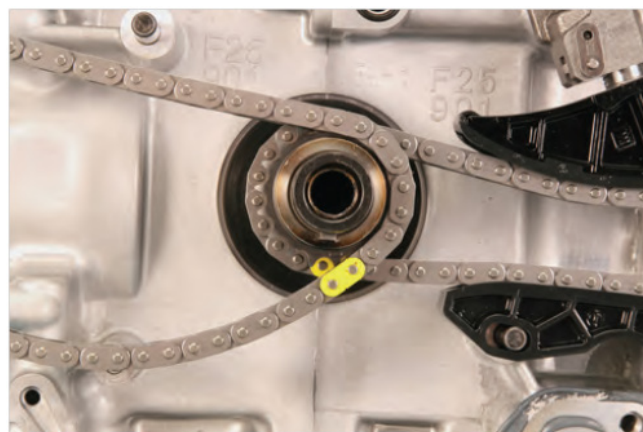
- Align the indicator link with the timing mark on the crankshaft sprocket as shown below.

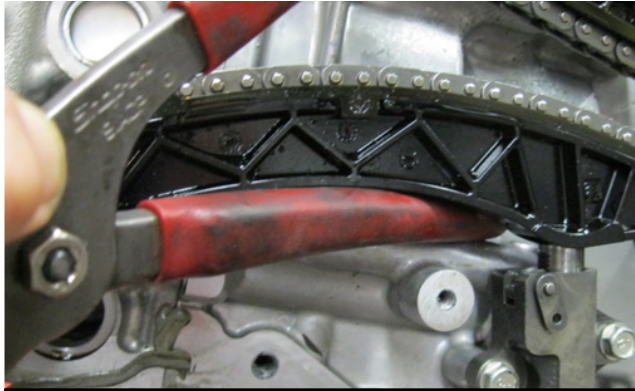
- Same as the left side, align the indicator links to the timing marks found on the cam sprocket assemblies. Install the chain guides and tensioner. Once proper positioning has been confirmed, pull the pin to release the tensioner. With your hand, grab and squeeze the upper and lower left side chain / guides together to allow the plunger in the tensioner to extend fully and click into its furthest notch as shown in the previous (right side) photo. If necessary, insert a rubber-coated plier handle between the ledge area on the front of the block and the right side (B1) lower chain guide. Then, **VERY CAREFULLY** lift up on the guide just enough to get the extra “click” on the tensioner as shown in the photo below.

Rubber-coated plier handle inserted between a ledge area on the front of the block and the B1 lower chain guide **VERY CAREFULLY** lifting upward on the lower guide.
