Service Bulletin

Bulletin No.: PI0040C

Subject: Poor Fit/Gap at Interface of Side Door Trim Panel and Lower Door and/or Rattle Noise Upon Opening/Closing Door

Models: 2007-2013 Cadillac Escalade Models
2007-2013 Chevrolet Avalanche, Silverado, Suburban, Tahoe
2007-2013 GMC Sierra, Sierra Denali, Yukon Models

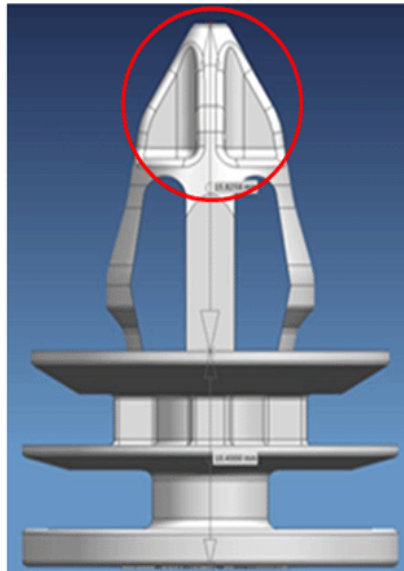
3351924

2. Inspect the rear and lower door trim retainers (circled in the graphic above) for damage or improper engagement.

3. Also inspect these locations for any white first design (1) retainers or yellow (2) retainers. These retainers should not be used and should be replaced with the white, second design retainer, referenced previously.

Important: When replacing any retainer in the locations noted in the following steps, only use the second design white retainer, GM P/N 11611339, which has a more robust tip.

4. Remove and discard any damaged retainers and replace with appropriate fasteners from the table below. The doors may have different combinations of fasteners, so ensure replacement of the proper color fastener at the proper location.
