# Service Bulletin

Bulletin No.: PI0235E

**Subject:** Exhaust Leak or Vibration/Rattle Noise at Approximately 900 RPM, Fuel Smell, White Smoke, Oily Substance on Exhaust Downpipe

**Models:** 2011-2013 Chevrolet Express 2500/3500/4500, Silverado 2500HD/3500HD  
2011-2013 GMC Savana 2500/3500/4500, Sierra 2500HD/3500HD  
Equipped with 6.6L Duramax™ Diesel Engine (RPOs LML or LGH)

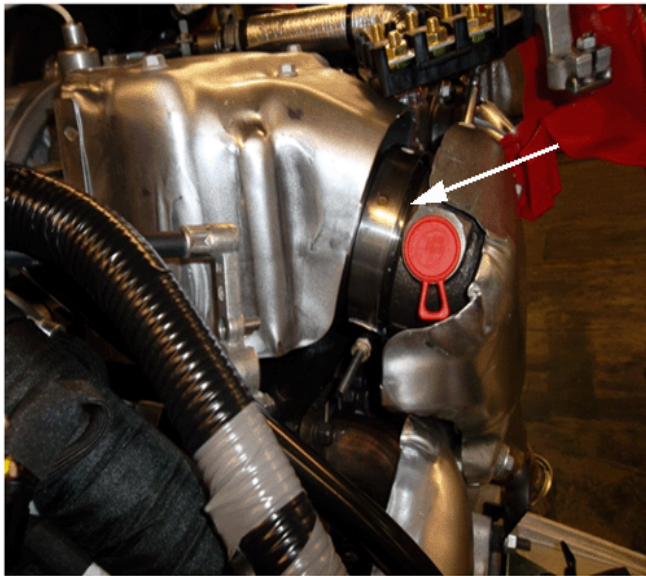
2748857

8. Visually verify the joint has good contact completely around the downpipe and the turbocharger exhaust pipe as shown in the illustration above.
