Service Bulletin

Bulletin No.: PI0689B

Date: August, 2013

Subject: Aftermarket Installed Service, Tool or Utility Box Sagging, Mis-aligned, Forward Box Mount Bracket Fractured on Trucks Equipped with Aftermarket Bodies

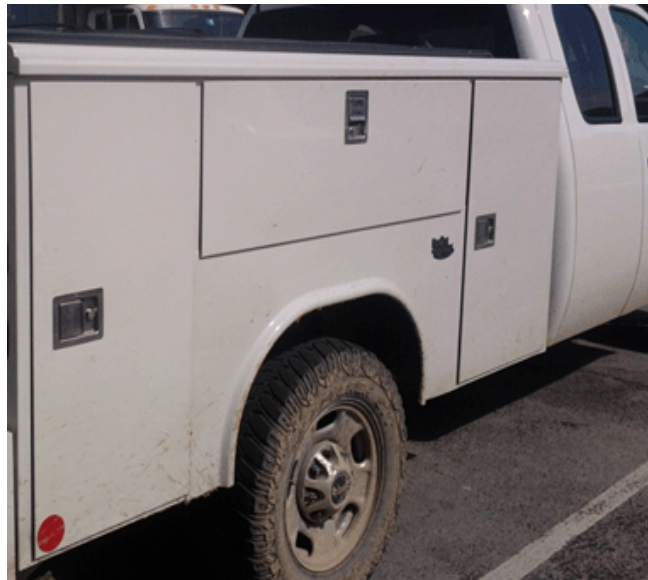
2779514

Some customers may comment that the utility box is sagging, not level or misaligned. Upon inspection, the technician may find cracked or fractured front bed mount bracket(s).
