Technical Service Bulletin

16-01-011-1

Elantra (MD/UD)

SUBJECT: YAW RATE/"G" SENSOR INSPECTION AND HECU UPDATE
(RECALL CAMPAIGN 137)

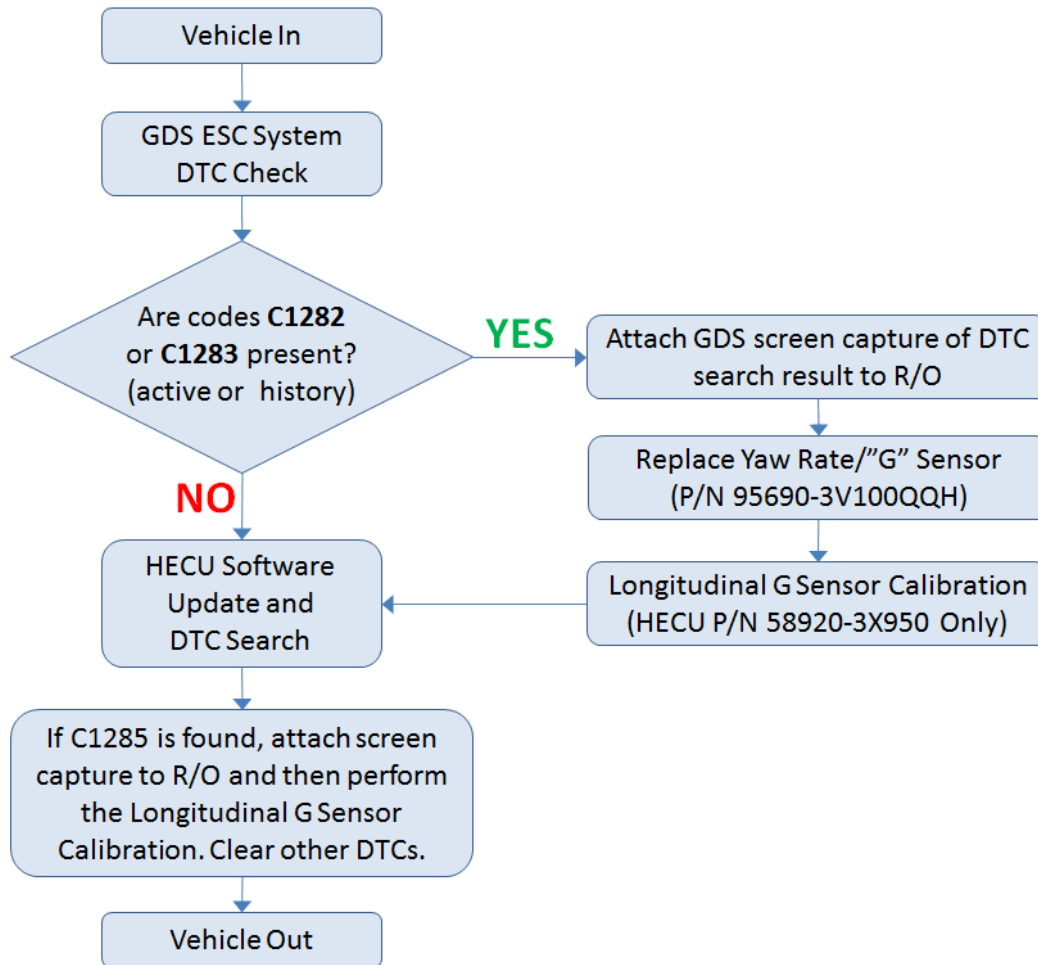
On certain 2011 to 2012 model year Elantras (MD/UD), the Yaw Rate/"G" sensor may send a signal that may result in one or more of the following:

1. Inadvertent ESC system intervention,
2. Illumination of the "ESC" indicator lamp in the instrument cluster.
3. Diagnostic codes C1282 and/or C1283 (for the yaw sensor) stored in the ESC Control Module.

ESC system intervention may include inadvertent brake application to one or more wheels and/or reduced engine torque, both of which can increase the risk of a crash. This bulletin describes the procedure to check for diagnostic codes, replace the Yaw/"G" sensor if necessary, and update the hydraulic unit ECU (HECU) software.

Follow the flow chart below.

- 2a. If codes **C1282** or **C1283** are found either as active or history;
1. Attach a GDS screen capture of the Fault Code Search screen, clearly showing the VIN and the C1282 and/or C1283 DTCs found.

2. Replace the Yaw Rate/"G" Sensor (A) according to the applicable workshop manual.
 - a. Locate the HECU (B) on the passenger side of the engine compartment and note the part number (C).

- 2b. If codes **C1282** or **C1283** are **NOT** found either as active or history;
1. Perform the HECU Update procedure below.
 2. Check for DTCs.
 - a. If **C1285** is found, attach screen capture to the R/O and then perform the Longitudinal G Sensor Calibration. Clear other DTCs. The procedure is complete.
 - b. If **C1285** is **NOT** found, clear other DTCs. The procedure is complete.
