AT15-006b

ITB15-011b

April 5, 2016

2013 JX35 AND 2014-2015 QX60; ENHANCED DIAGNOSTIC LOGIC FOR CVT JUDDER

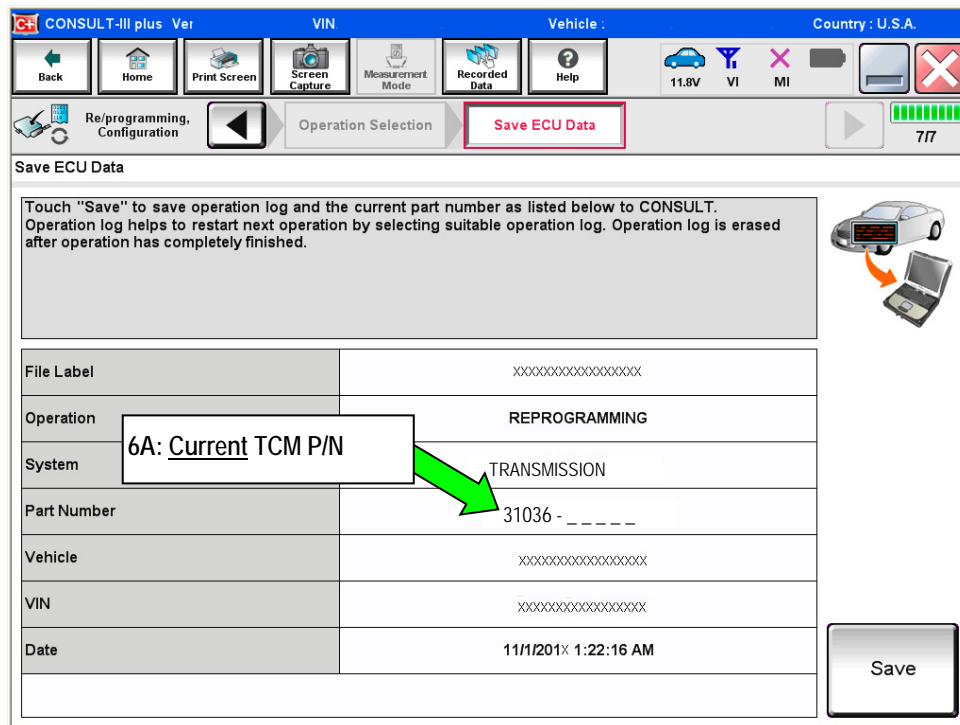
Figure 2

6. When you get to the screen shown in Figure 2, confirm this bulletin applies as follows.

A. Find the TCM Part Number and write it on the repair order.

NOTE: This is the current TCM Part Number (P/N).

B. Compare the P/N you wrote down to the numbers in the **Current TCM Part Number** column in **Table A** below.

- If there is a match, this reprogramming applies. Continue with the reprogramming procedure.
- If there is not a match, this bulletin does not apply.

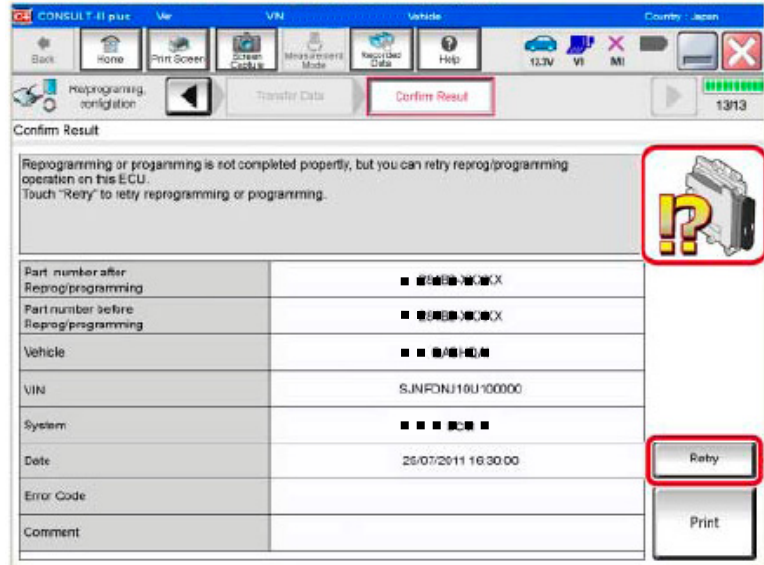
Figure 5

If reprogramming does not complete and the “!?” icon displays as shown in Figure 5:

- Check battery voltage (12.0–15.5 V).
- Ignition is ON, engine OFF.
- External Bluetooth® devices are OFF.
- All electrical loads are OFF.
- Select retry and follow the on screen instructions.
- “Retry” may not go through on first attempt and can be selected more than once.

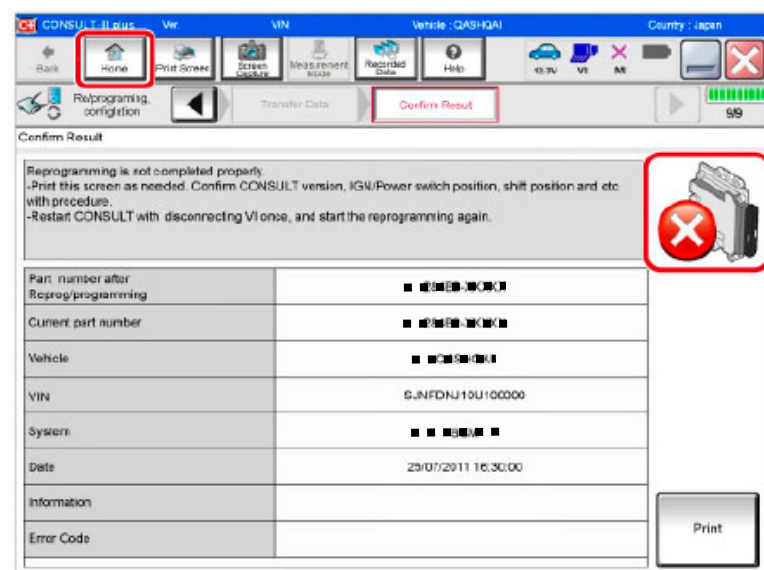
Figure 6

If reprogramming does not complete and the “X” icon displays as shown in Figure 6:

- Check battery voltage (12.0 – 15.5 V).
- CONSULT A/C adapter is plugged in.
- Ignition is ON, engine OFF.
- Transmission is in Park.
- All C-III plus / VI cables are securely connected.
- All C-III plus updates are installed.
- Select Home, and restart the reprogram procedure from the beginning.
