## Battery Cable Routing CXU

### PI0802, Battery Cable Routing

(December 2012)

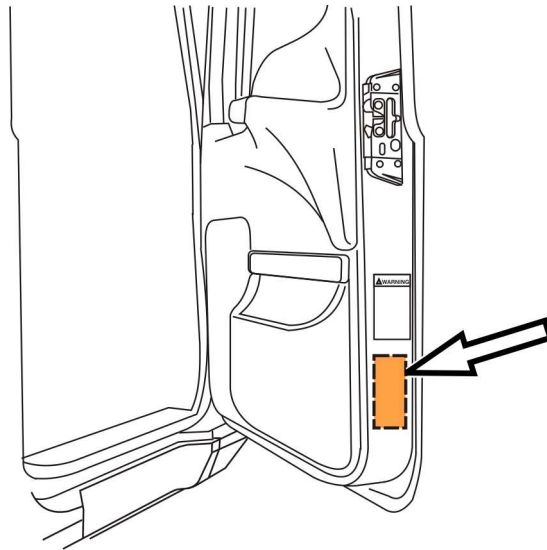
W8034103

**Note:** To signify that the campaign has been completed, using a permanent-type marker (such as a Sharpie®) write the campaign number (PI0802) and completion date in the spaces provided on the Campaign Completion label located inside the cab as shown in the illustration below. If a label is not already affixed inside the cab, apply a label (part No. TS897) and supply the information as required. Campaign Completion labels are available in packs of 50 and can be ordered by faxing a completed BR313 to Pacesetters Business Services at 610-264- 9465.
