Service Bulletin

SUBJECT: Special Coverage Adjustment – Transmission Clutch Wave Plate

MODELS: 2007-2009 Buick Enclave
2008-2009 Chevrolet Equinox, Malibu
2009 Chevrolet Traverse
2007-2009 GMC Acadia
2007-2009 Pontiac G6
2008-2009 Pontiac Torrent
2007-2009 Saturn AURA, OUTLOOK
2008-2009 Saturn VUE
Equipped with FWD or AWD and 6-Spd Automatic Transmission
(RPO MH2, MH4, MH6, or MY9)

Subject: 14404A – Special Coverage Adjustment
Transmission Clutch Wave Plate
Revised Models, RPO Codes and Warranty Information

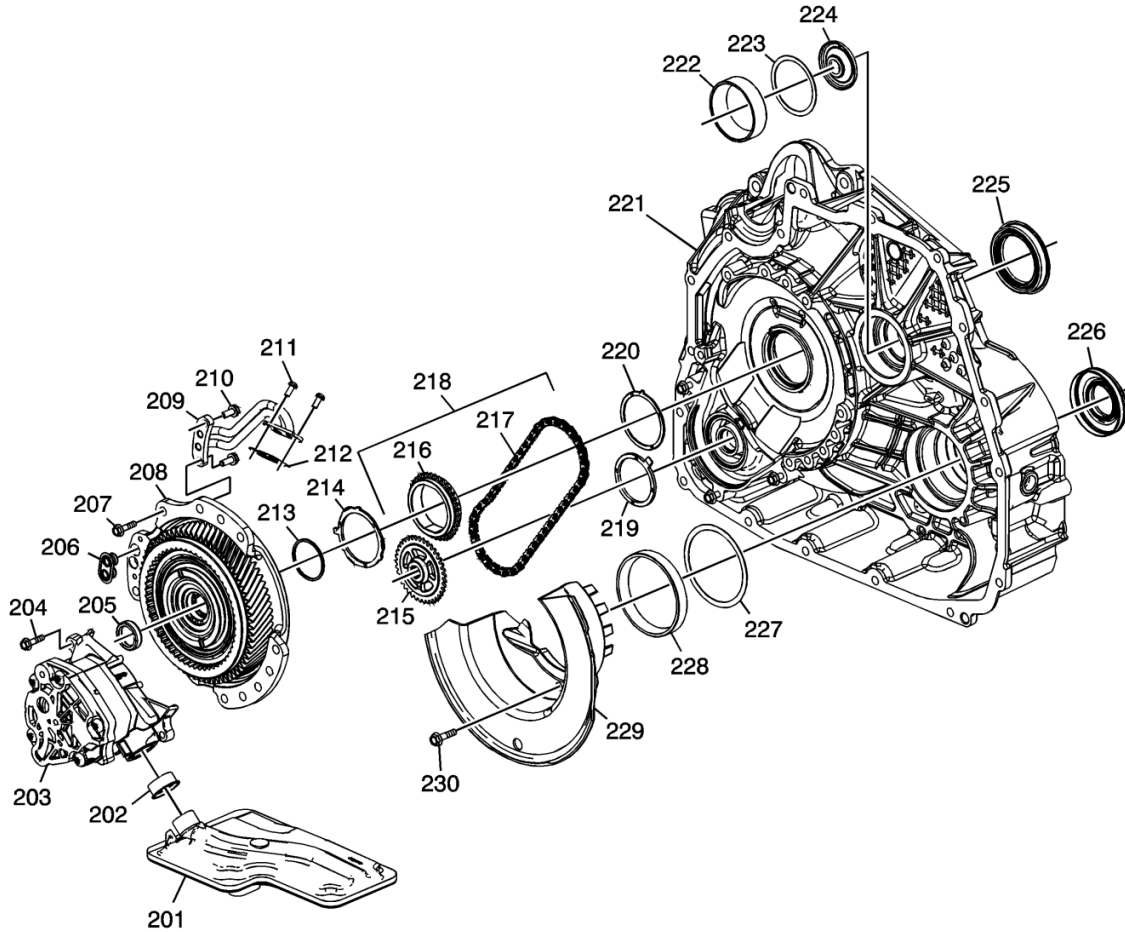
1725882

A broken 35R wave plate can generate varying amounts of debris inside the transmission. In most cases this debris has not passed through the pump fluid filter (201) potentially damaging the pump, valve bodies or torque converter. This debris can be cleaned and the transmission successfully repaired.

Note: Debris generated by the condition must be cleaned from the entire transmission and the pump fluid filter (201) and the control solenoid filter plate (16) must be replaced. Failure to separate the case halves, disassemble the transmission, clean the debris and replace the pump fluid filter (201) and the control solenoid filter plate (16) could lead to repeat transmission damage and repairs.
