SERVICE BULLETIN

APPLICABILITY: 2012 (AFTER VIN C*411693)- 14 MY
 Forester Models with 2.5L FB Engines

NUMBER: 02-144-13R

SUBJECT: Surface Treatment Change To Oil Control
 Piston Rings

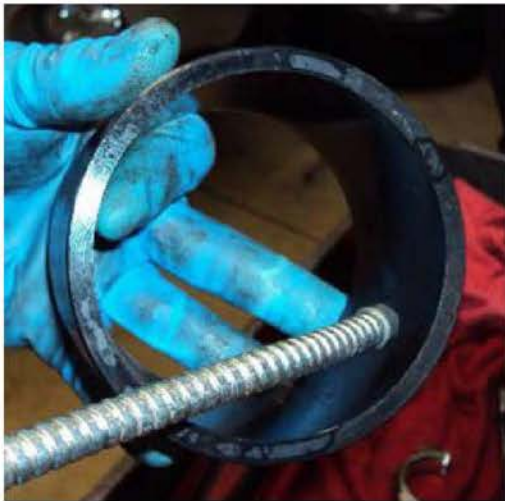
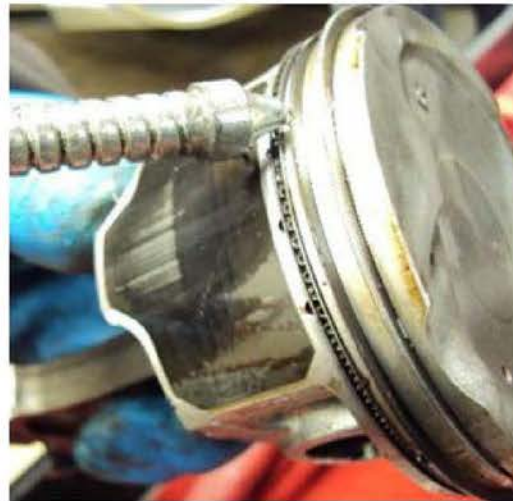
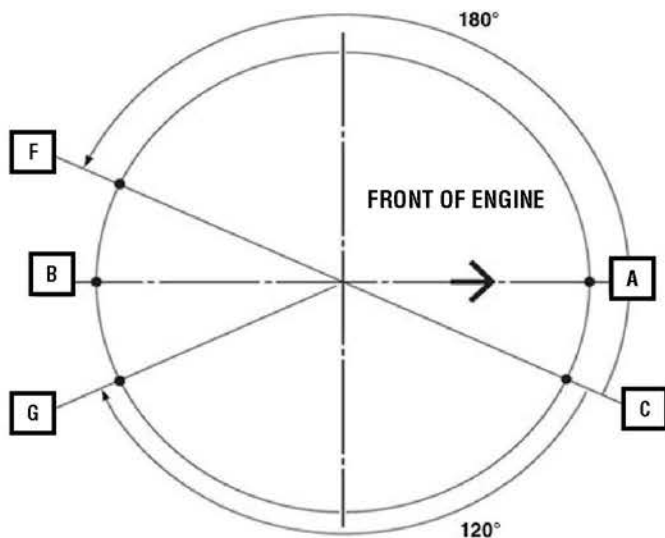
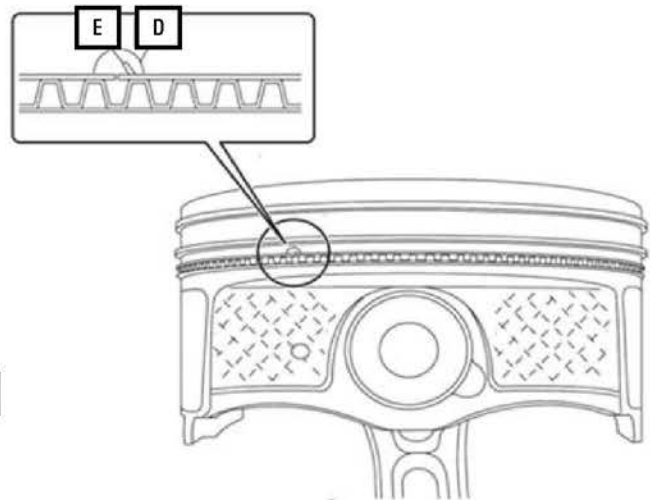
- “A” - Top compression ring end gap location
- “B” - Second compression ring end gap location (180 degrees away from “A”)
- “C” - Top oil control scraper ring end gap
- “D” - Recess in top of ring land to accept the “tang” of the upper oil control scraper ring - “E”
- “F” - Expander gap (180 degrees away from “C”)
- “G” - Bottom oil control scraper ring end gap (120 degrees away from “C”)

- When cleaning the pistons prior to installing the new rings, take care not to damage the anti-friction coating applied to the skirts. A mild parts cleaner may also be used with the Scotch-Brite Ultra-Fine #7448 (gray in color) to loosen and remove carbon deposits from the piston crown and from between the ring lands. Do not use Scotch-Brite to clean the piston skirts as it can damage the anti-friction coating. The ends of a removed compression ring may be used to carefully clean deposits from inside the ring lands. Rinse the piston / rod assemblies thoroughly and dry before installing the new rings onto the pistons. Refer to the Service Manual and the illustrations below for ring direction (marks facing upward) and end gap placements before placing the piston/rod assembly into the ring compressor.

REMINDER: Always lubricate the rings, ring compressor, piston skirts, cylinder walls, wrist pin areas, rod bearing surfaces and rod bolt heads and threads liberally with engine oil before reassembly.

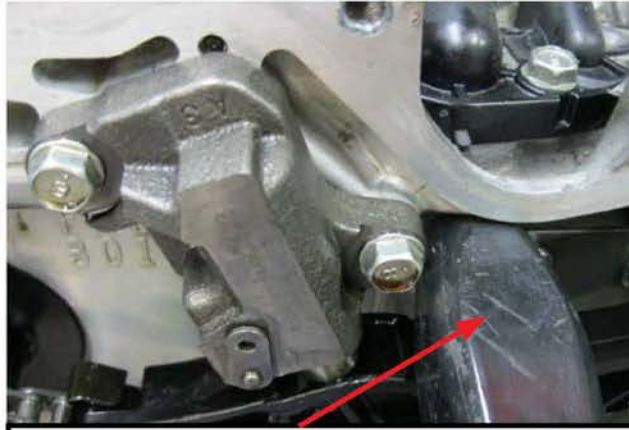
Plastic screw driver handle inserted between front lip of the block and the B2 upper chain guide **VERY CAREFULLY** pushing downward on the upper guide.

- If necessary, insert a plastic screwdriver handle between the lip of the block and the left side (B2) guide. Then, **VERY CAREFULLY** push down on the guide just enough to get the extra tensioner notch / “click”. When using this method, always make sure you are using plastic on plastic and NOT metal on plastic to avoid damaging the chain guides.

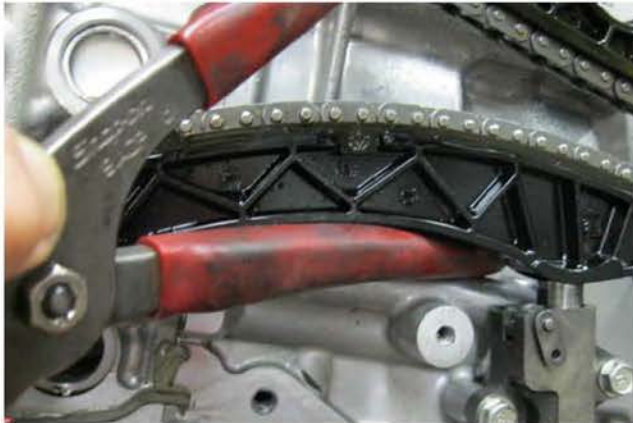
Rubber-coated plier handle inserted between a ledge area on the front of the block and the B1 lower chain guide **VERY CAREFULLY** lifting upward on the lower guide.

- Same as the left side, align the indicator links to the timing marks found on the cam sprocket assemblies. Install the chain guides and tensioner. Once proper positioning has been confirmed, pull the pin to release the tensioner. With your hand, grab and squeeze the upper and lower left side chain / guides together to allow the plunger in the tensioner to fully extend and click into its furthest notch as shown in the previous (right side) photo. If necessary, insert a rubber-coated plier handle between the ledge area on the front of the block and the right side (B1) lower chain guide. Then, **VERY CAREFULLY** lift up on the guide just enough to get the extra “click” on the tensioner as shown in the photo below.
