074 (Rev 1, 9/13/2016)	August 2016
NUMBER	DATE
СНА	Multiple Models
GROUP	MODEL

TECHNICAL SERVICE BULLETIN

MDPS FLEXIBLE COUPLING REPLACEMENT

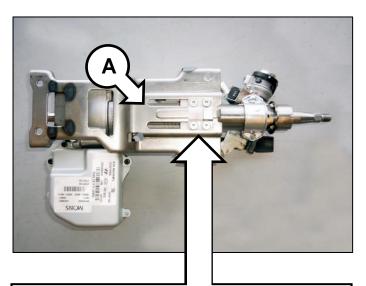
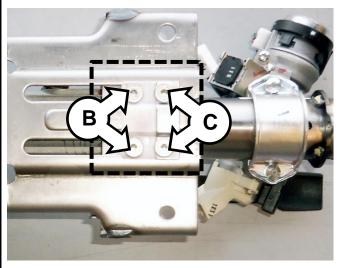
Locate the steering column guide bracket (A) and remove four (4) Torx[®] head screws (B/C) securing it to the steering column.

> Tightening torque: B: 3.6 lb-ft (4.9 Nm) C: 2.2 lb-ft (2.9 Nm)

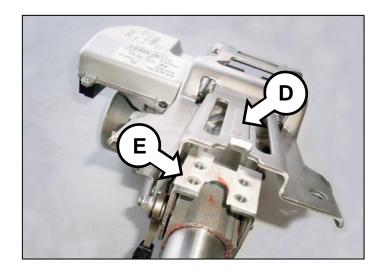
Lift the steering column guide bracket (D) and remove the plastic spacer (E). Retain all parts as they will be reused.

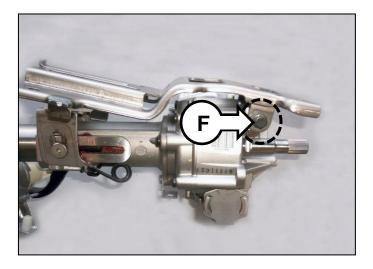
4. Remove the steering column guide bracket hinge bolt (F)

Tightening torque: 13~14.5lb-ft (17.7~19.6 Nm)

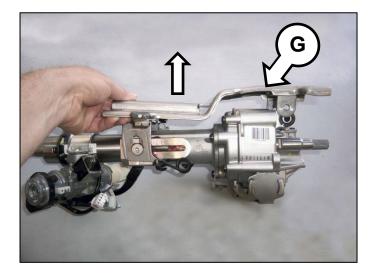
5. Remove the steering column guide bracket (G) from the steering column.

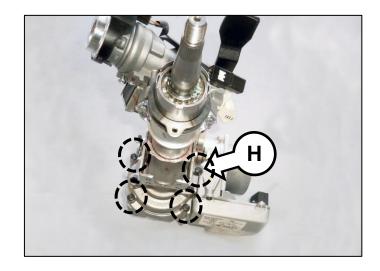
Hold the MDPS upright and loosen four Torx[®] head screws (H) securing the column to the motor housing.

> Tightening torque: 6.5~9.4lb-ft (8.8~12.7 Nm)

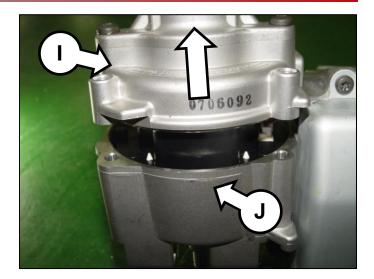
7. Separate the upper half (I) of the motor housing from the lower half (J).

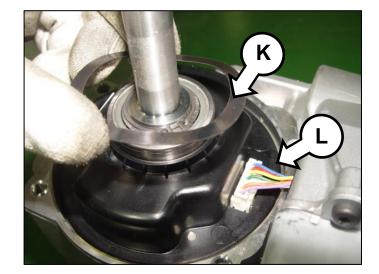
8. Remove the washer-gasket (K) and connector (L) from lower portion of the MDPS.

To avoid damage, use caution when removing the connector.

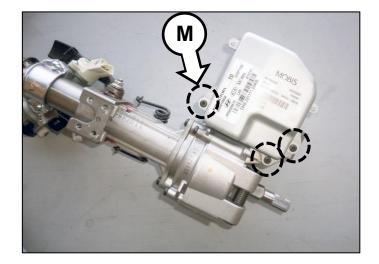
9. Remove the 3 Torx[®] head screws (M) securing the MDPS ECU cover.

Tightening torque: 3.6~5.1lb-ft (4.9~6.9Nm)

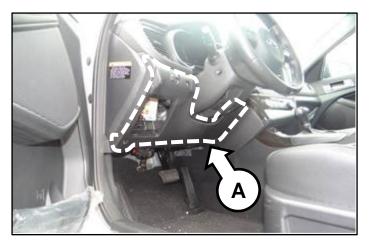
Remove the crash pad lower panel (A) by referring to "Body (Interior and Exterior) → Interior → Crash Pad → Repair procedures" on KGIS.

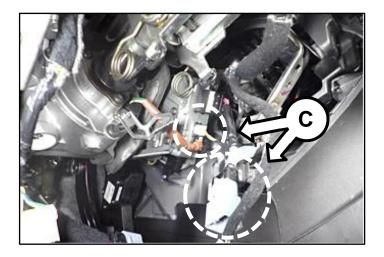
3. Disconnect the MDPS electrical connectors (C).

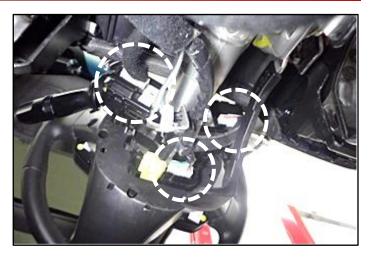
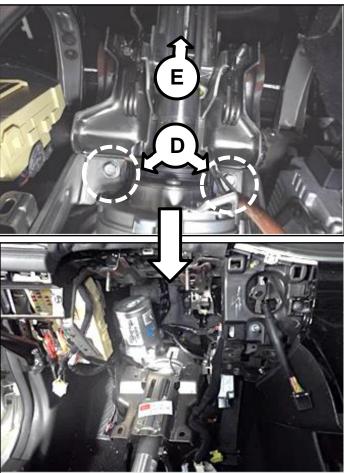
Loosen both steering column retaining bolts (D) and rear bolt (E) and lower the steering column assembly.

> Tightening torque: 9.4~13.0 lb-ft (12.7~17.7 Nm)

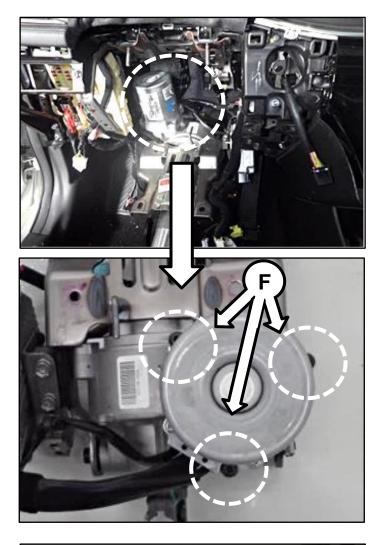
6. Loosen the three MDPS motor retaining bolts (F) and lift the MDPS motor and set it to the side.

Tightening torque: 5.8~8.7 lb-ft (7.8~11.8 N-m)

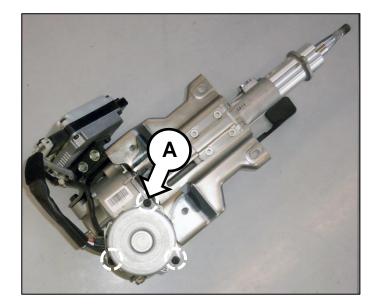
- 1. Remove the MPDS unit by referring to the applicable procedure on KGIS.
- 2. Remove 3 bolts (A) securing the MPDS motor to the housing.

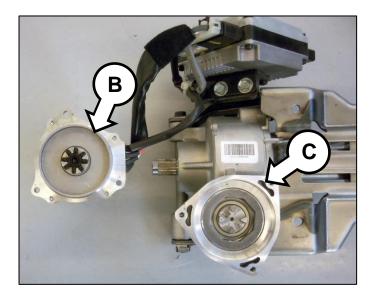
3. Separate the MDPS motor (B) from the housing (C), as shown.
