EL12-061b

ITB12-054b

September 28, 2016

## NO AUDIO DURING PHONE CALL WITH APPLE iOS 10, NAVIGATION SYSTEM REBOOTS, AND/OR AUDIO CONTROLS WILL NOT RESPOND

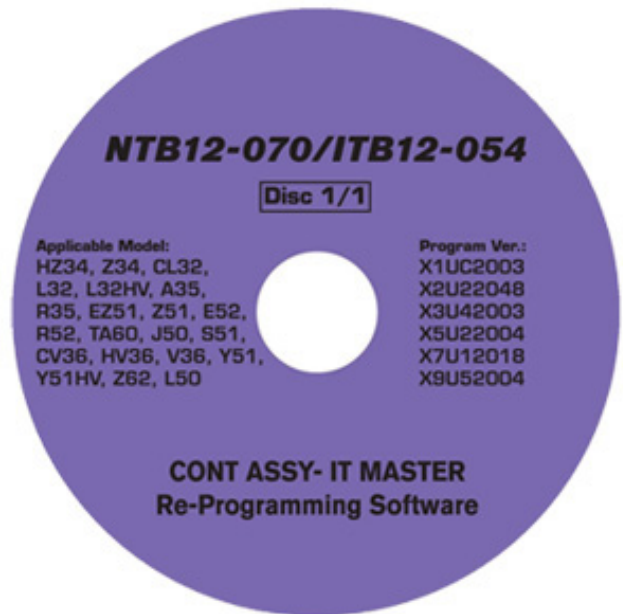
Figure A

Re-programming software DVD required for this procedure:

- Each retailer has been mailed one NTB12-070/ITB12-054 Re-programming Software DVD, free of charge, from Clarion.
- Should you require an additional NTB12-070/ITB12-054 Re-programming Software DVD due to loss or damage, it can be ordered free of charge by contacting Clarion toll free at 1-800-347-8933.
