**SERVICE BULLETIN**

**APPLICABILITY:** 2014-15MY XV Crosstrek Hybrid Electric Vehicle (HEV)    **NUMBER:** 16-94-15  
**SUBJECT:** Diagnosis and Repair of DTCs P172A and P0B0B                      **DATE:** 07/30/15

**INTRODUCTION**

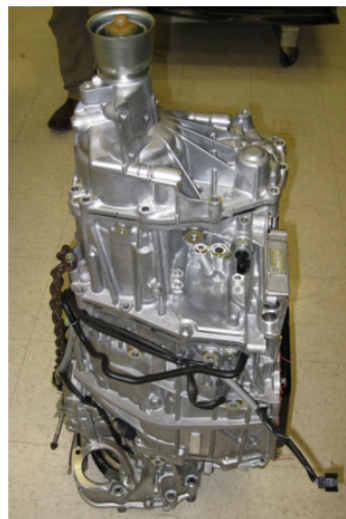
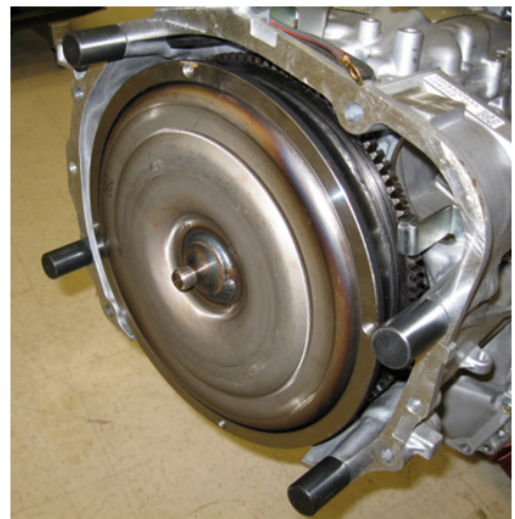
The bulk of this procedure is best performed with the transmission assembly standing vertically. Use the 4- 6M/T stands (S/T# 18632AA000) pictured below for support.

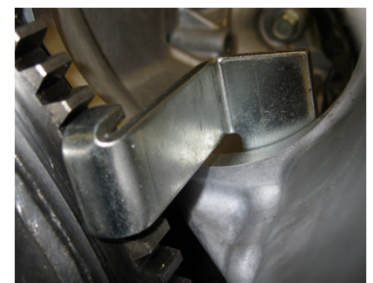
- The torque converter can also be left in place. Either support it from the underside after standing the unit up with a block of wood or use a retainer strap / bracket included with remanufactured and replacement transmission assemblies to keep the torque converter in place.
