Subject: WRINKLES ON LEATHER SEAT SURFACE OF NEW VEHICLE	Bulletin No: 09-016/16
	Last Issued: 06/22/2016

2015-2017 Mazda3	2015-2017 Mazda6	2015-2016 Mazda CX-5	2015-2016 Mazda MX-5
2015-2016 Mazda5	2016 Mazda CX-3	2015-2016 Mazda CX-9

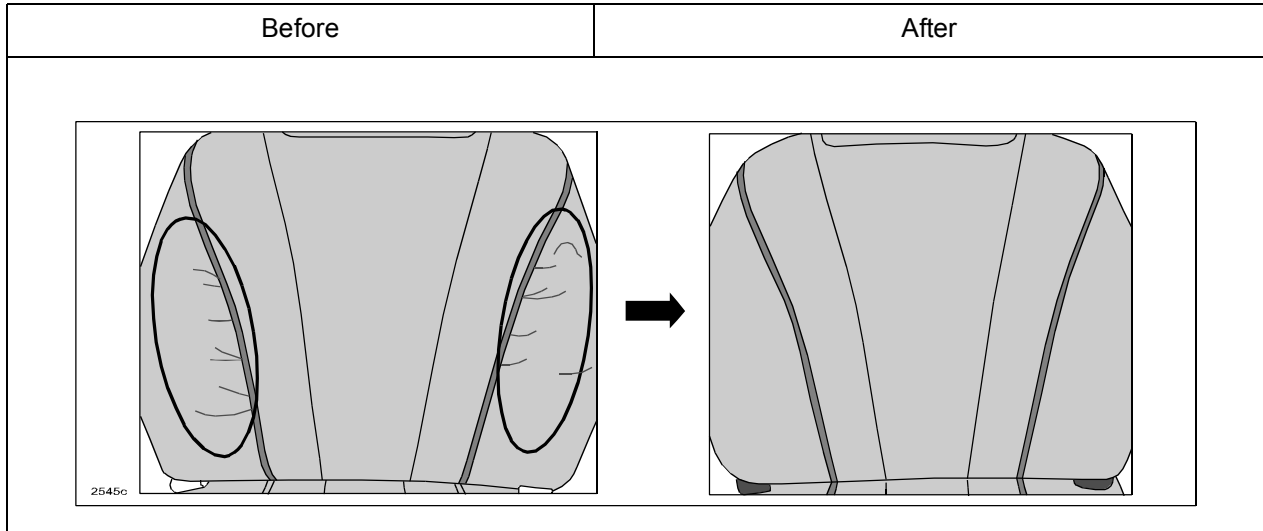
- Do NOT keep the steamer head at the same place for a long time.
- Do NOT run the steamer head without a water-soaked cloth especially over seat trim beading and seat side trim area.
- Seat damage may occur if the caution points above are not followed as shown below.
