SERVICE BULLETIN

APPLICABILITY: 2013-14MY Legacy and Outback Models with 2.5L FB Engines
 2011-14MY Forester Models with 2.5L FB Engines
 2015 MY Forester (Manual Transmissions Only) with 2.5L FB Engines
 2012-13 MY Impreza and XV Crosstrek Models with 2.0 FB Engines
 2014-15 MY Impreza and XV Crosstrek Models (Manual Transmissions Only) with 2.0 FB Engines

NUMBER: 02-157-14R
DATE: 08/28/14
REVISED: 11/12/15

SUBJECT: Surface Treatment Change To Oil Control Piston Rings

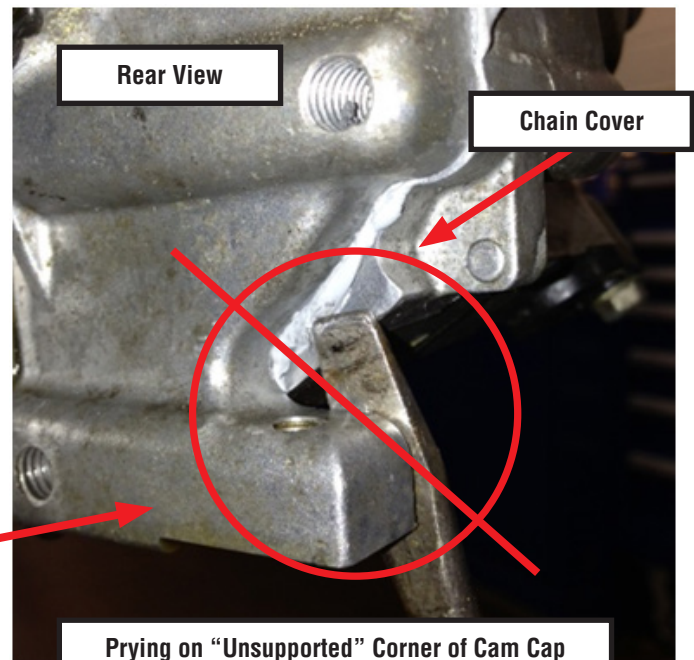
- There is no need to remove the oil dipstick tube or the original oil filter from the front chain cover. While the cover is removed, store it face (front side) down to minimize the chances of damaging the machined sealing surface on the block / head side. Also, don't use it as a tray to store other removed parts.
- **IMPORTANT:** After all 32 bolts securing the chain cover are removed, be **EXTREMELY** careful where you pry and what you pry on to break the silicone sealant's bond. The photos below show an example of where **NOT** to pry. In this case, the cam cap became cracked requiring a complete cam carrier replacement. *Patience is the key!*
