TECHNICAL BULLETIN  
K248 UPS5714-1bNAS2  
15 OCT 2014

Update Prior to Sale: Luggage Compartment Lid Interior Trim Loose

**F-TYPE (X152)**

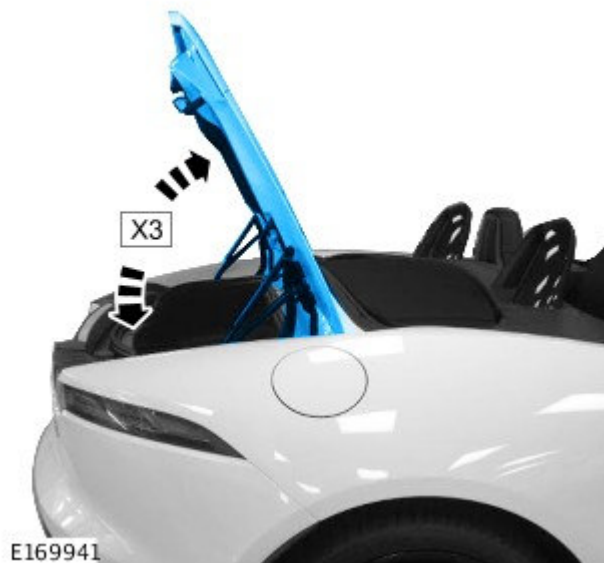
1. Open and 'slam shut' the luggage compartment lid three (3) times.

2. Open the luggage compartment lid and make sure the luggage compartment lid trim is securely in place.

- If the luggage compartment lid trim is securely held in place, continue to step 5.
- If the luggage compartment lid trim is not securely held in place, continue to step 3.

3. If the luggage compartment lid trim is loose / hanging / detached from **any** of the retaining clips, continue to step 4.

Replace the luggage compartment lid liner.
