© 2012 Mazda Motor of America, Inc.

<b>Subject:</b> <b>CONDENSATION / FOG IN FRONT AND REAR COMBINATION LIGHTS</b>	<b>Bulletin No:</b> 09-046/12
	<b>Last Issued:</b> 12/21/2012

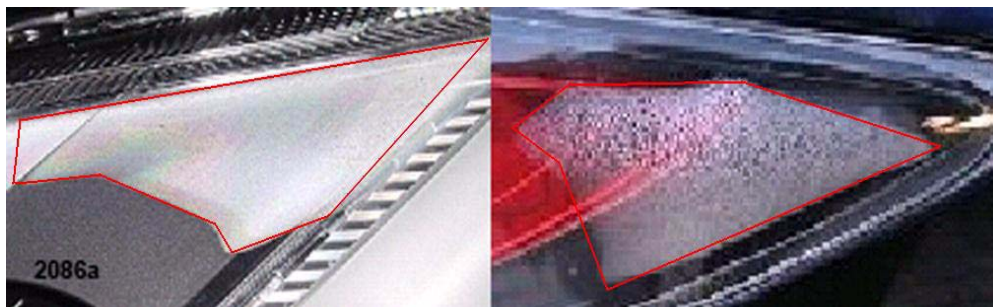
Some customers may complain of condensation/fog inside the front or rear combination lights. The recent new models have been fitted with a clear lens which can cause the symptom to be more noticeable, however, it does not affect the performance of the light. This condensation/fog is a natural phenomenon that occurs when there is a fairly large temperature difference between the inside and the outside of the light housing. It is normal for very small water drops to appear in certain locations on the light units where the air is stagnant (condensation), making the lens look whitish (fog). This happens mostly in the corners and narrow spaces, and will typically clear during warmer ambient temperatures, or when the lights have been on for some time.

Explain to the customer that this is a natural phenomenon and not a quality defect. DO NOT attempt repairs as this is considered normal, and is NOT covered under Warranty. Replacing the light unit will not correct this symptom.
