Subject: INFORMATION DISPLAY SHOWS "FOW INSPECTION REQUIRED" AND DTC C1A67:78 IS STORED	Bulletin No: 01-016/14
	Last Issued: 07/08/2014

2014 Mazda6 vehicles with VINs lower than JM1 GJ ***** 149082 (produced before October 01, 2013)

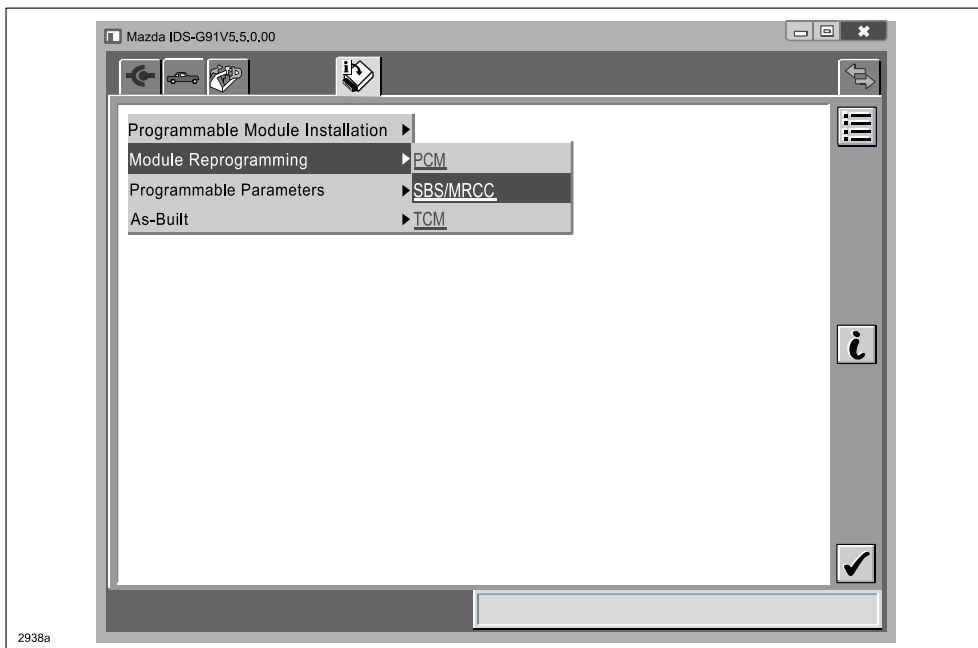
- a. Select “Module Reprogramming”, then select “SBS/MRCC”.

NOTE: The menu “SBS/MRCC” appears regardless of the equipment of MRCC System. For vehicles without the MRCC System, do not click this menu.
