Classification:	Reference:	Date:
EL18-010	ITB18-012	March 19, 2018

2017-2018 QX30; DEACTIVATION AND ACTIVATION OF INTELLIGENT KEYS

APPLIED VEHICLES: 2017-2018 QX30 (H15)

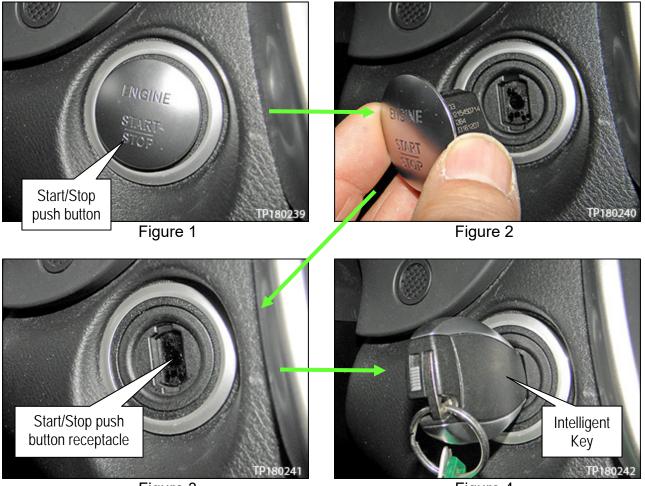
a. Gently remove the Start/Stop push button (Figure 1) by hand (Figure 2), to expose the Start/Stop push button receptacle.

b. Insert Intelligent Key (Figure 4) into the Start/Stop push button receptacle.
