TECHNICAL INSTRUCTIONS

LIMITED SERVICE CAMPAIGN G0T

SOFTWARE UPDATE FOR COMBINATION METER

CERTAIN 2016 MODEL YEAR PRIUS

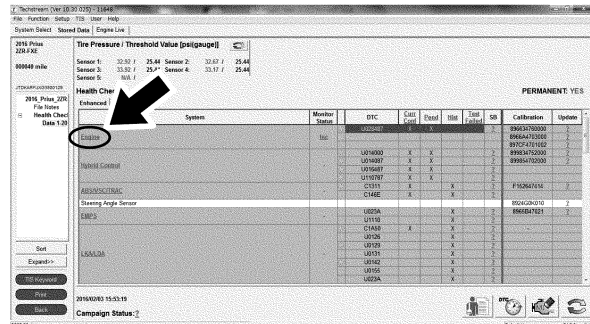
S07020aS

- a) Click on "Engine"

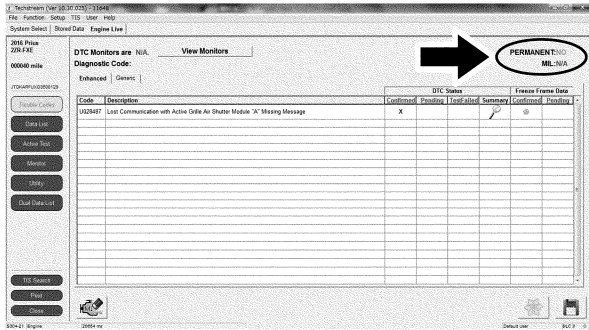
S07017aS

- b) Turn the power switch on (READY), and wait for 60 seconds.
- c) Turn the power switch off, and wait for 90 seconds.

“PERMANENT” and “MIL” indicators change in 90 seconds after the power switch is turned off.

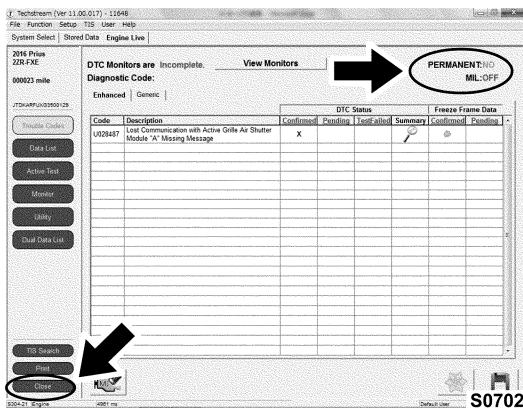
S07022aS

- d) Turn the power switch on (READY) again.
- e) Repeat steps (b) and (c) instructed above until “PERMANENT” and “MIL”, which are provided in the top right of the screen, show “NO” and “OFF” respectively.
- f) Turn the power switch off.
- g) Turn the power switch on (IG).
- h) Click on “Close.”
