NUMBER: WQL-48R

PRODUCT CAMPAIGN BULLETIN

APPLICABILITY: 2003-2004 Subaru Legacy and Outback

SUBJECT: Front Passenger Air Bag Inflator Replacement

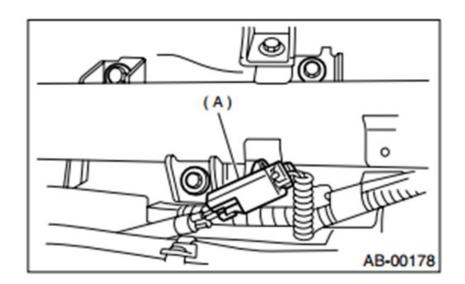
- Disconnect the airbag module harness connector (A) and release it from the support beam bracket.

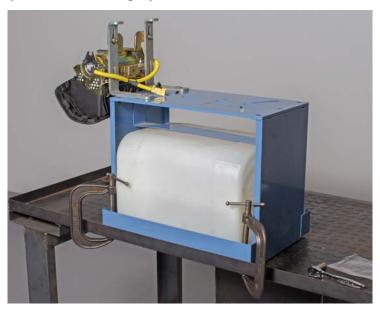
• IMPORTANT: The removed airbag module must be mounted to the Airbag Deployment Fixture (part number J-39401-B) as shown in the photo below to better secure it during the inflator and wiring harness component replacement procedures. When mounting the module to the fixture, pay close attention to the harness routing as shown in the photo below. Always perform this work in an area away from others to reduce chances of inadvertent injury should any deployment occur. Take your surroundings into account to avoid possible hazards should inadvertent deployment occur or sources of static or other electricity that could potentially induce such a deployment.

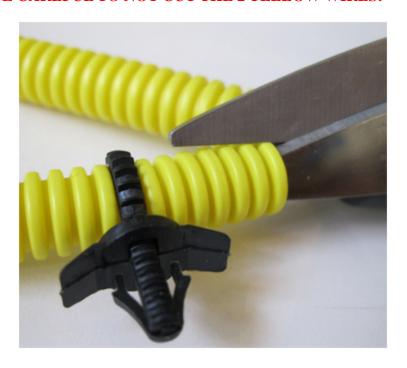
STEP 3- <u>CAREFULLY</u> cut the yellow harness cover (approximately 1 1/2 inches) enough to expose the 2 yellow wires inside and provide enough room to install the Electro-Tap (shorting) connector using a scissor or wire cutter (no knives or razors). **TAKE YOUR TIME AND BE CAREFUL TO NOT CUT THE 2 YELLOW WIRES!**

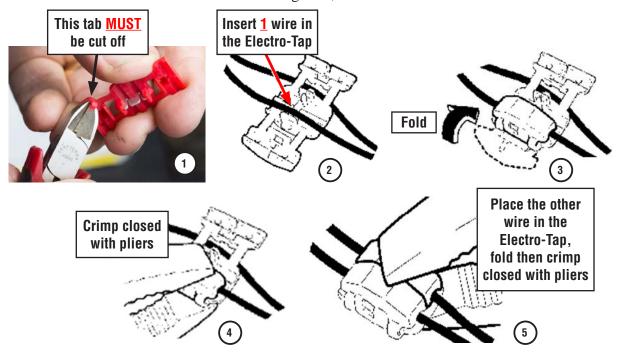
STEP 4- Short the 2 yellow wires together by installing the Electro-Tap connector. The connector creates a short circuit which acts as a safeguard to prevent against static discharge that may deploy the removed inflator. The tab portion of the Electro-Tap connector **MUST** be cut off prior to use to insure a good short-circuit is made as shown in the illustration below. **Follow the sequence below** for installing the Electro-Tap connector. Use pliers to squeeze closed the two sections of the connector together, **one section at a time**.

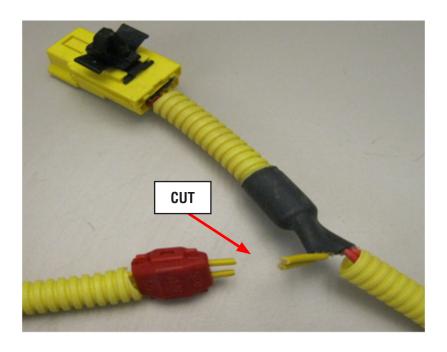
STEP 5- Once the Electro-Tap connector is fully crimped in place, cut the 2 yellow wires on the **body harness connector side** of the Electro-Tap connector.

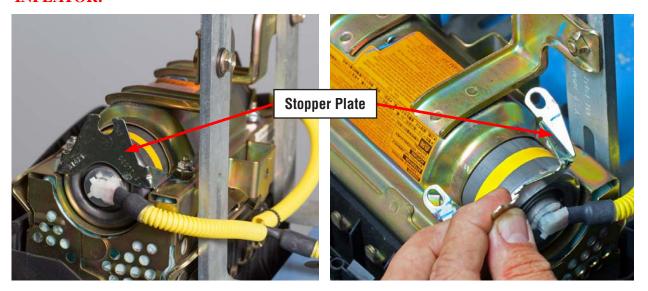
STEP 6- Remove the two 8mm self-locking nuts securing the stopper plate. Loosen but **do not remove** the other two nuts on the mounting bracket as leaving them in place will help keep the airbag assembly together.

NEVER ATTEMPT TO REMOVE THE HARNESS CONNECTORS FROM THE INFLATOR!

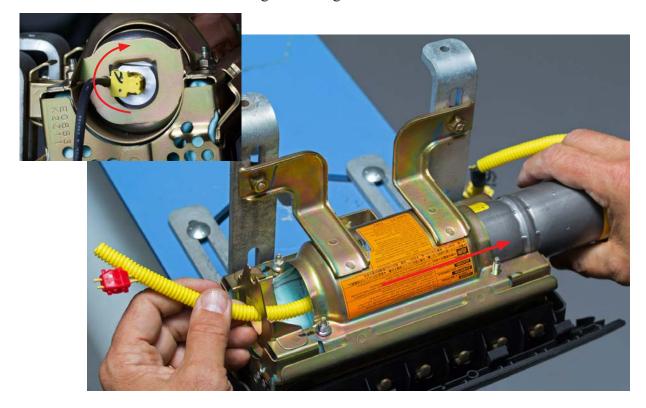
STEP 7- With the stopper plate removed and the other 2 self-locking nuts loosened, unseat the inflator off the mounting bracket end plate then rotate it slightly **CLOCKWISE** to make it easier to remove as shown below. Slide the original inflator out of the mounting bracket while feeding the cut off portion of the wiring harness through the "D-Shaped" hole in the end plate. **NEVER ATTEMPT TO REMOVE THE HARNESS CONNECTORS FROM THE INFLATOR!** Place the removed original air bag inflator in the "cradle" of the Kit Box insert.

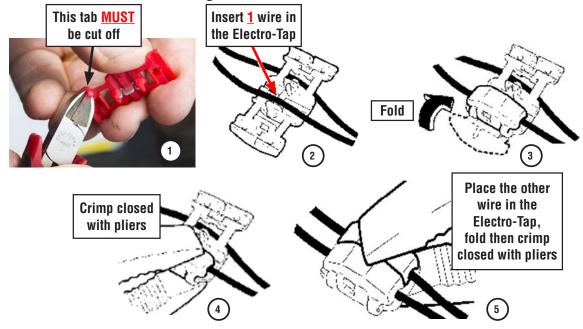
STEP 4- Short the 2 wires together by installing the Electro-Tap connector. The connector creates a short circuit which acts as a safeguard to prevent against static discharge that may deploy the removed inflator. The tab portion of the Electro-Tap connector **MUST** be cut off prior to use to insure a good short-circuit is made as shown in the illustration below. **Follow the sequence** below for installing the Electro-Tap connector. Use pliers to squeeze closed the two sections of the connector together, **one section at a time**.

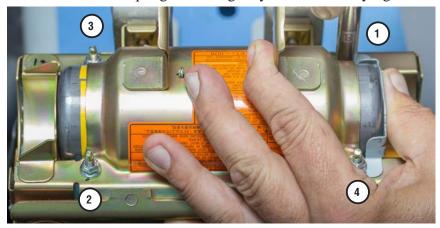
STEP 10- As shown below, install but do not fully tighten 2 of the NEW self-locking nuts while holding the stopper plate tight against the inflator. Remove the nuts still installed on the mounting bracket and replace them with 2 **NEW** self-locking nuts. Once all 4 **NEW** nuts are in place, torque to 31 - 38 inch pounds in the sequence shown below. Use a marker to mark the nuts after torquing indicating they have been fully tightened.

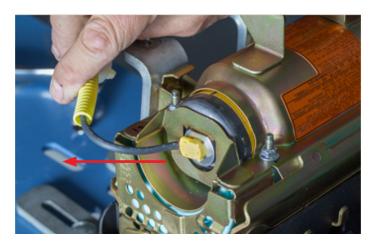
STEP 11- VERY IMPORTANT: When connecting the new harness to the inflator, the harness MUST be routed toward the module's mounting brackets as shown in the photo below. Peel off the white dust cover and CAREFULLY align the 2 inflator pins with the female terminals of the harness connector as shown in the sequence below. Once pin alignment is confirmed, push down firmly to engage the connector's 2 locking tangs into the locking groove of the connector boss. Confirm the connector is fully locked by prying up LIGHTLY with a small flat-blade screwdriver.

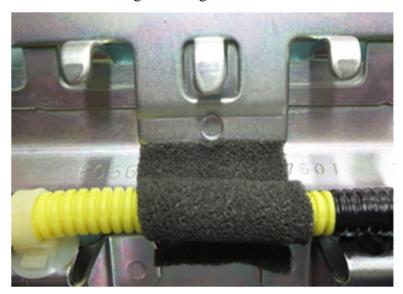
STEP 13- Peel the adhesive backing and install the new Sponge Tape onto the yellow harness tube first then adhere it to the airbag mounting bracket as shown in the illustrations below.
