Subject: Update – Limited Service Campaign 9SM

Subject: Limited Service Campaign – 9SM
Certain 2000 – 2003 Model Year Toyota Tundra Vehicles
Excessive Corrosion of the Rear Cross-Member

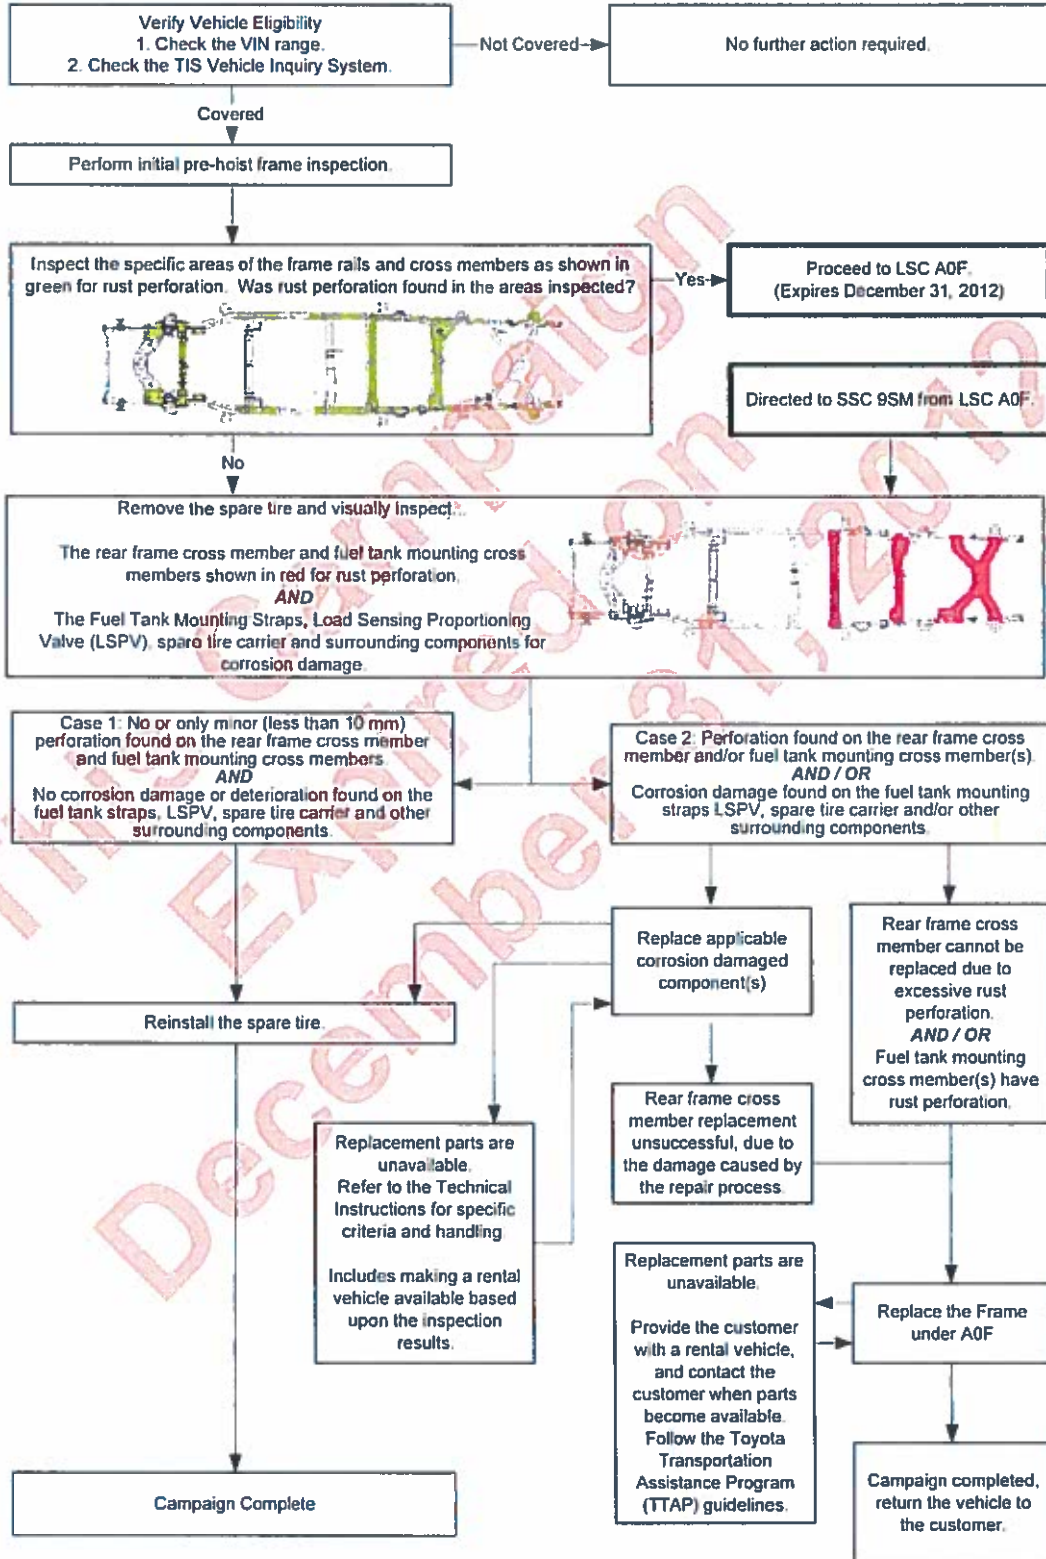
OPERATION FLOW CHART

- This Limited Service Campaign involves the inspection of the Rear Cross-Member, Fuel Tank Mounting Cross-members, Brake Tubes, LSPV, Spare Tire Carrier and Fuel Tank Strap, and if applicable the replacement of the aforementioned parts.

Safety Recall #	Op. Code	Description	Flat Rate Hour
9SM	0624M A	Inspect the Rear Cross-Member and surrounding components for Rust Perforation [Minor or No Rust Perforation found of the rear cross-member or fuel tank mounting system and no surrounding component damage found] (CASE 1 shown in the Flow Chart) NO PARTS REPLACEMENT REQUIRED	0.5 hr/vehicle
	0624M B	Inspect the Rear Cross-Member and surrounding components for Rust Perforation Rust Perforation and/or surrounding component damage found (CASE 2 shown in the Flow Chart) PARTS REPLACEMENT REQUIRED	0.5 hr/vehicle
