Technical Service Bulletin

SUBJECT:			No: TSB-16-13-001
ECM REPROGRAMMING FOR HARD TO RE-START ENGINE WITH LOW COOLANT TEMPERATURE			DATE: January, 2016
			MODEL: 2014-15 Outlander
CIRCULATE TO:	<input type="checkbox"/> GENERAL MANAGER	<input type="checkbox"/> PARTS MANAGER	<input checked="" type="checkbox"/> TECHNICIAN
<input checked="" type="checkbox"/> SERVICE ADVISOR	<input checked="" type="checkbox"/> SERVICE MANAGER	<input checked="" type="checkbox"/> WARRANTY PROCESSOR	<input type="checkbox"/> SALES MANAGER

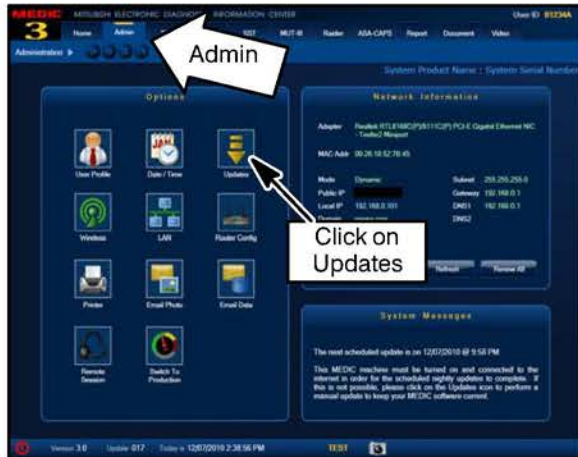
2. Verify the MEDIC 3/4 is at version 3.5 and at update **357** or higher.

If your **MEDIC 3/4 update is at least 357**, continue with the Reprogramming Procedure on page 4.

If your **MEDIC 3/4 update is below 357**, update your MEDIC as follows.

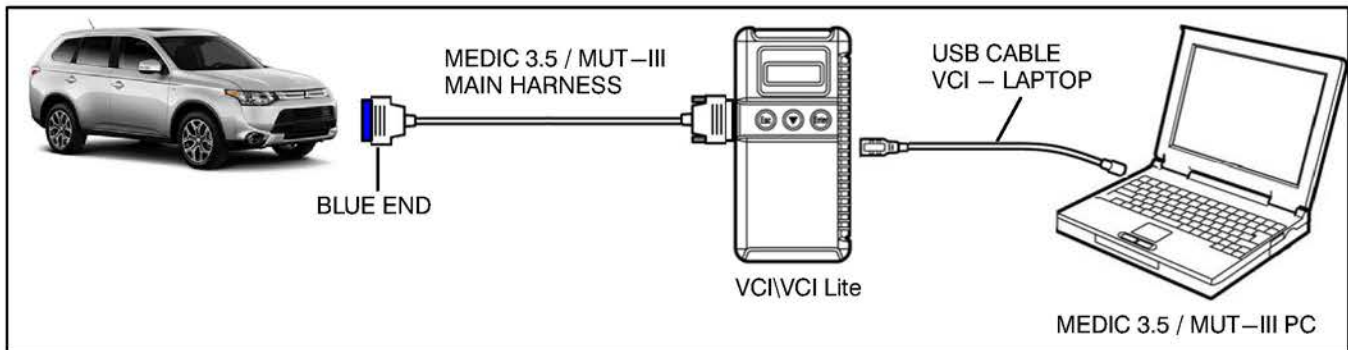
- Turn the MEDIC PC/tablet on. If the battery indicator in the lower right hand corner of the screen does not show a full charge, it is recommended that either the battery be charged prior to beginning, or be used with the A/C power adaptor connected.
- Connect the USB cable to the VCI/VCI Lite.
- When the laptop/tablet displays the MUT-III main screen, connect the USB cable to the device.
- Connect the MUT-III main harness with the blue DLC connection to the VCI/VCI Lite.
- Connect the blue connection of the MUT-III main harness to the vehicle's data link connector.
- Turn the VCI power switch ON . Verify that the indicator lamp in the upper right corner of the screen is green.

NOTE: VCI and MEDIC 3.5 Laptop shown for illustration purposes only.

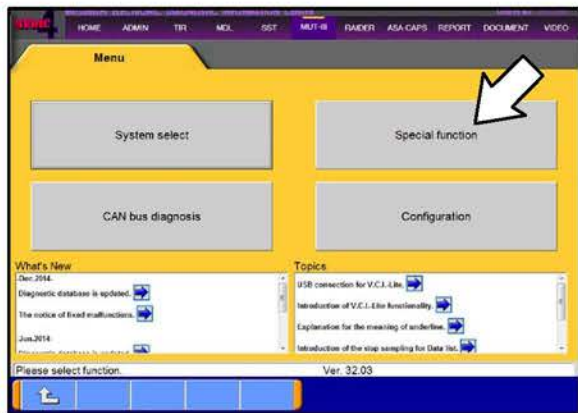
3. If using MEDIC, from the main page, click the MUT-III STV icon at the top center of the screen to open MUT-III.

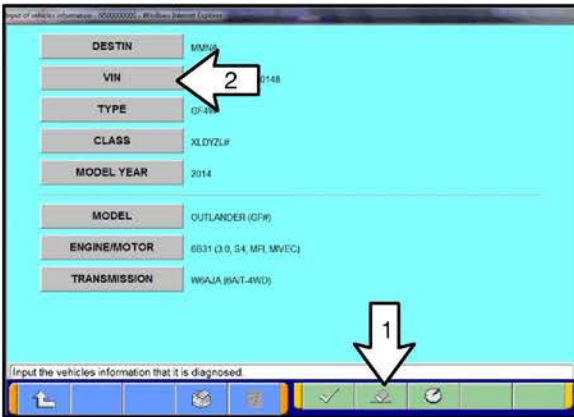
7. Press the model information display button (car icon) and verify that all vehicle information is correct.

- If vehicle information is NOT correct, follow steps a – c below.
- If vehicle information is correct, click the check mark at the bottom of the page, then go to step 8.

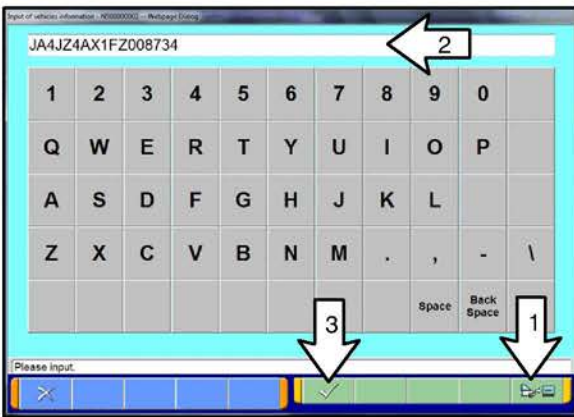
- a. If the VIN or vehicle description displayed does not match the vehicle you are working on, click the eraser icon at the bottom of the page to erase vehicle data. Then click the “VIN” button.

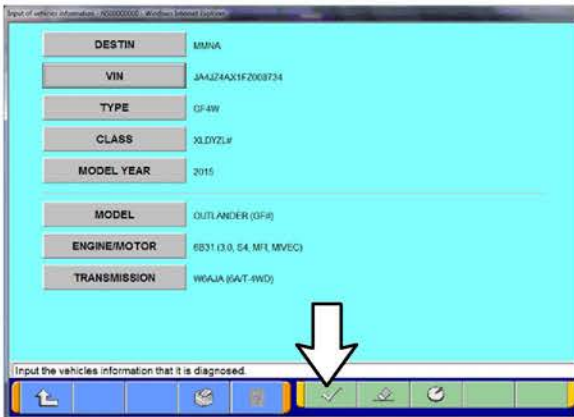
- b. Click the icon in the lower RH corner of the screen to have MUT—III automatically read the VIN.

If a message appears saying the VIN cannot be input automatically, manually enter the 17 digit VIN into the VIN field at the top of the page.

Make sure the VIN is correct and click the check mark.

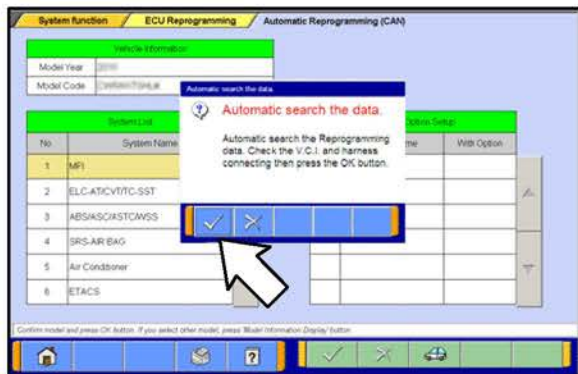
8. “MFI” should be highlighted by default. If not, click on it to highlight it. Click the **check mark** to continue.

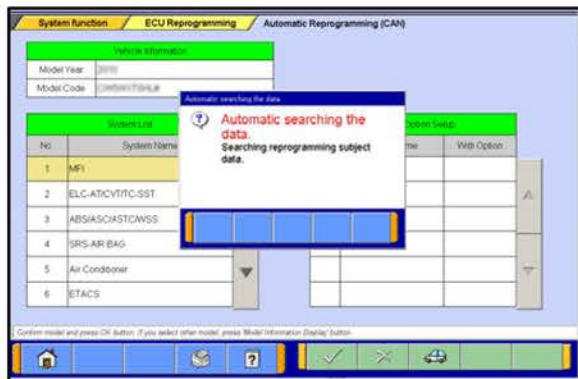
9. A message will advise the system will “Automatic search the data.”

Click the check mark to continue.

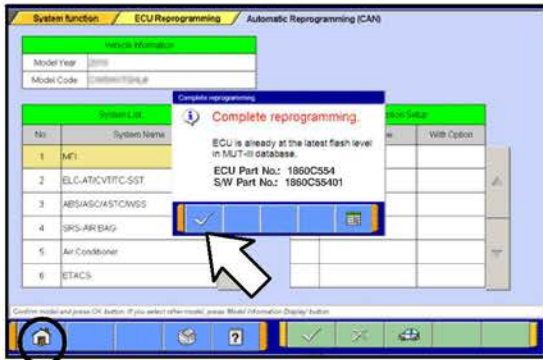
IF ECU IS ALREADY AT LATEST VERSION

If the message seen at left is displayed, the ECU software is already at the most current level. Do not continue with the reprogramming procedure. This TSB does **not** apply.

Click the check mark to clear the window, then click the Home icon at the lower left corner of the screen to return to the System Select main page.

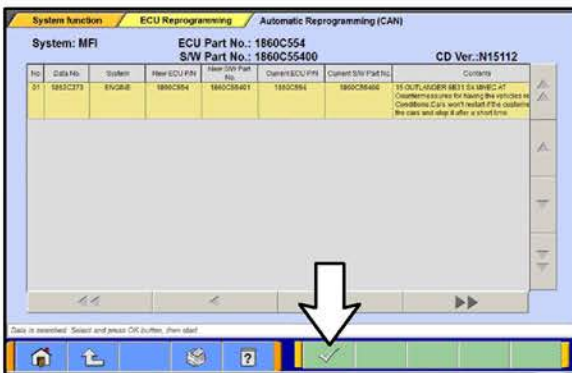
If a "Complete Reprogramming" message **does not** appear, continue with the reprogramming procedure.

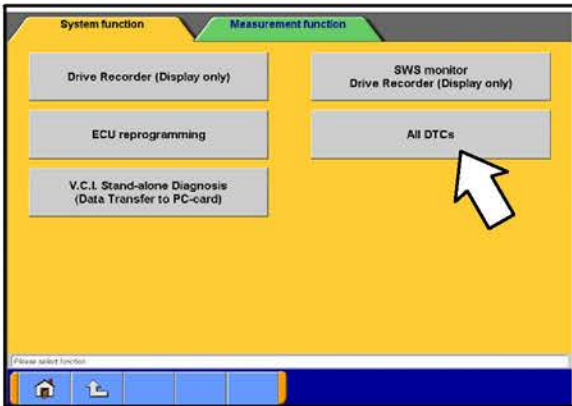
16. Perform an "Erase and Read all DTCs."
 - a. Select "Special function."

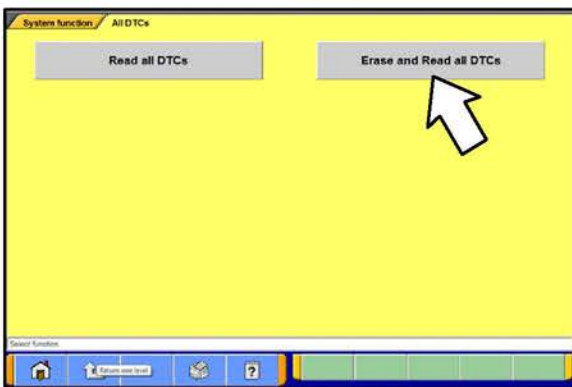
b. Select "All DTCs."

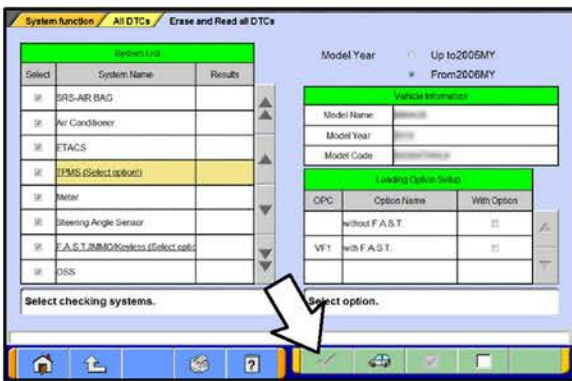
c. Select "Erase and Read All DTCs."

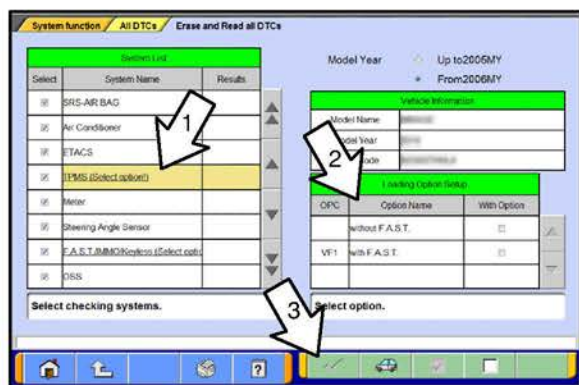
d. The "System List" on the left side of the screen will have all selections checked. Do not change these selections. DTCs may be set if the vehicle is equipped with options that are unchecked.

e. Click the check mark to continue.
