June 20, 2017

06542 Version 1

2014–17 Odyssey: Judder from the Torque Converter Lock-Up Clutch

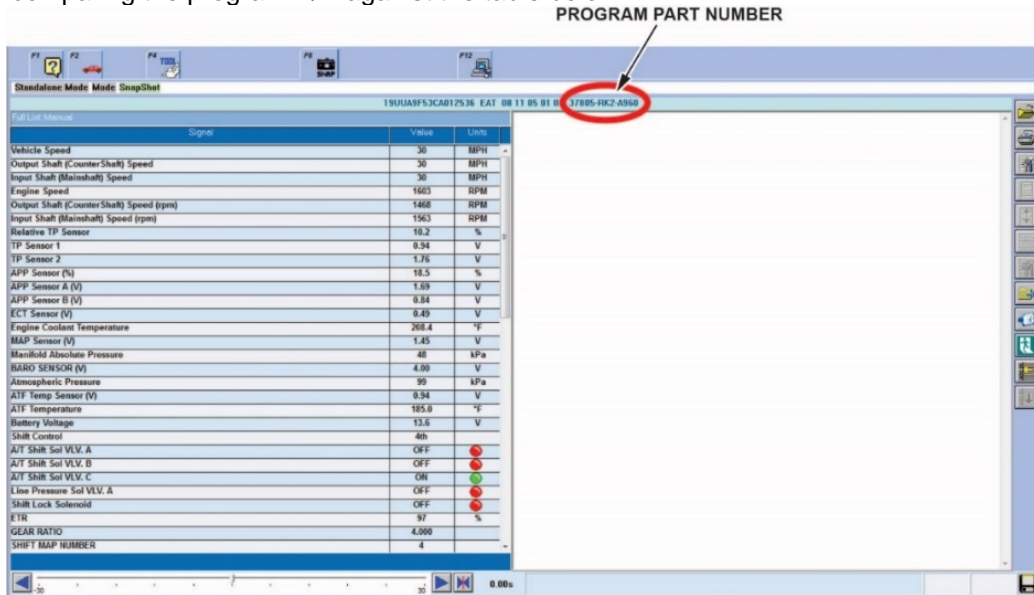
PROGRAM PART NUMBER

Signal	Value	Units
Vehicle Speed	30	MPH
Output Shaft (CounterShaft) Speed	30	MPH
Input Shaft (Mainshaft) Speed	30	MPH
Engine Speed	1663	RP#
Output Shaft (CounterShaft) Speed (rpm)	1468	RP#
Input Shaft (Mainshaft) Speed (rpm)	1563	RP#
Relative TP Sensor	10.2	%
TP Sensor 1	0.94	V
TP Sensor 2	1.76	V
APF Sensor (I)	10.5	%
APF Sensor A (V)	1.08	V
APF Sensor B (V)	0.84	V
ECT Sensor (V)	0.48	V
Engine Coolant Temperature	208.4	°F
MAP Sensor (V)	1.45	V
Manifold Absolute Pressure	48	kPa
BARO SENSOR (V)	4.06	V
Atmospheric Pressure	99	kPa
ATF Temp Sensor (V)	0.94	V
ATF Temperature	185.0	°F
Battery Voltage	13.6	V
Shift Control	4th	
AT Shift Sol VLV. A	OFF	●
AT Shift Sol VLV. B	OFF	●
AT Shift Sol VLV. C	ON	●
Line Pressure Sol VLV. A	OFF	●
Shift Lock Solenoid	OFF	●
ETR	97	%
GEAR RATIO	4.000	
SHIFT MAP NUMBER	4

1. Connect the i-HDS, and go to the A/T Data List. Check the program P/N.
 - If the software program P/N starts with **37805**, it is a **Continental** PCM. There is no software available at this time, go to VERIFICATION PROCEDURE.
 - If the software program P/N starts with **37806**, it is a **Keihin** PCM. Check if the PCM has been updated by comparing the program P/N against the table below.

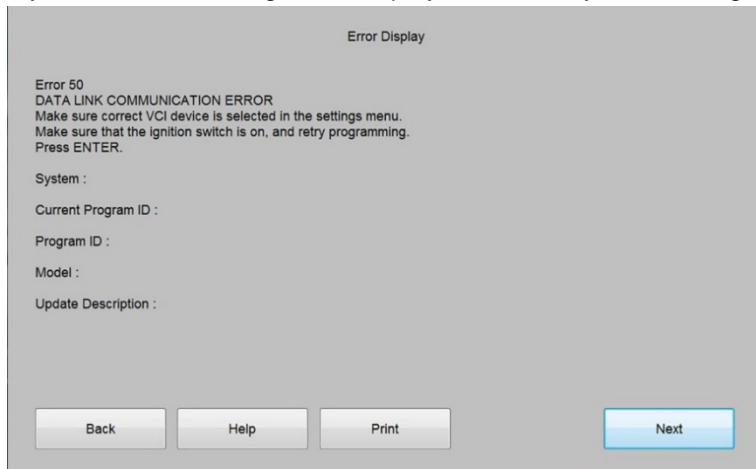
- You can't update the vehicle using the MVCI as a standalone tool.
- **Do not** use the MongoosePro VCI tool.
- Make sure the 12 volt battery is fully charged before starting an update.
- Connect a fully charged jumper battery to the vehicle and leave it connected during the entire procedure to maintain steady voltage.
- Never turn the ignition to OFF or ACCESSORY during the update. If there is a problem with the update, leave the ignition turned to ON.
- To prevent PCM damage, do not operate anything electrical (headlights, audio system, brakes, A/C, power windows, door locks, etc.) during the update.
- If you see the following Error Display, check that you are using the correct tool (MVCI or DST-i) with the i-HDS.

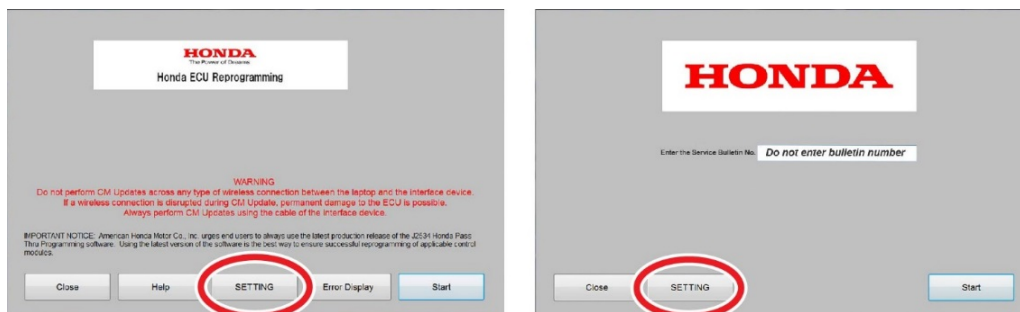
To change this, click on either of the SETTING selection buttons at the bottom of the J2534 initial screens as shown.

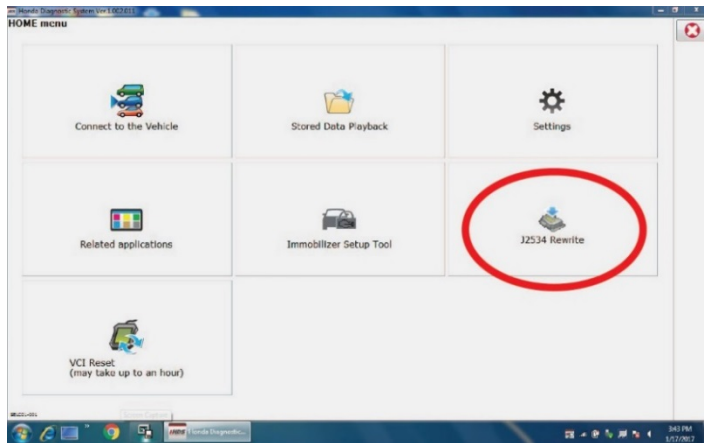
2. Select **J2534 Rewrite**.

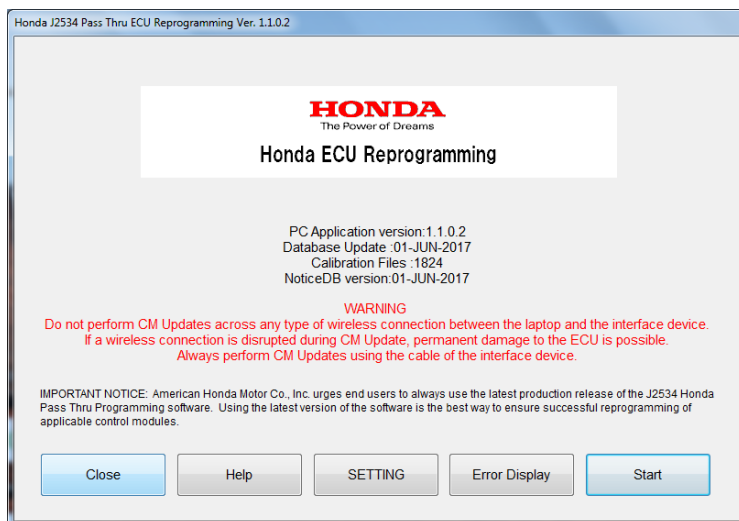
3. Confirm the software is the same **or later** as listed in SOFTWARE INFORMATION.

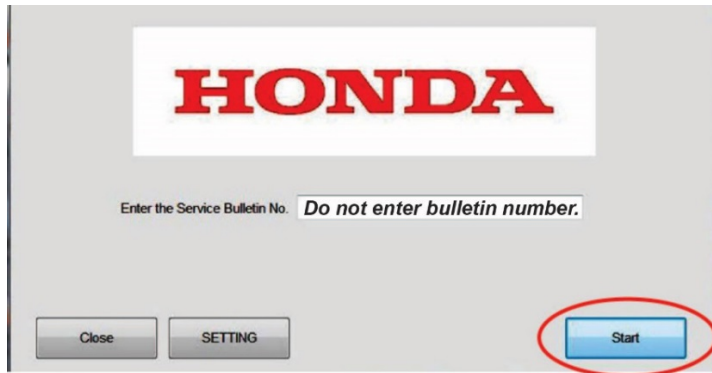
- **Don't enter a bulletin number.**
- If you receive a message that the vehicle has been already updated or that no update is available, check the transmission data list. The header should indicate one of the following numbers (or later).

37806-RV0-5070
